March 30, 2022
Crawford No. 19-514.1

Subject: **FINAL GEOTECHNICAL MEMORANDUM**
Evaluation of Slope Creep Along Segment 2 of the Raw Water Pipeline
Project
Fort Bragg, California

City of Fort Bragg Raw
 Water Pipeline Replacement
 Segment 2 Slope Stabilization
 Fort Bragg, CA

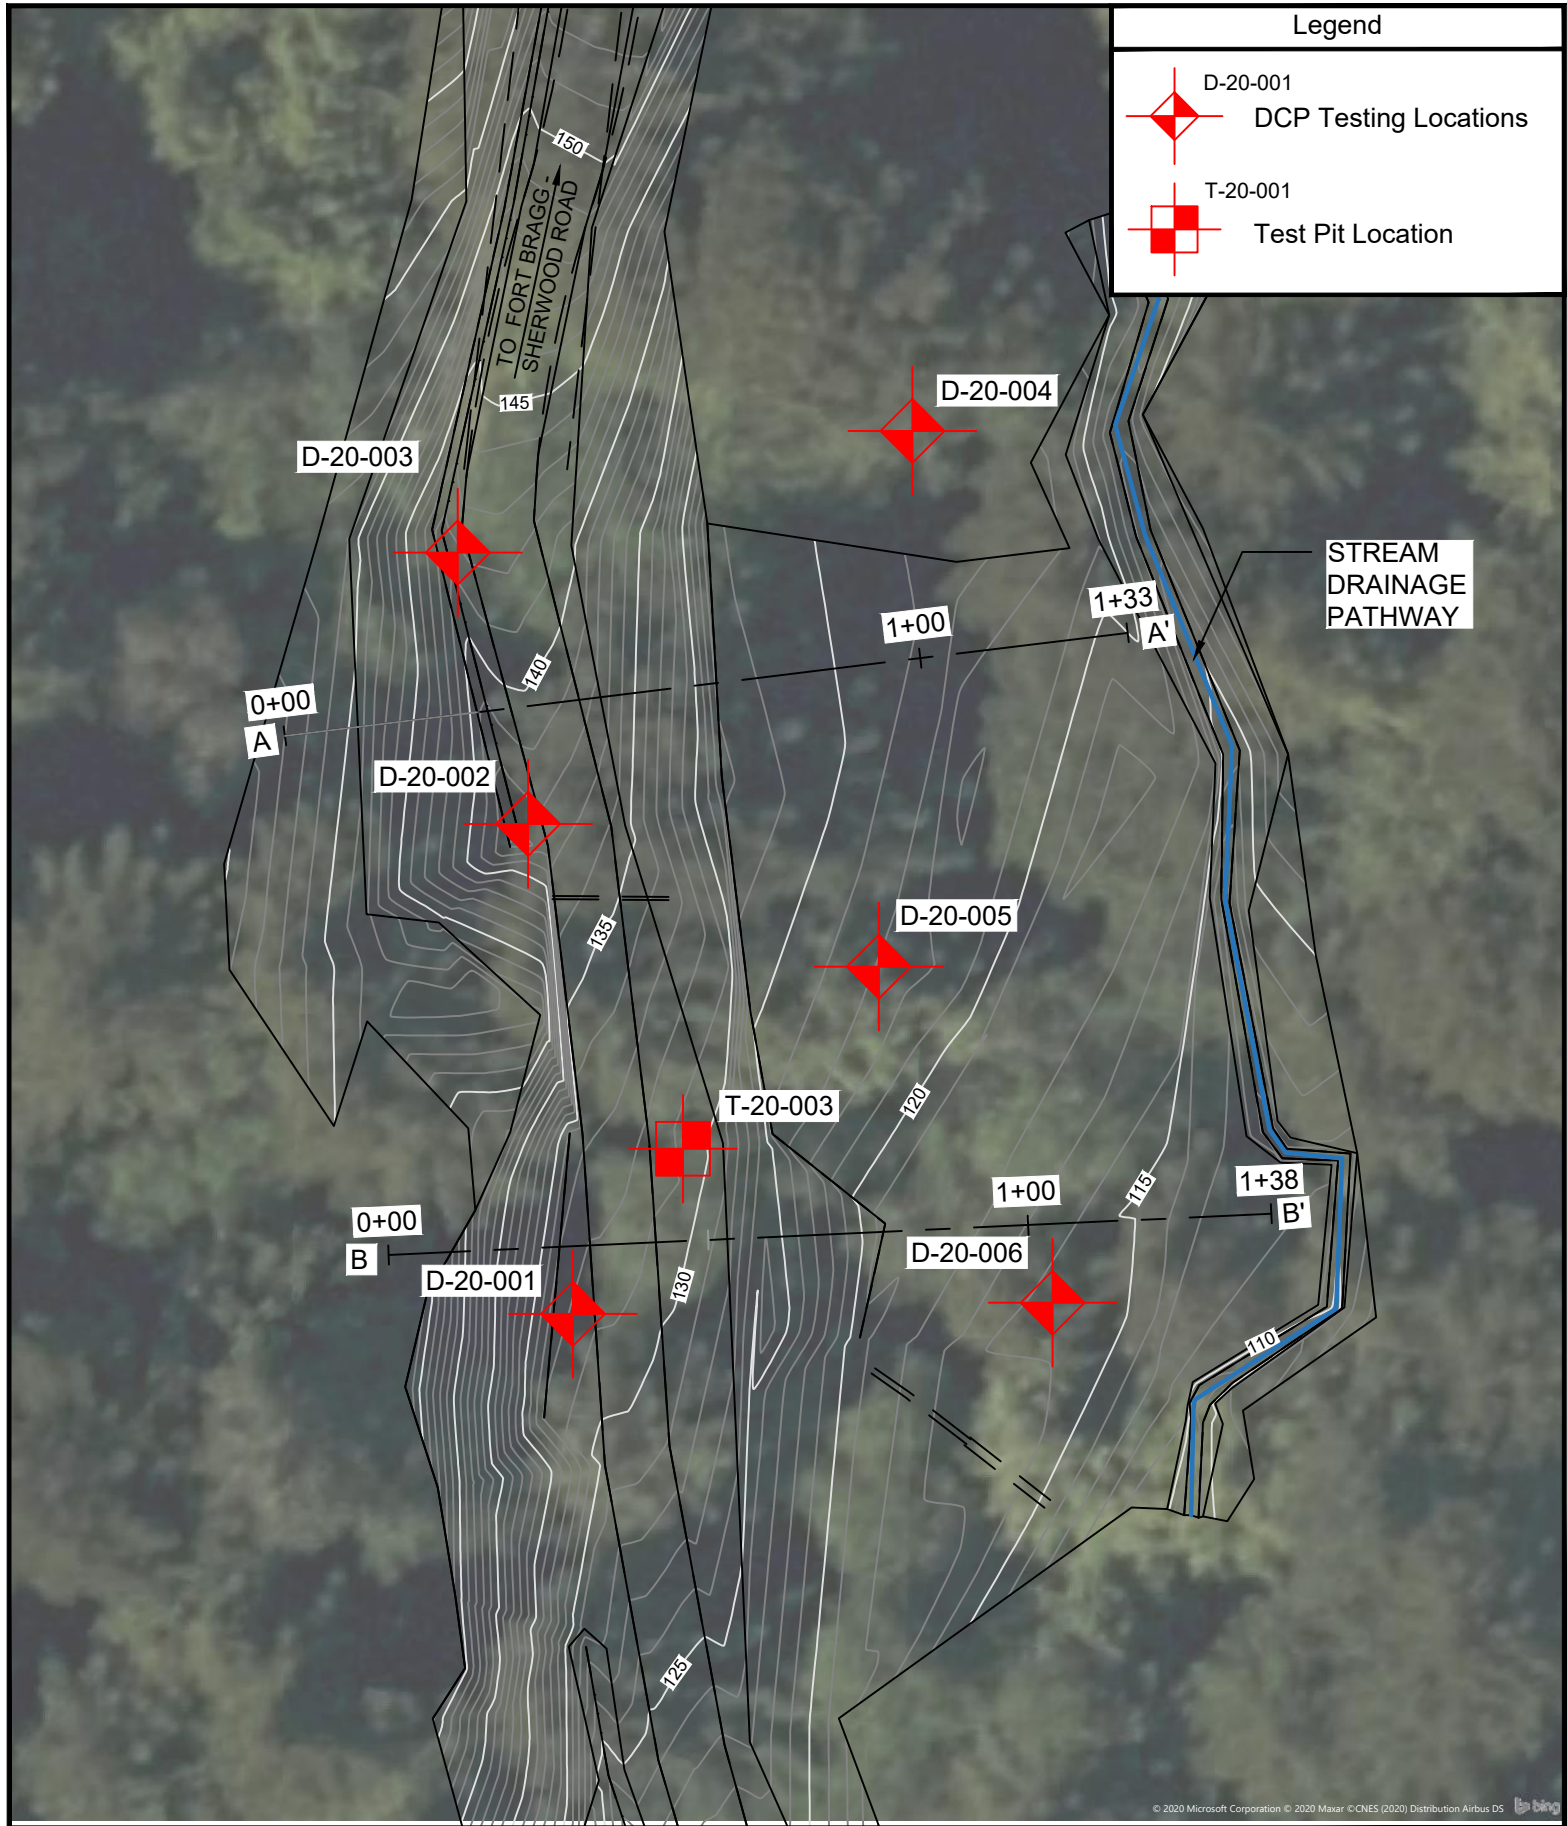
Figure 2
 Location of Field
 Tests

Three DCP tests were completed along the access road at the toe of the upslope, and three DCP tests were completed downslope of the access road. Groundwater observations were recorded during field operations when/if encountered.

The DCP tests completed at the toe of the upslope (D-20-001, D-20-002, and D-20-003) along the access roadway generally encountered very soft to medium stiff cohesive material (Unit 1) to a depth of 3.7 ft, 6.0 ft, and 7.0 ft, respectively. T-20-003 encountered Unit 1 materials to a depth of approximately 4.0 ft. The DCP tests conducted downslope (D-20-004, D-20-005, and D-20-006) of the access roadway generally encountered Unit 1 materials to a depth of 9.3 ft, 12.0 ft, and 11.7 ft, respectively. Unit 2 materials were encountered below Unit 1 materials and consisted of stiff to hard cohesive material to the maximum depth explored.

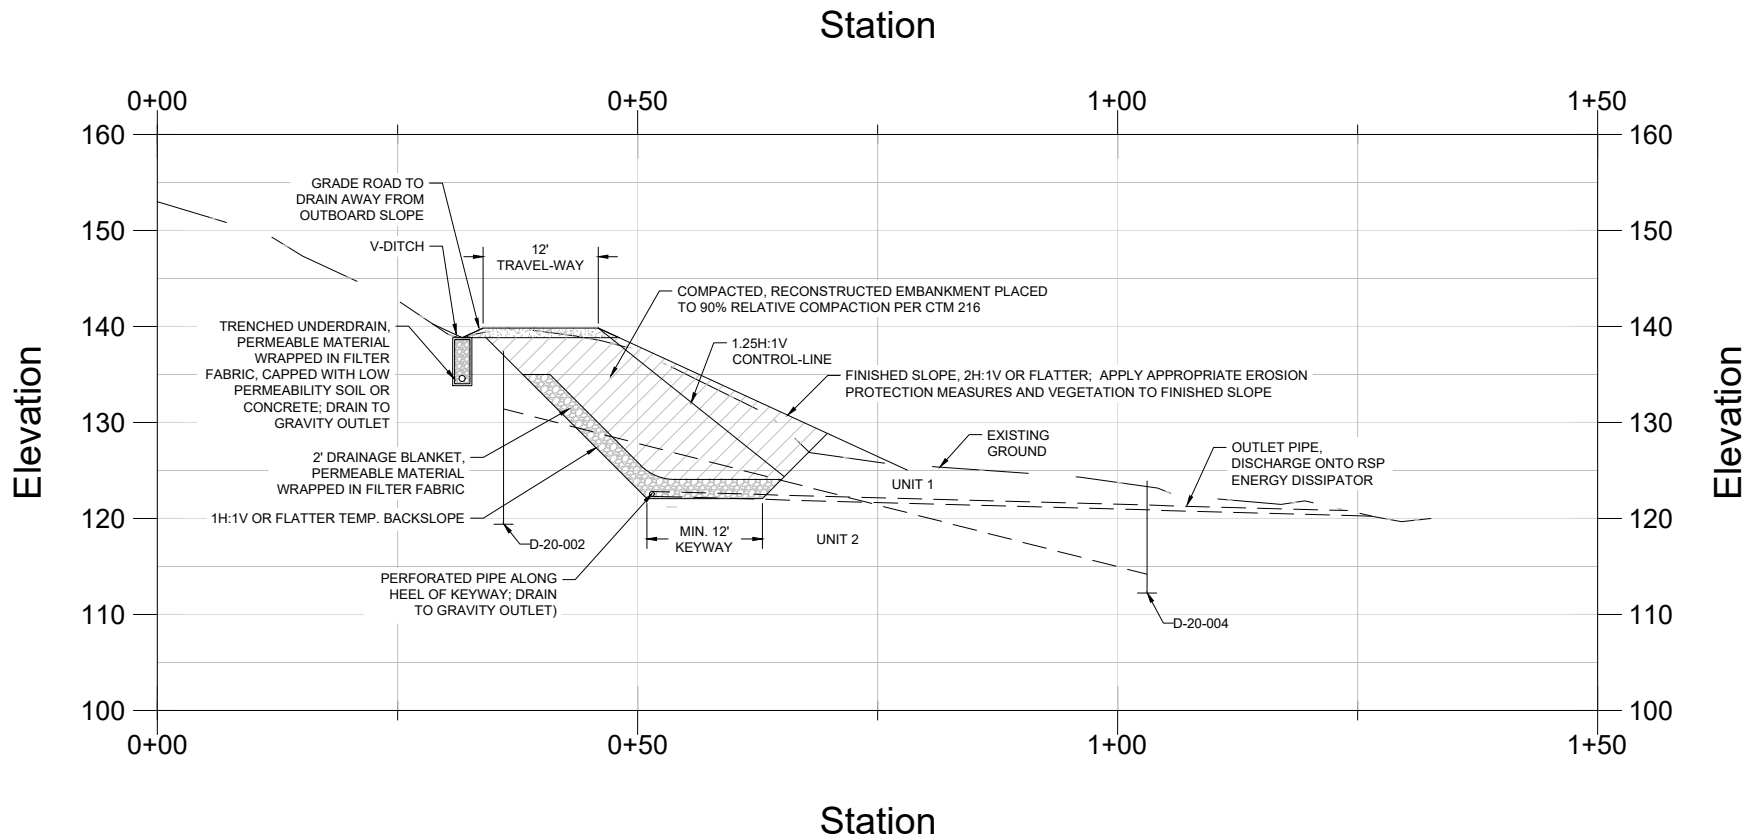
Profile View of Cross Section A-A'

Based on the limited DCP and test pit data, discussions with the City, and field observations in June 2020, the slope creep appears to be mainly a translational feature primarily occurring within Unit 1 materials with potential depth of movement at approximate depths of 4 to 7 ft deep on the inboard of the road and 10 to 12 ft deep on the slope below the roadway. The slope creep is likely caused by oversaturation and the presence of weak near surface native and fill materials. The drainage features in the area were likely overwhelmed and allowed significant storm water to infiltrate/saturate the Unit 1 materials (beneath the road) and on the over-steepened outboard slope.

Refer to Figure 6 that shows a cross-section sketch with the estimated “Intact” material plane. As discussed above, the vegetation made identifying the extent and location of the slope creep difficult during our site visit and field exploration.

The following summarizes the general key elements of the reconstructed embankment. A diagram is provided in Figure 6.

1. Reconstruct embankment section the full length of the distressed area (length to be verified by the City).
2. Establish the base of the reconstructed embankment in the central portion of the failed area, determined by extending a 1.25H:1V line downward from the restored hinge-line to the estimated Unit 2 line. Establish base at higher elevation as needed to transition at each end of repair.
