GEOTECHNICAL INVESTIGATION AND GEOLOGIC HAZARDS EVALUATION

FORT BRAGG FIRE DEPARTMENT
STATION #830
141 MAIN STREET
FORT BRAGG, MENDOCINO COUNTY,
CALIFORNIA

10511.3

July 16, 2009

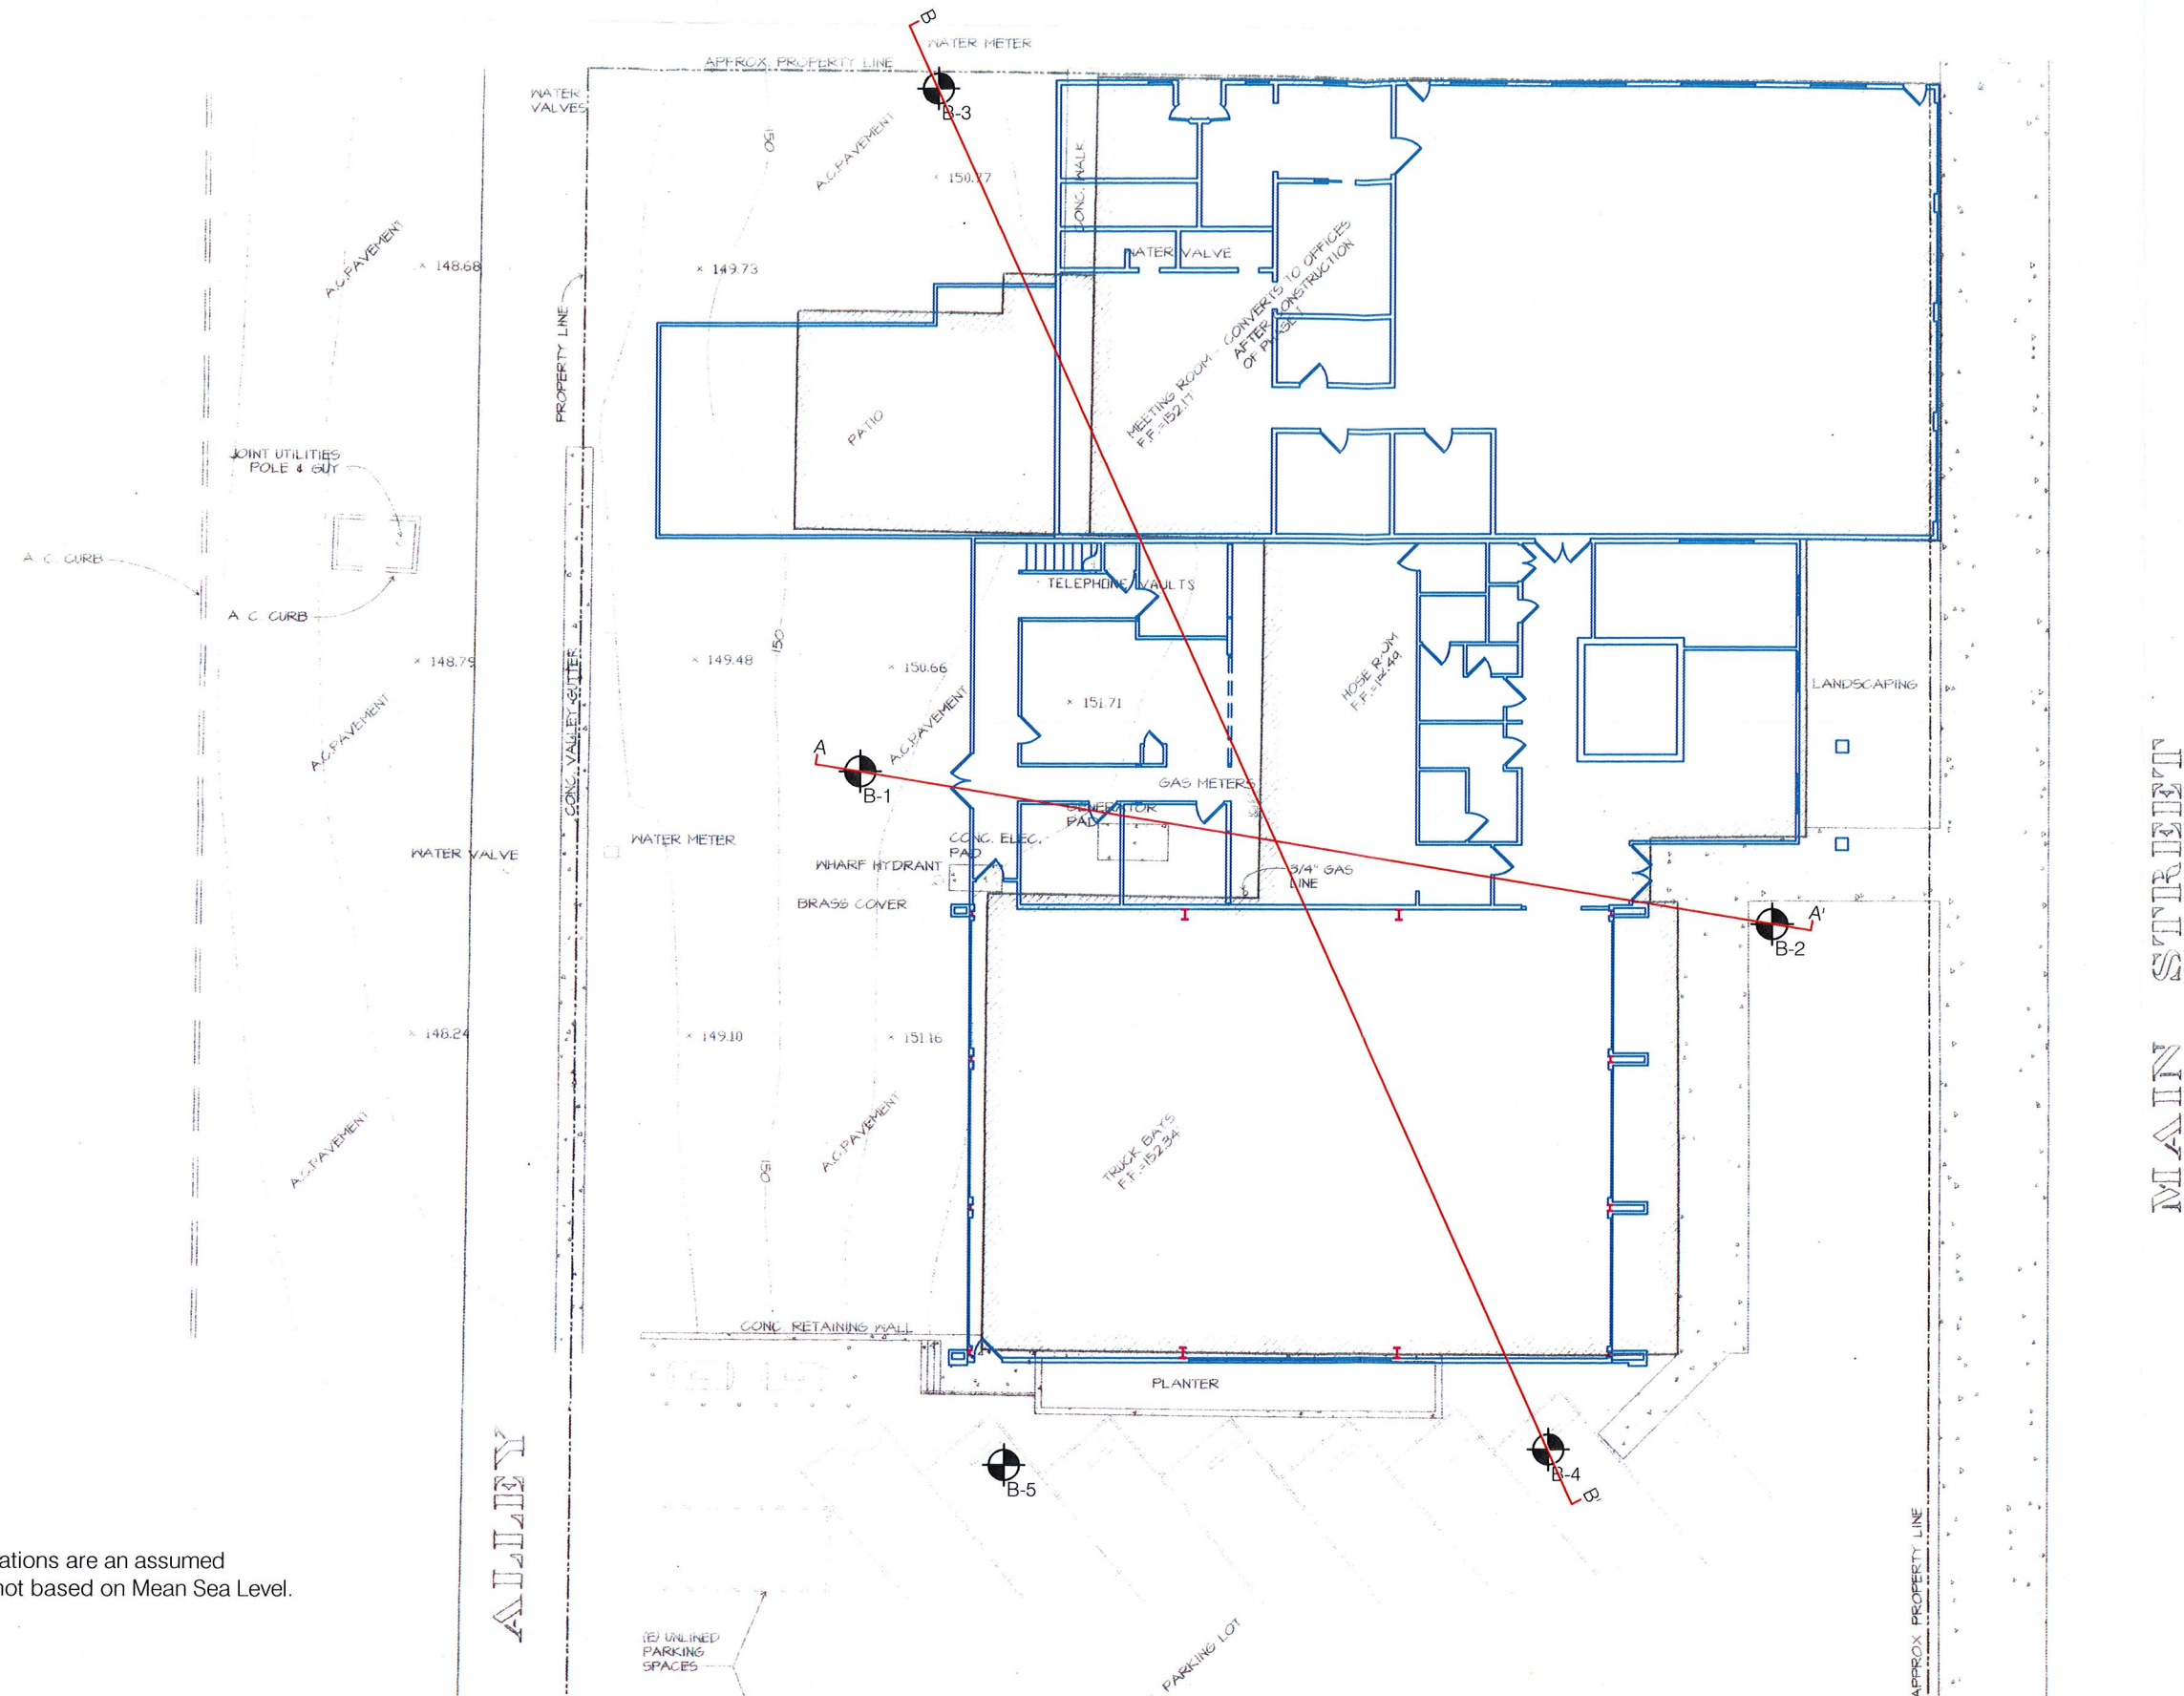
PLATE
2

Number and approximate location of test boring

Our subsurface drilling exploration was conducted on January 6, 2009, and consisted of drilling, logging, and sampling five exploratory test borings, Borings B-1 through B-5. The approximate test boring locations are shown on Plate 2. Each of the test borings was advanced to practical drilling refusal with the exception of B-4, which was terminated due to suspected petroleum hydrocarbon contamination. In each of the other borings, practical drilling refusal was encountered within bedrock between approximately 11 to 20 feet below ground surface (bgs). The borings were advanced with a truck-mounted drill rig (B-53) utilizing 7-inch diameter hollow-stem flight auger equipment.

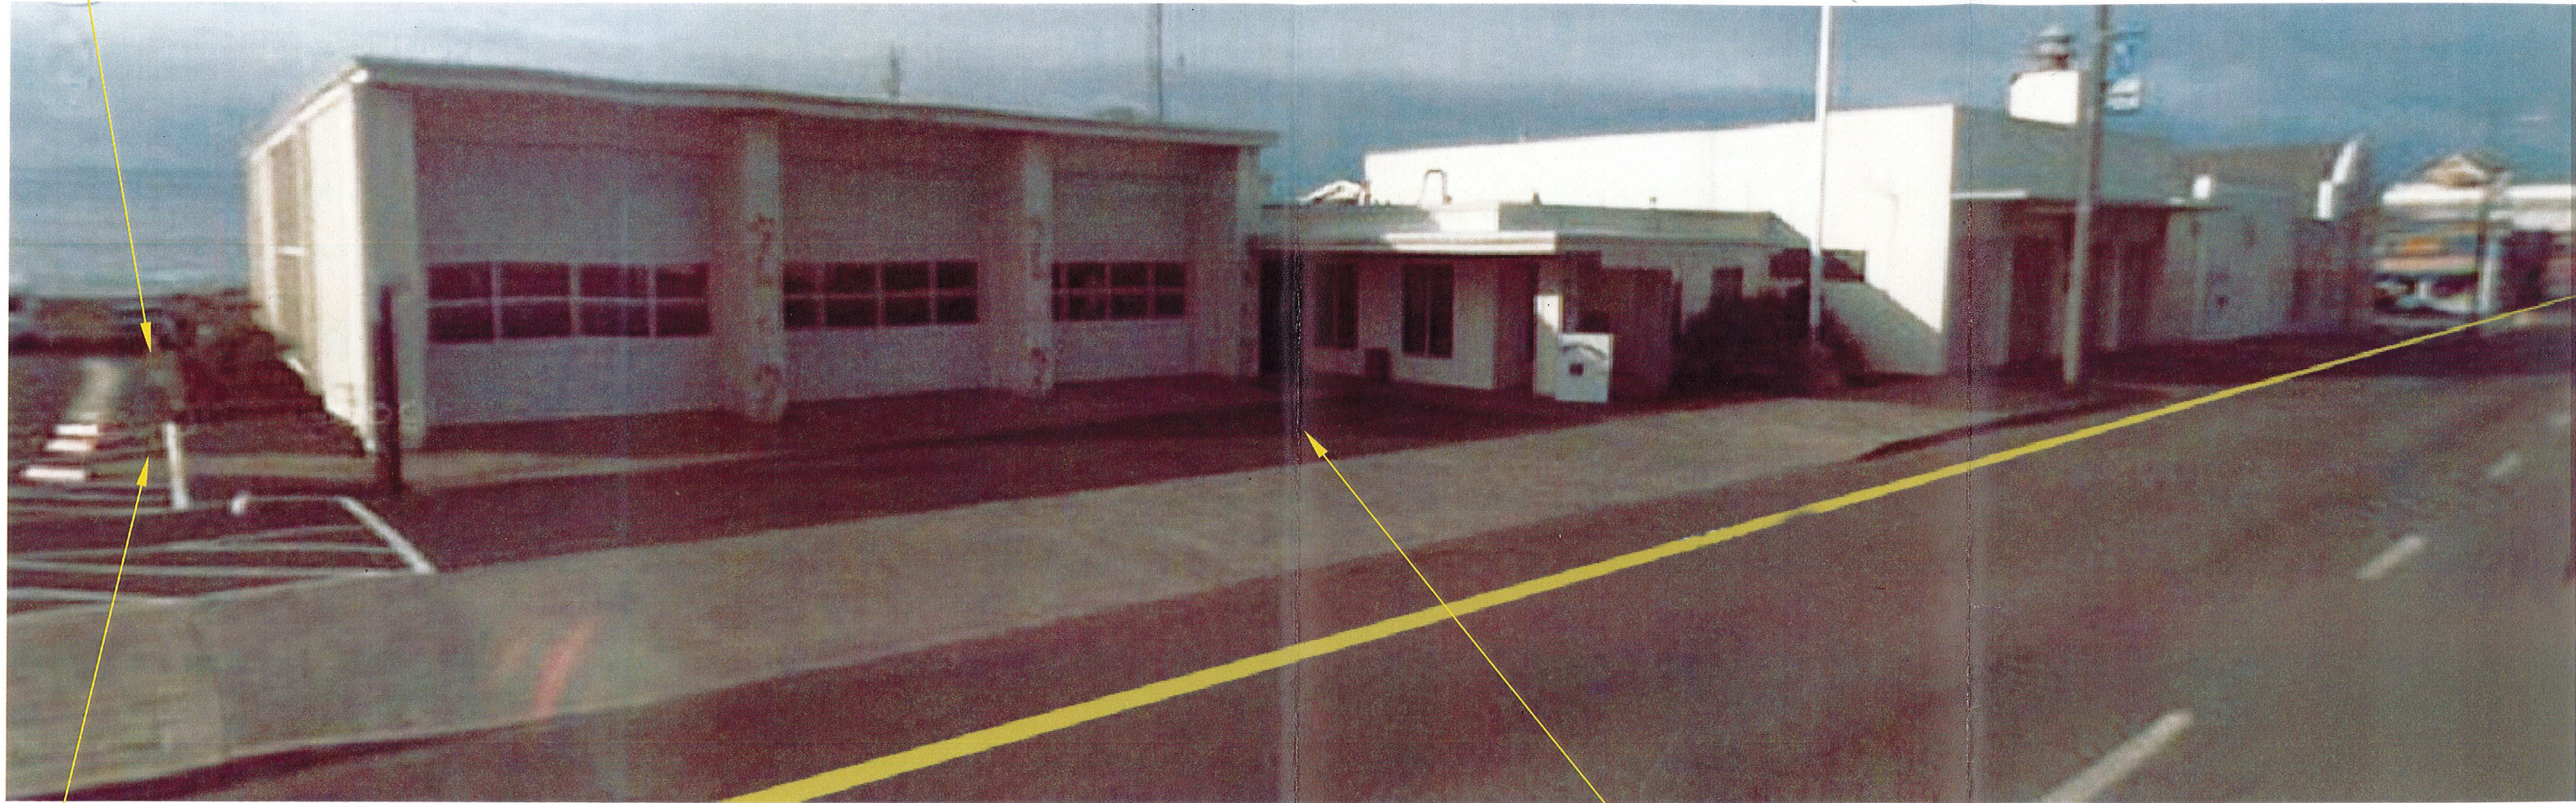
PLATE
3

Fort Bragg Fire Department Station #830
Looking north-northwest

SITE PHOTOGRAPH A
FORT BRAGG FIRE DEPARTMENT
STATION #830
141 Main Street
Fort Bragg, Mendocino County, California

BACE's Principal Engineering Geologist and Senior Civil Engineer performed an initial site reconnaissance on December 12, 2008, to assess site conditions, observe the existing structure, including foundation stem walls, slabs, and pavements, check for evidence of settlement distress, and mark test boring locations. Our Senior Civil Engineer also returned on January 6, 2009, to observe site conditions and subsurface drilling operations. Site Photograph A on Plate 3 shows the site and existing buildings from the southeast.

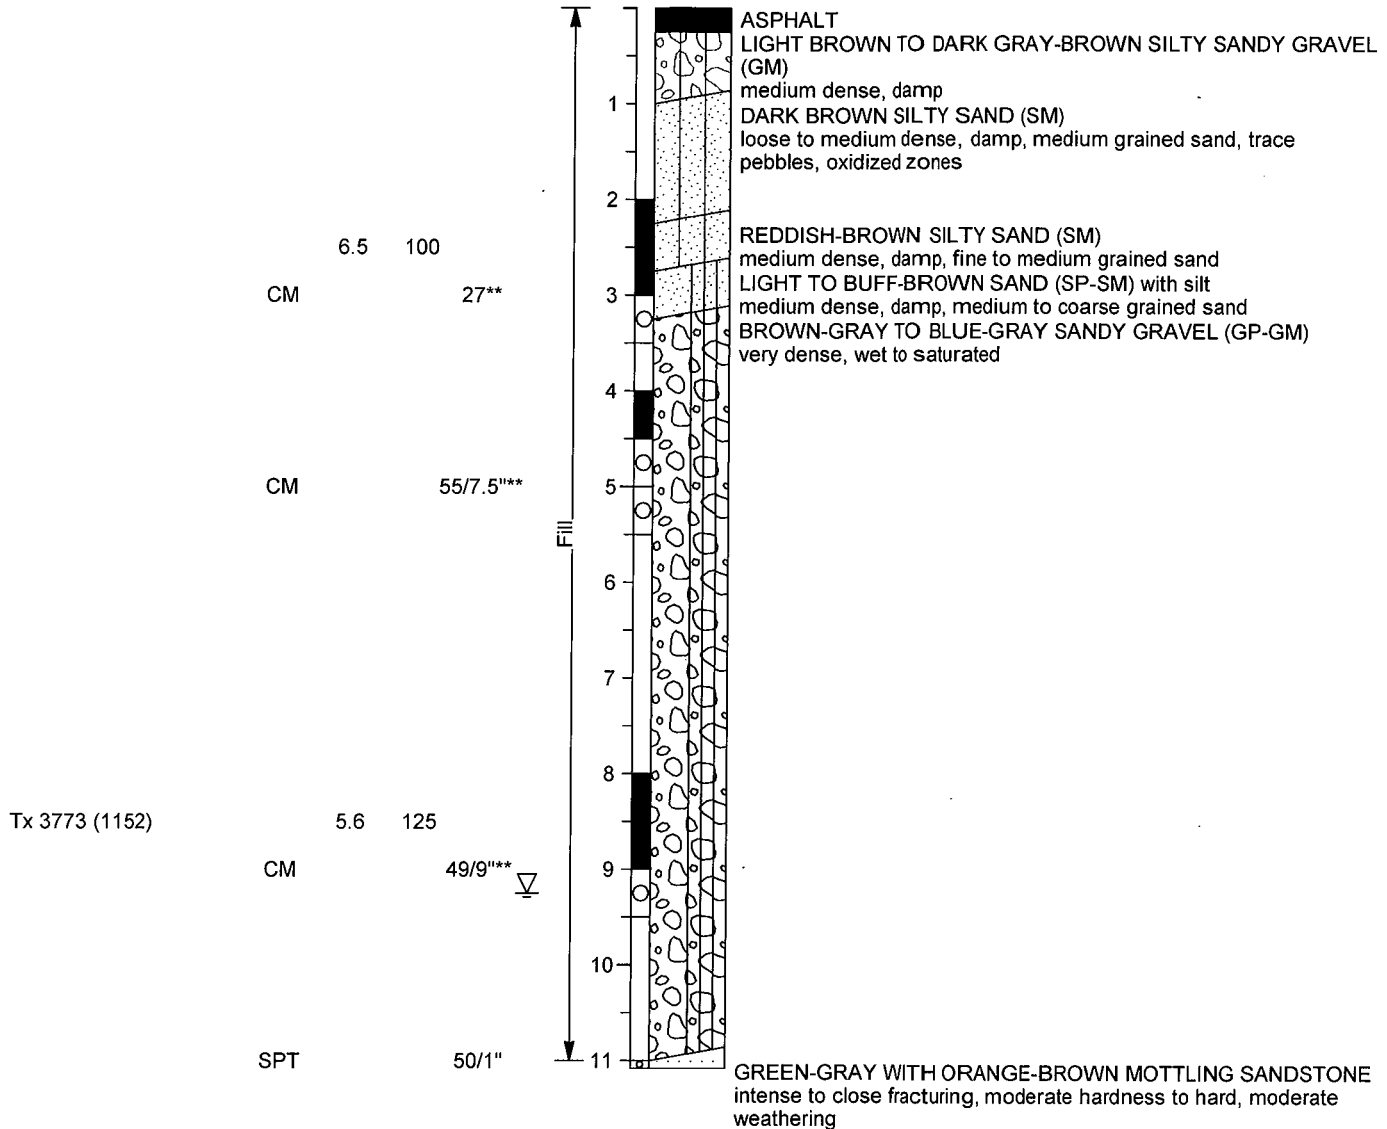
*CA - California Modified Split Tube Sampler 3.0-inch O.D.
CM - California Modified Split Tube Sampler 2.5-inch O.D.

SPT - California Split Tube Sampler 2.0-inch O.D.

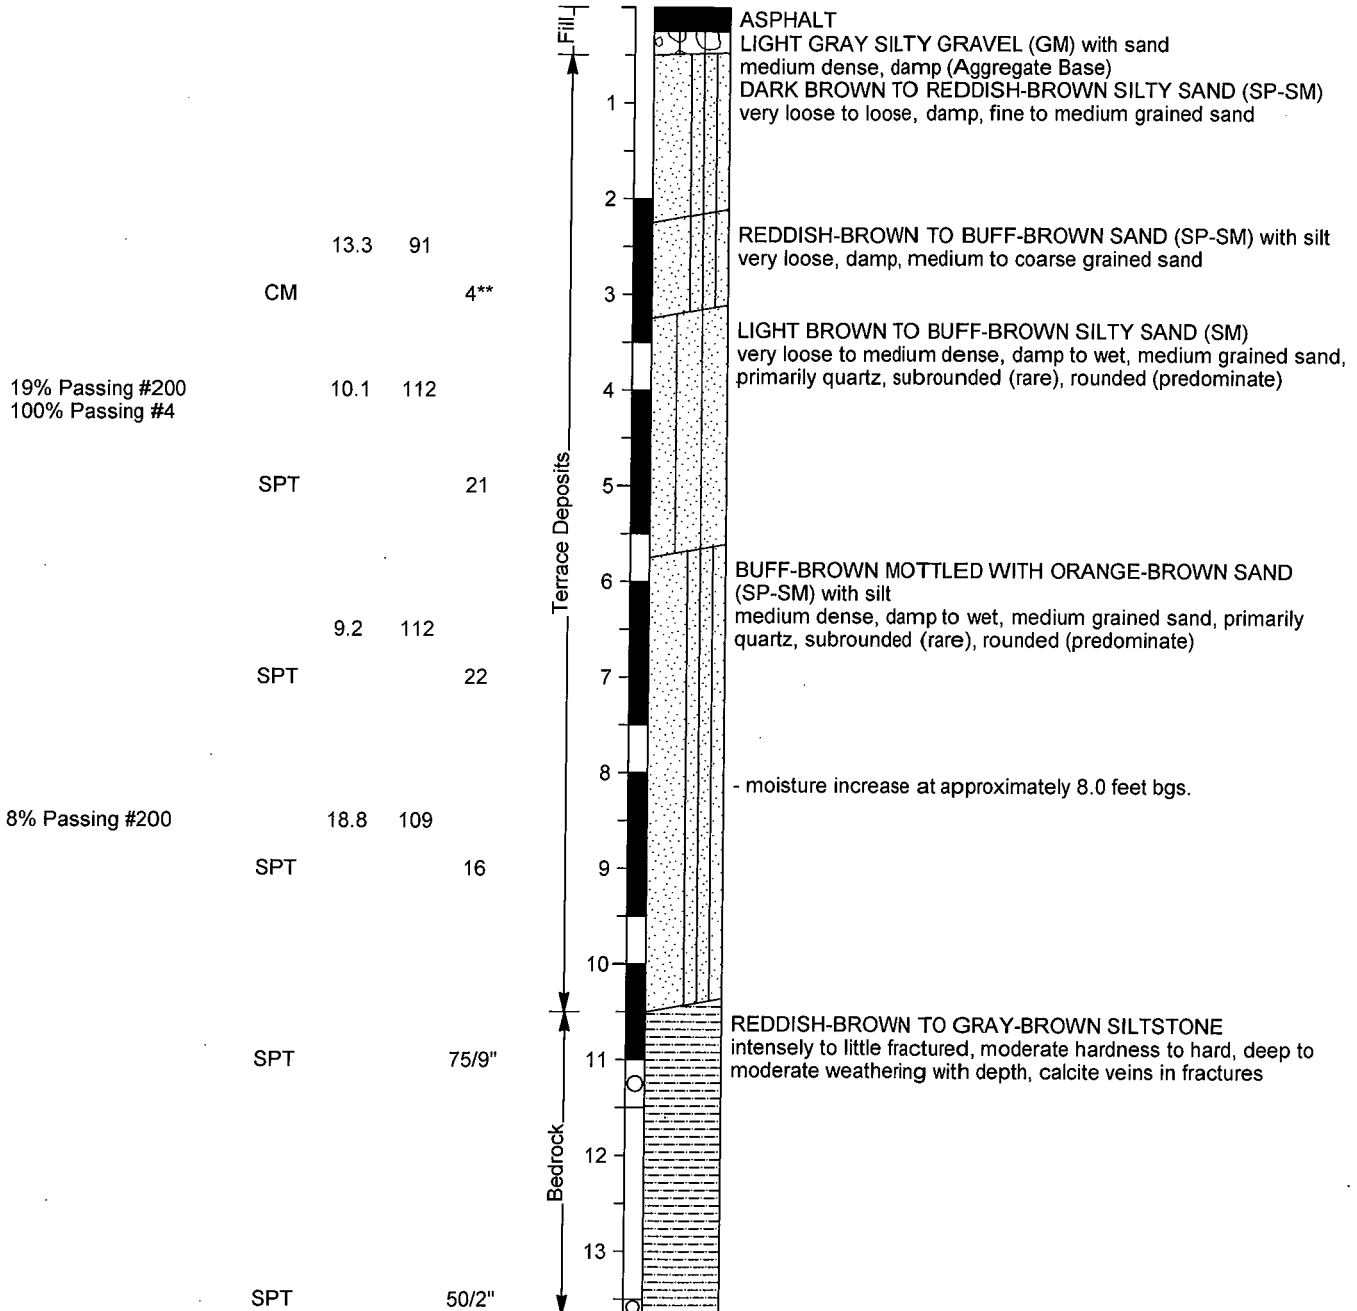
1. Caving occurred after removing hollow-stem auger.
2. No free water encountered
3. Practical drilling refusal at 13.5 feet bgs.

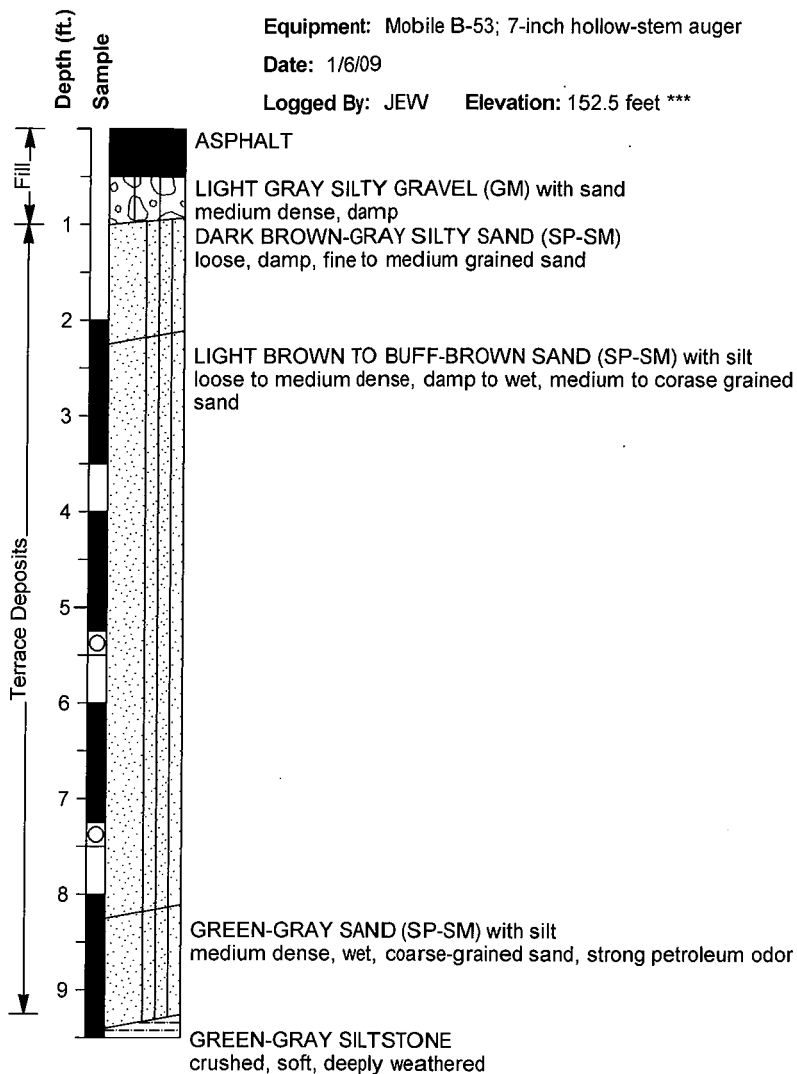
CM	6.6	89	10**
DS 348 (500)	CM	7.7	111	17**
11% Passing #200 100% Passing #4	SPT	7.7	112	17
	SPT			15

1. No free water encountered
2. No caving
3. Drilling terminated at 9.5 feet due to petroleum odor

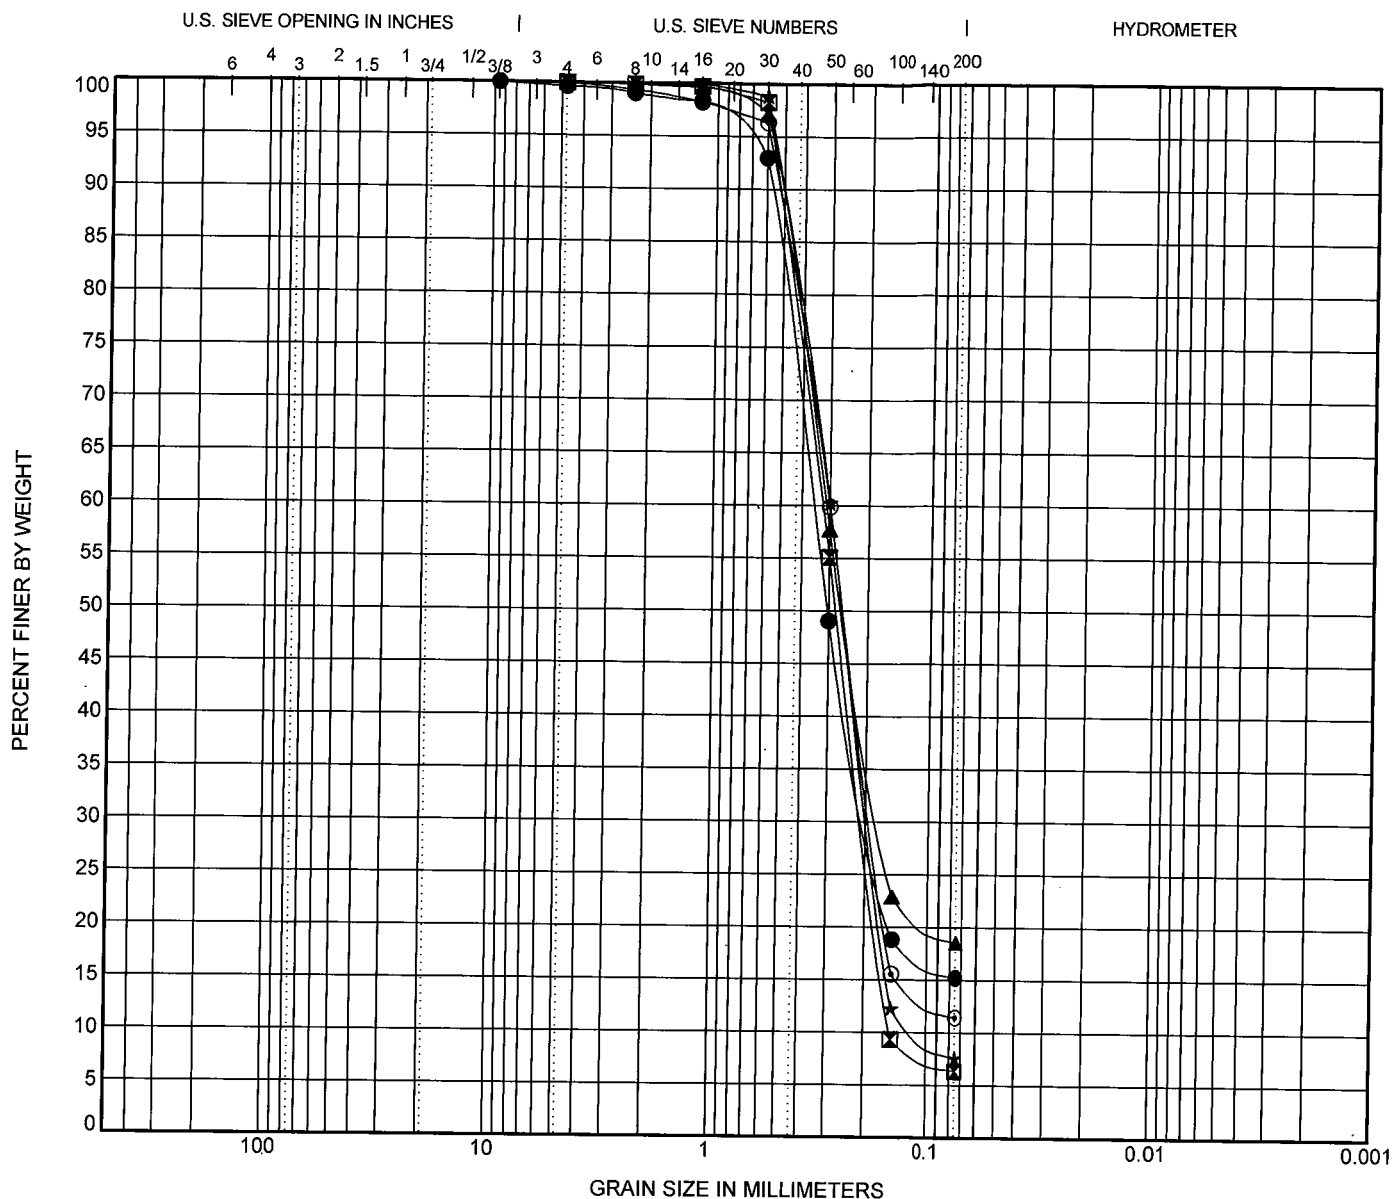
Specimen Identification			Classification			LL	PL	PI	Cc	Cu
●	B-1	2.5 ft	DARK BROWN SILTY SAND (SM)							
☒	B-1	8.5 ft	LIGHT BROWN SAND (SP-SM) with silt						0.86	2.14
▲	B-3	4.0 ft	LIGHT BROWN TO BUFF-BROWN SILTY SAND (SM)							
★	B-3	8.5 ft	BUFF-BROWN MOTTLED WITH ORANGE-BROWN SAND (SP-SM) with silt						1.17	2.79
⊙	B-4	6.5 ft	LIGHT BROWN TO BUFF-BROWN SAND (SP-SM) with silt						2.00	5.11
Specimen Identification			D100	D60	D30	D10	%Gravel	%Sand	%Silt	%Clay
●	B-1	2.5 ft	9.5	0.357	0.194		0.3	84.4	15.2	
☒	B-1	8.5 ft	4.75	0.325	0.205	0.152		93.7	6.3	
▲	B-3	4.0 ft	4.75	0.313	0.173			81.5	18.5	
★	B-3	8.5 ft	2.36	0.299	0.194	0.107		92.4	7.6	
⊙	B-4	6.5 ft	4.75	0.301	0.188			88.6	11.4

The test results are presented opposite the samples tested on the test boring logs. A Key to Test Data is provided on Plate 10. In addition, grain size distribution test results are presented on Plates 13 and 14, triaxial compression test data on Plate 15, and direct shear test results on Plate 16. Near-surface soil samples were sent to JDH Corrosion Consultants, Inc. for corrosivity potential testing consisting of resistivity, pH, chloride, sulfate and redox. Corrosivity test results are presented in Appendix B.

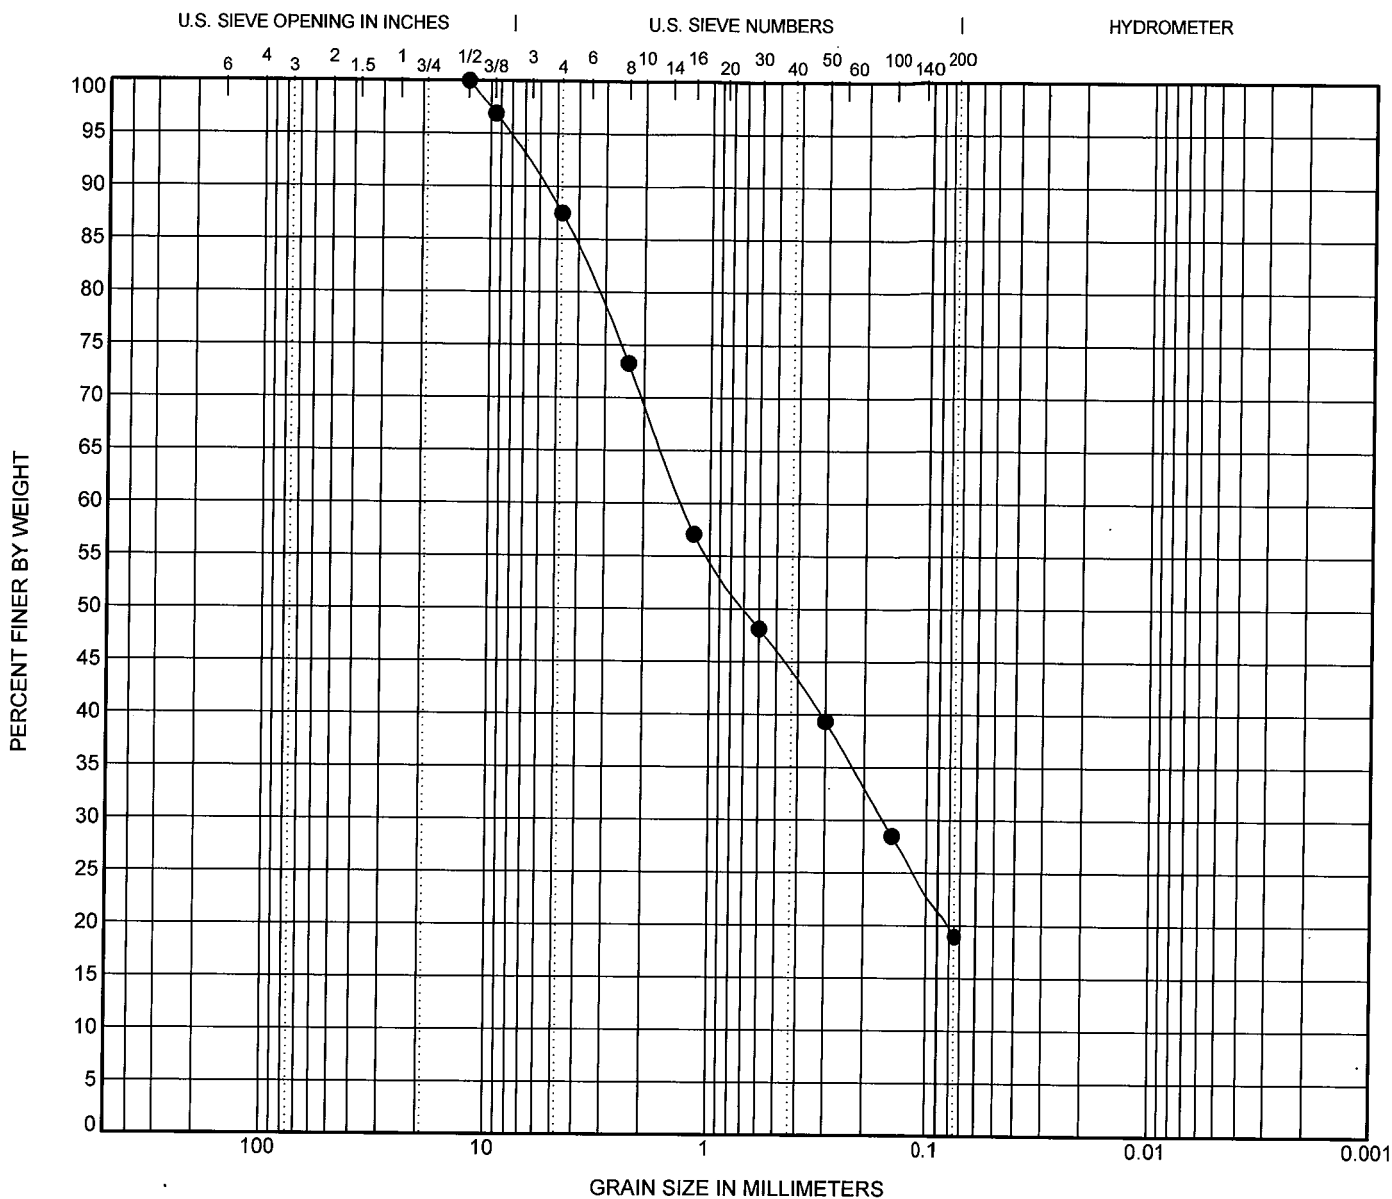
Specimen Identification	Classification					LL	PL	PI	Cc	Cu
● B-5 10.0 ft	GREEN-GRAY SILTY SAND (SM)									
Specimen Identification	D100	D60	D30	D10	%Gravel	%Sand	%Silt		%Clay	
● B-5 10.0 ft	12.5	1.338	0.165		12.5	68.5	19.0

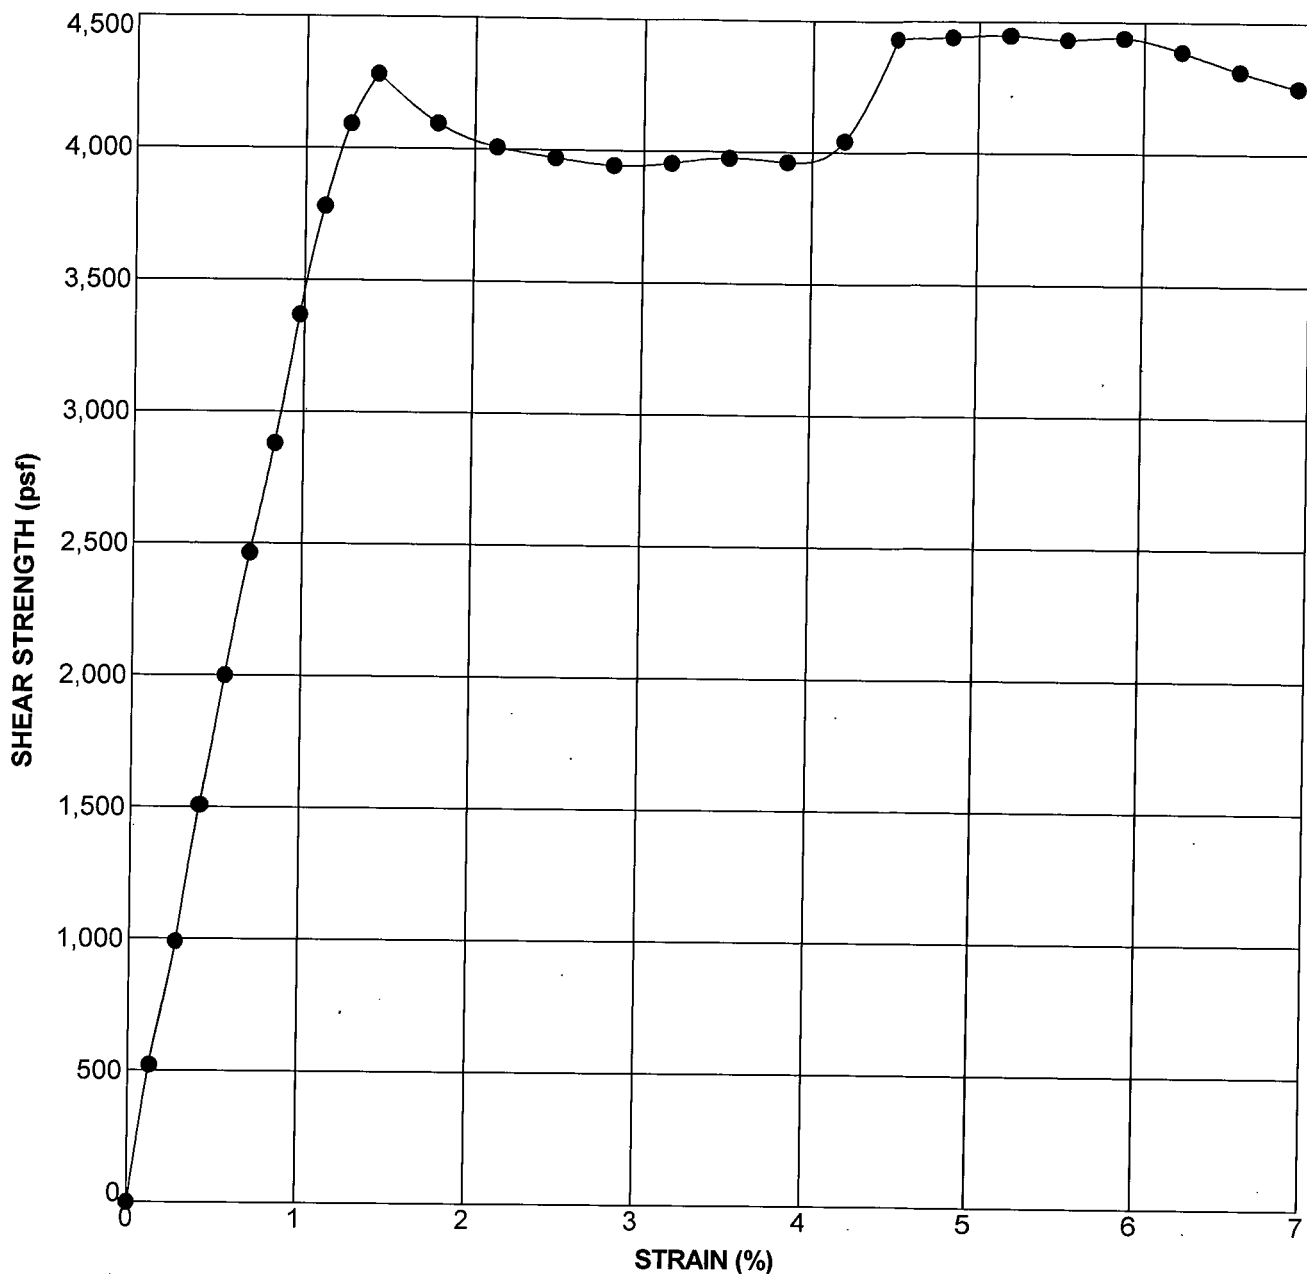
Sample Source	Classification	Confining Pressure (psf)	Yield Strength (psf)	Strain (%)	Dry Density (pcf)	Moisture Content (%)
● B-2 @ 8.5 ft	BROWN-GRAY TO BLUE-GRAY SANDY GRAVEL (GP-GM)	1152	3773	1.1	125	5.6

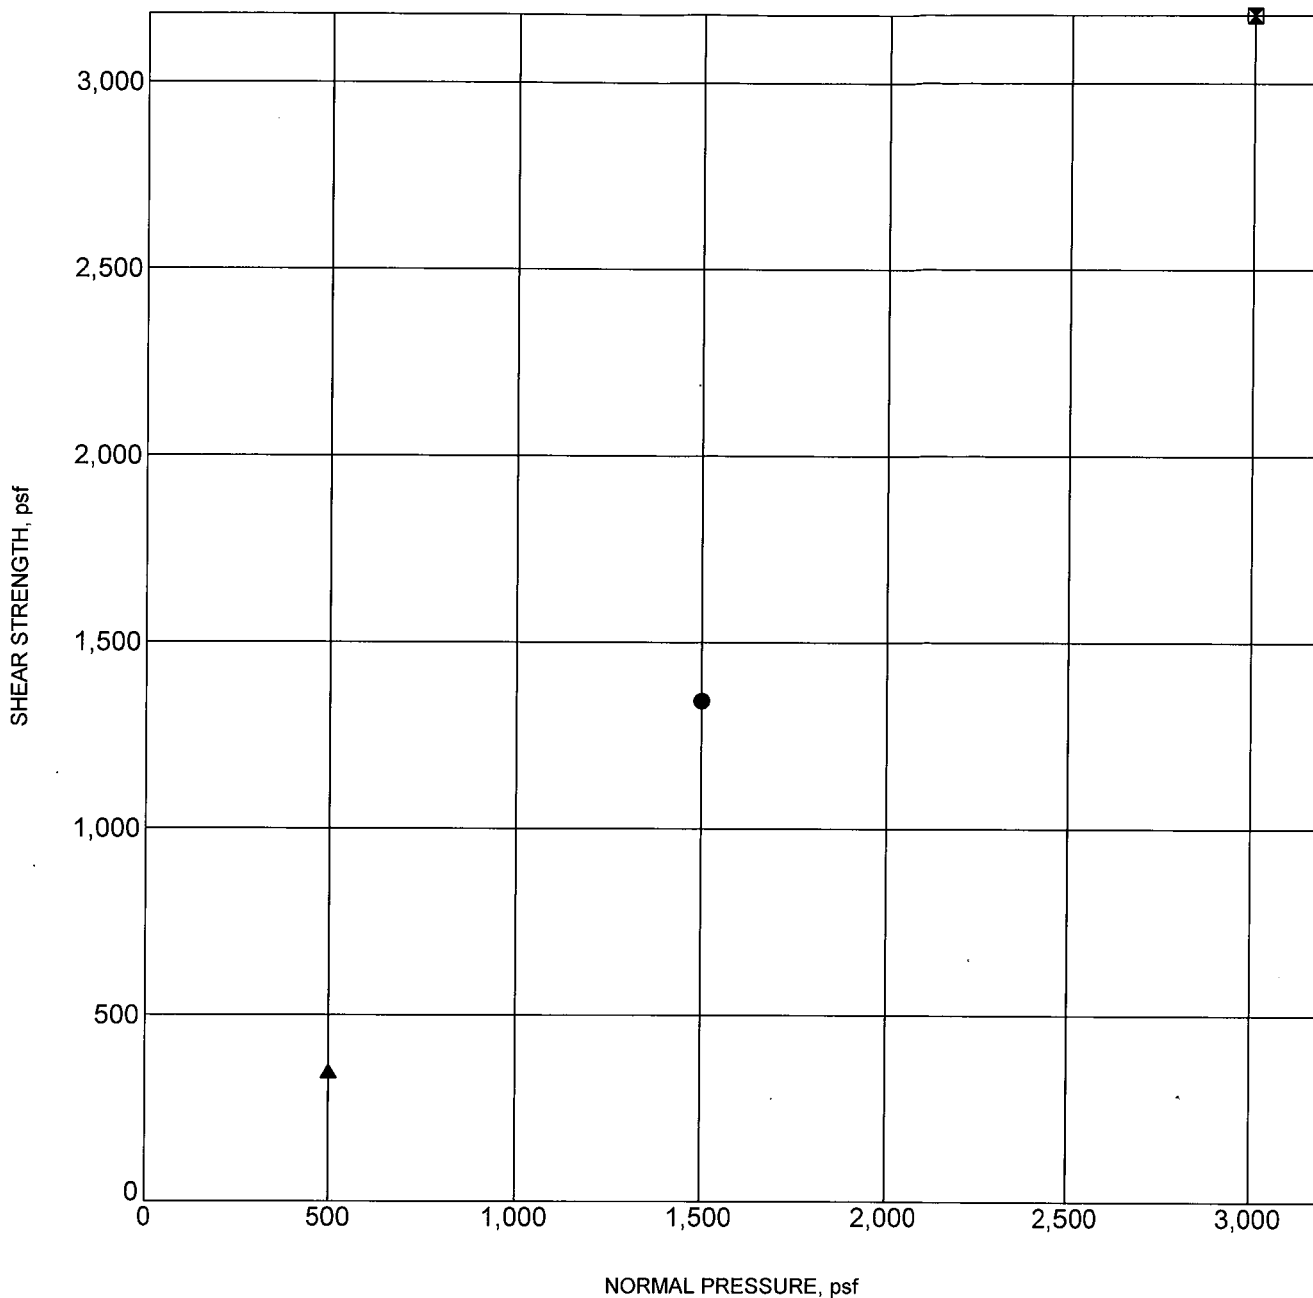
Specimen Identification	Classification	γ_d	MC%	c	ϕ (degree)
● B-1 at 6.5 ft	BUFF TO LIGHT BROWN SAND (SP) with silt	116	13.2	0	42
☒ B-1 at 10.5 ft	LIGHT BROWN SAND (SP-SM) with silt	110	17.9	0	47
▲ B-4 at 4.5 ft	LIGHT BROWN TO BUFF-BROWN SAND (SP-SM) with silt	111	7.7	0	34
Average				0	41
