GEOTECHNICAL INVESTIGATION AND GEOLOGIC HAZARDS EVALUATION

FORT BRAGG FIRE DEPARTMENT
STATION #830
141 MAIN STREET
FORT BRAGG, MENDOCINO COUNTY,
CALIFORNIA

10511.3

July 16, 2009

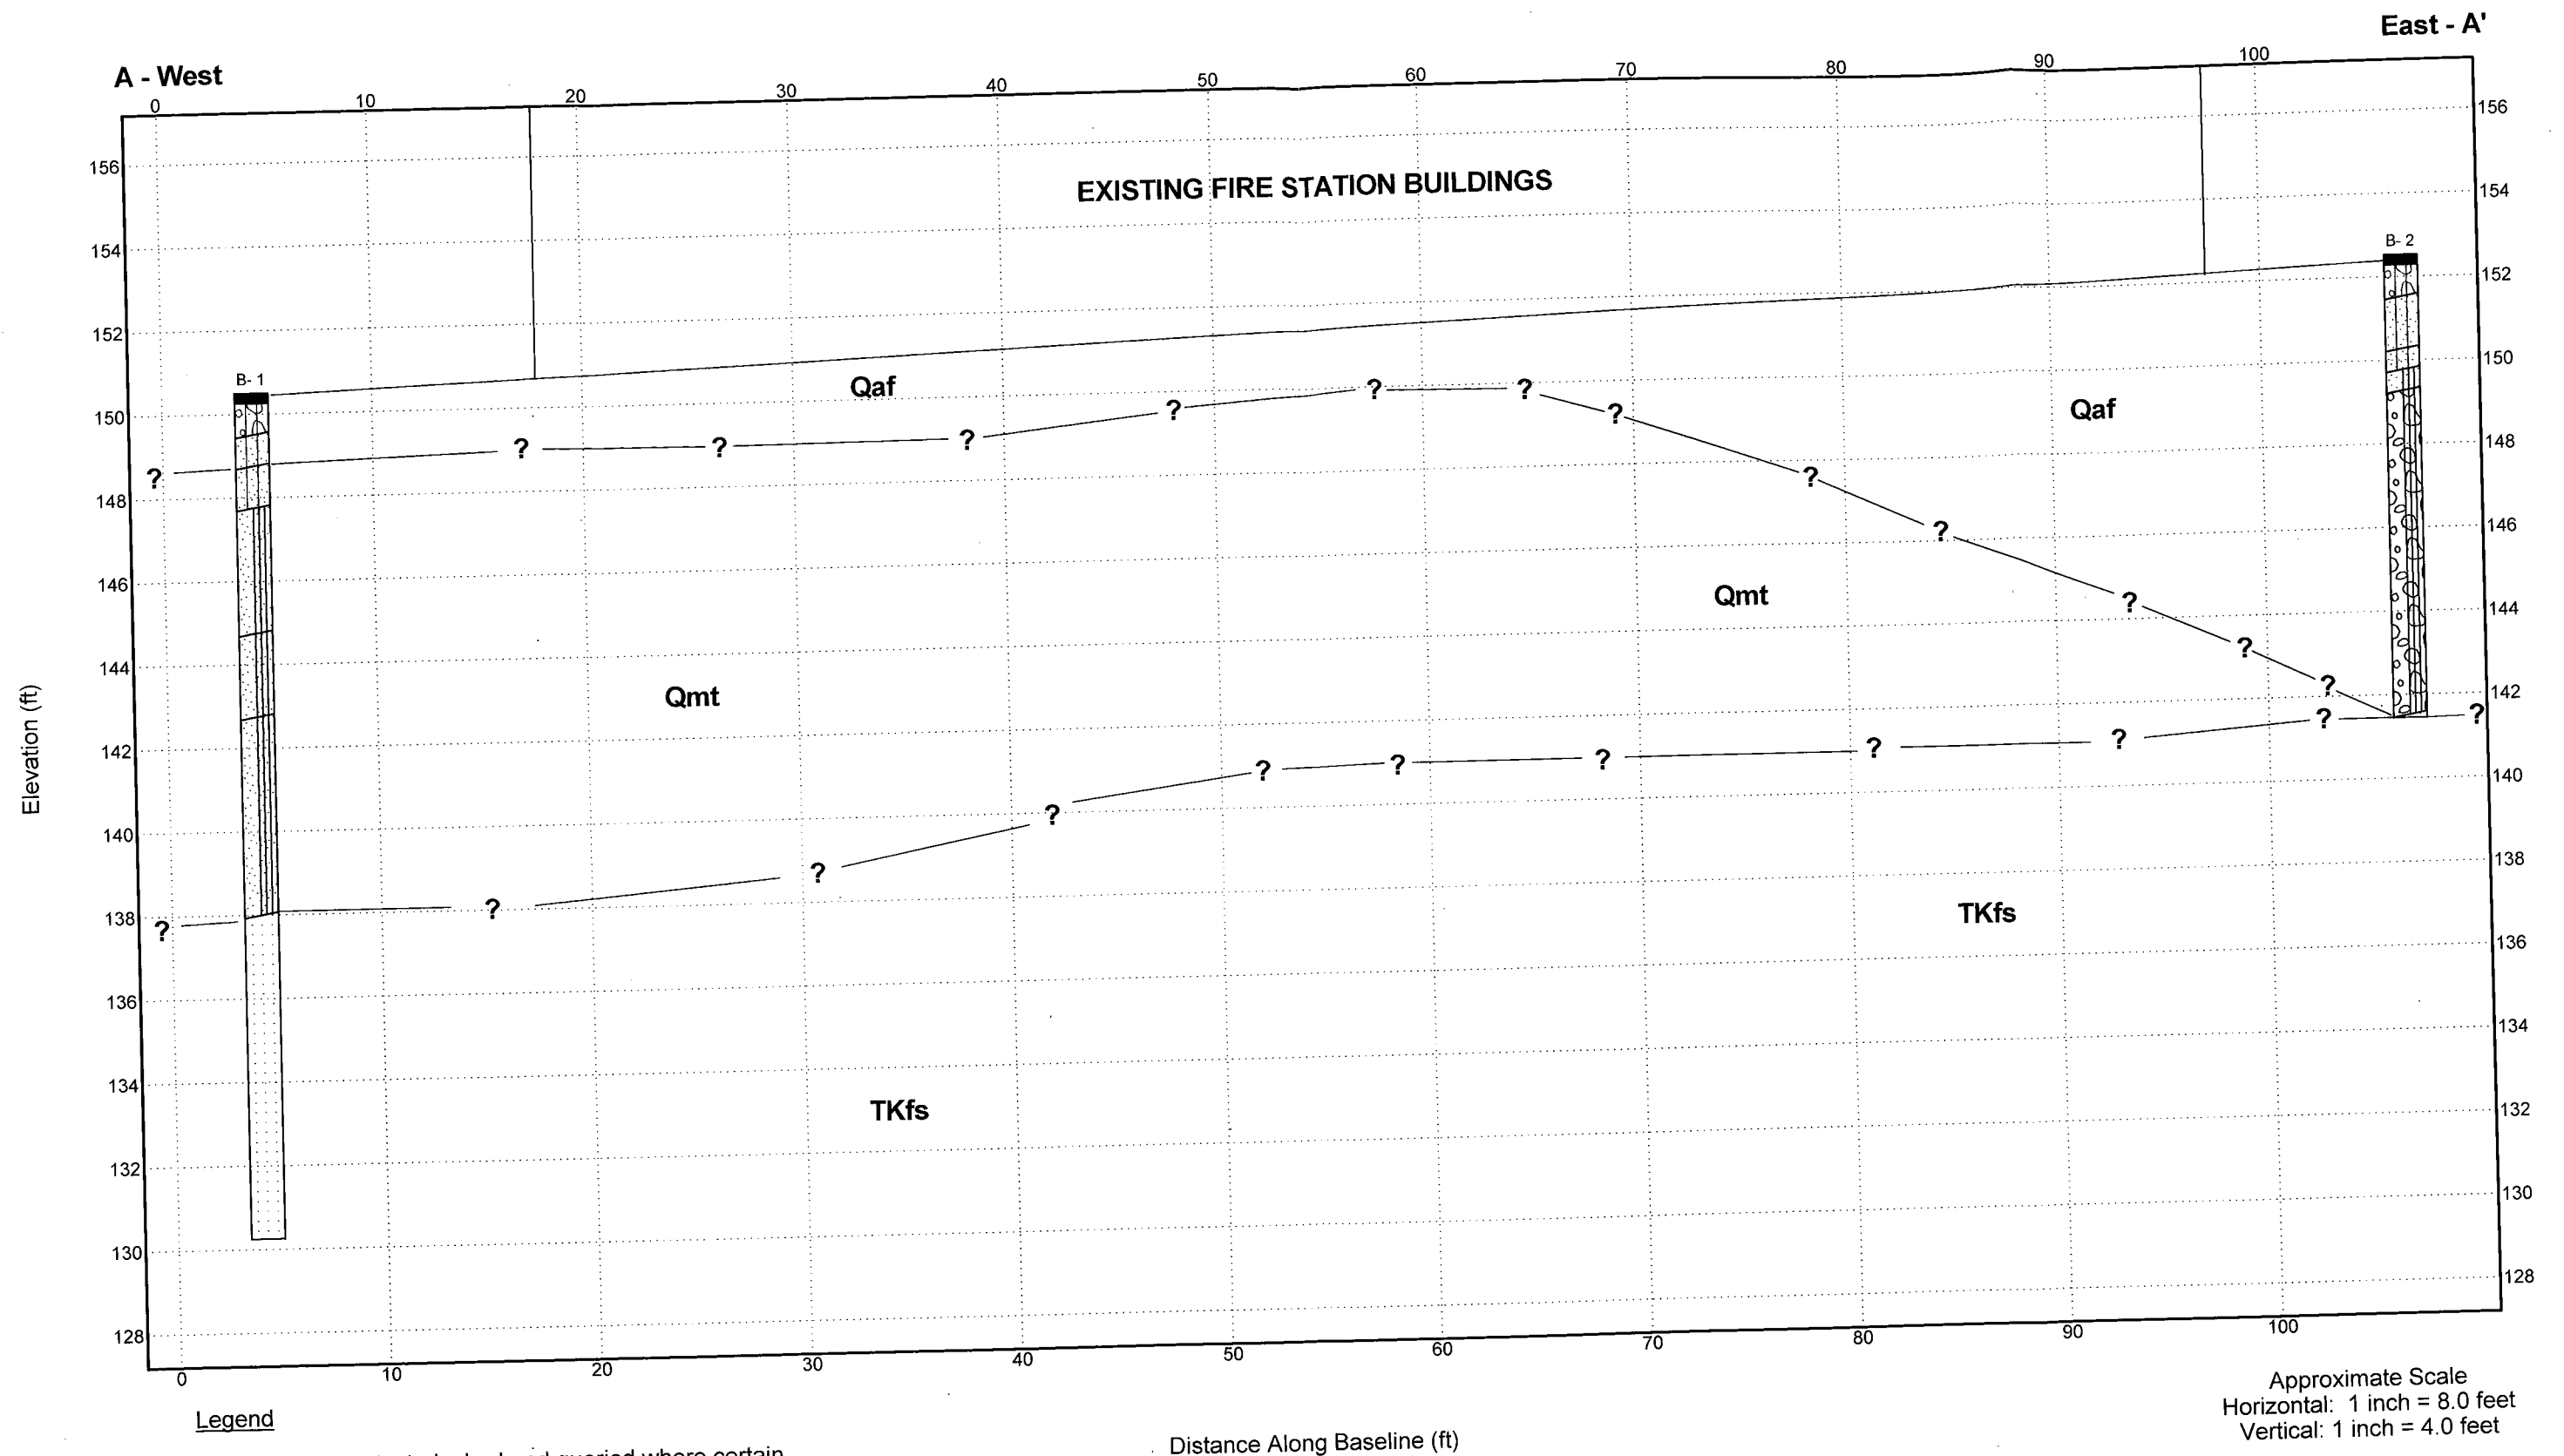
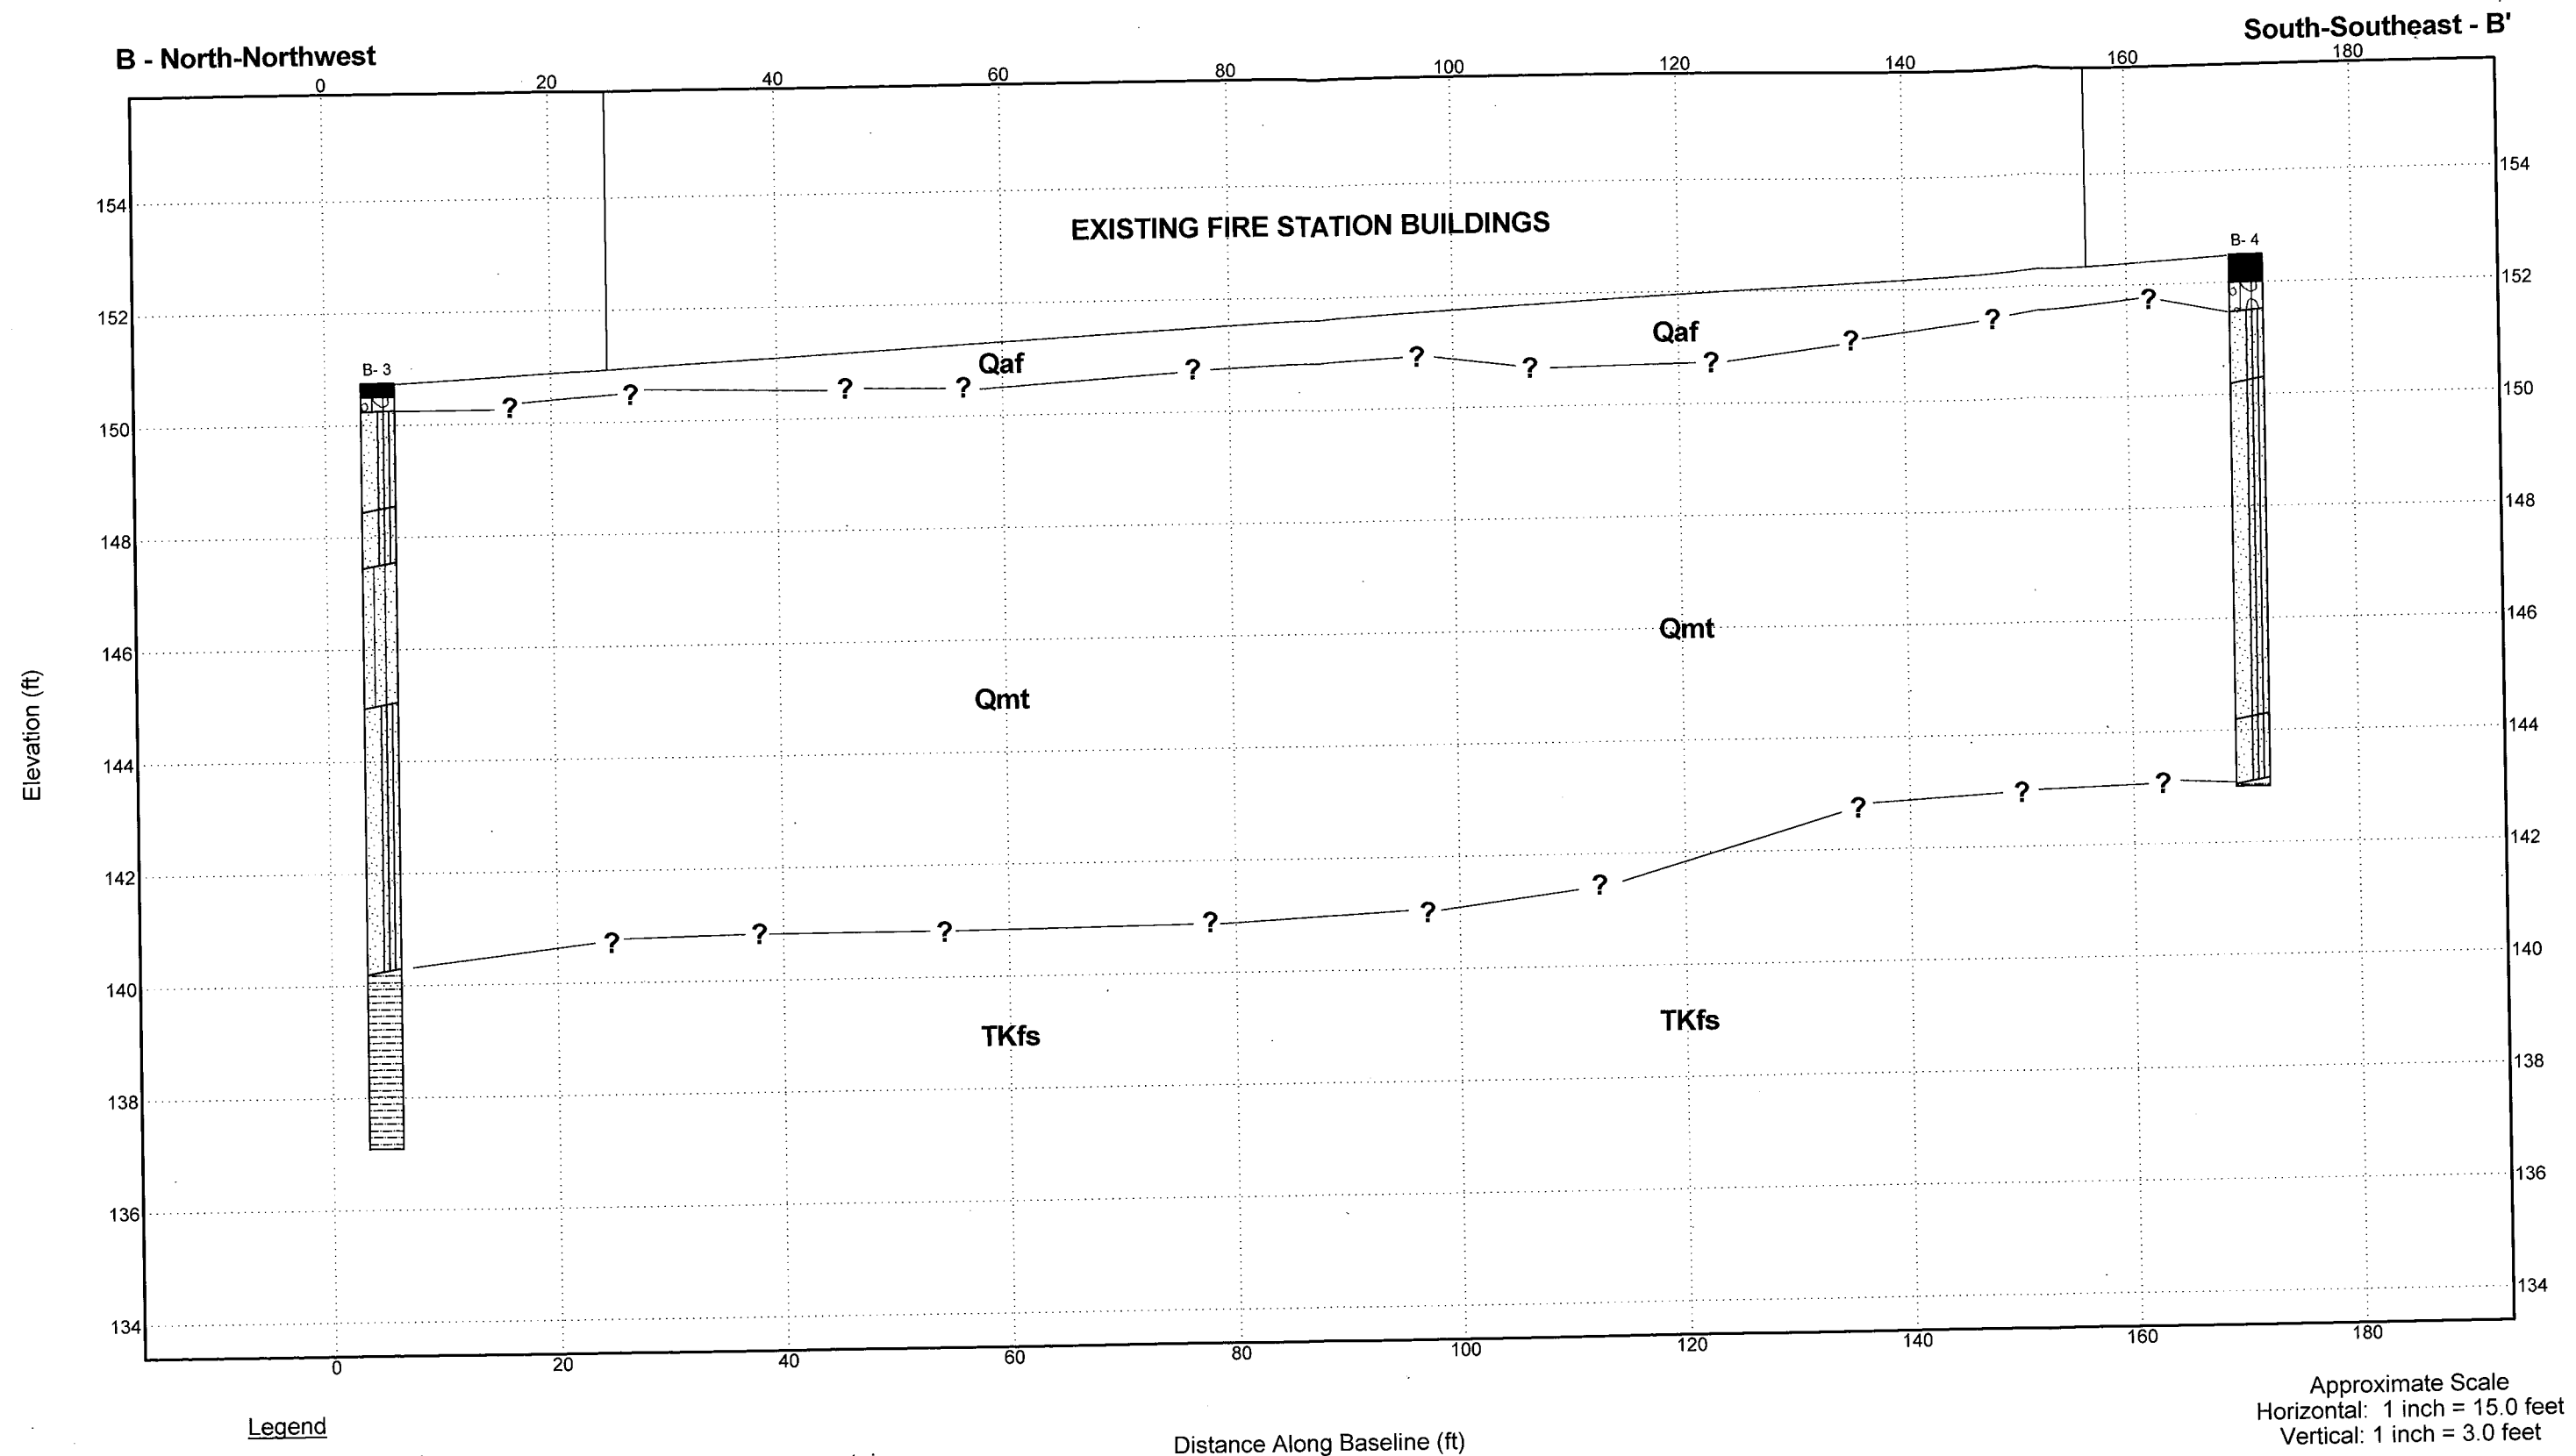
Note:
 Boring widths are exaggerated for clarity
 See Plate 2 for elevation reference

BACE GEOTECHNICAL a division of Bruning Associates, Inc. (707) 528-6108	Job No.: 10511.3 Appr.: <i>KAC</i> Date: 07/16/09	SECTION B - B' FORT BRAGG FIRE DEPARTMENT STATION #830 141 Main Street Fort Bragg, Mendocino County, California	PLATE 20
--	---	---	--	--------------------

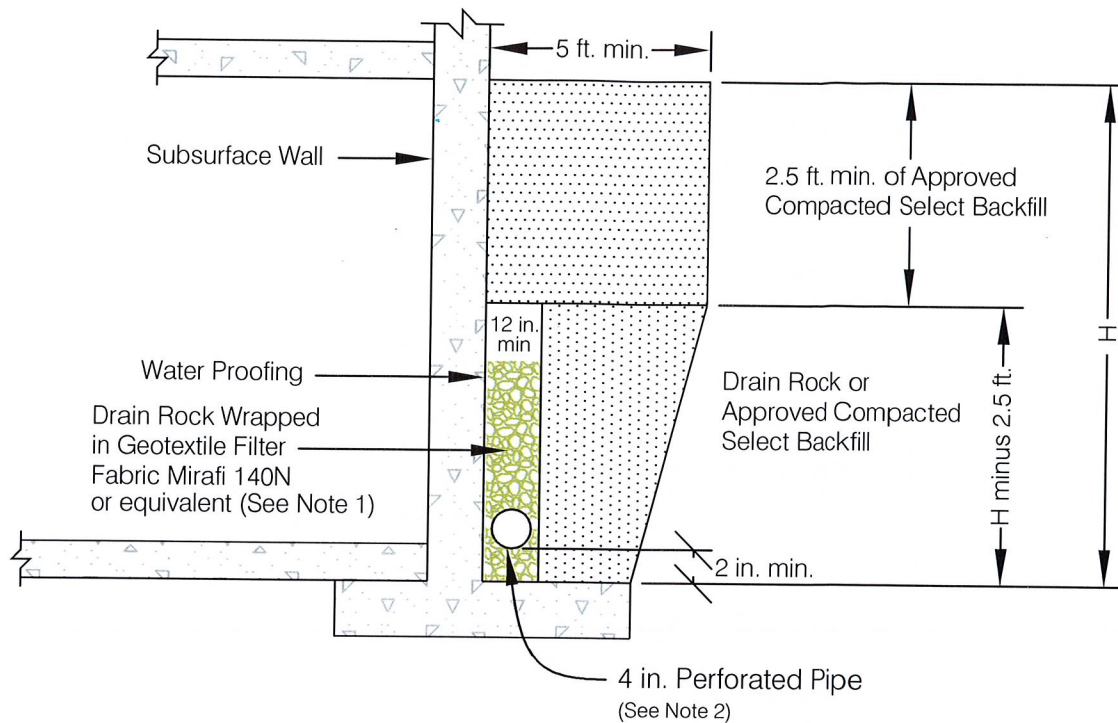
SUBSURFACE WALL DRAINAGE DETAIL
(Not to Scale)

If retaining or subsurface walls are utilized for existing or new structures, walls should be provided with permanent back drainage to prevent buildup of hydrostatic pressure. Drainage and backfill details are presented on Plate 22. Quality, placement and compaction requirements for backfill behind subsurface walls are the same as previously presented for select fill. Light compacting equipment should be used near the wall to avoid overstressing the walls.

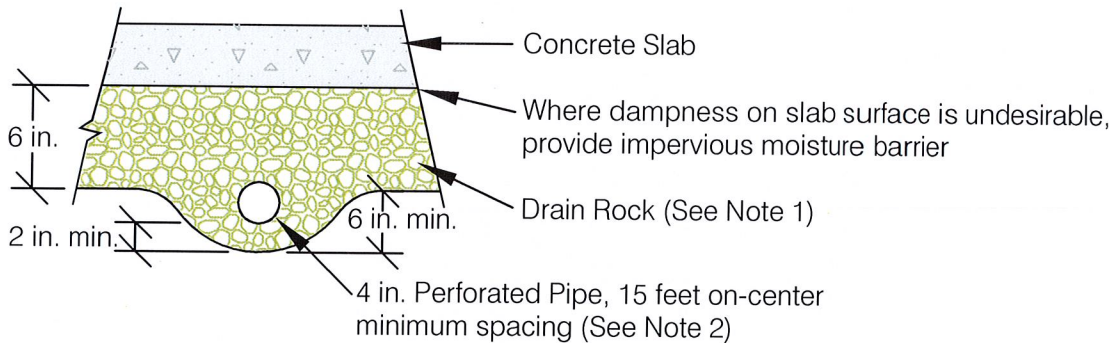
PIT UNDER SLAB DRAINAGE DETAIL (see Note 3)
(Not to Scale)

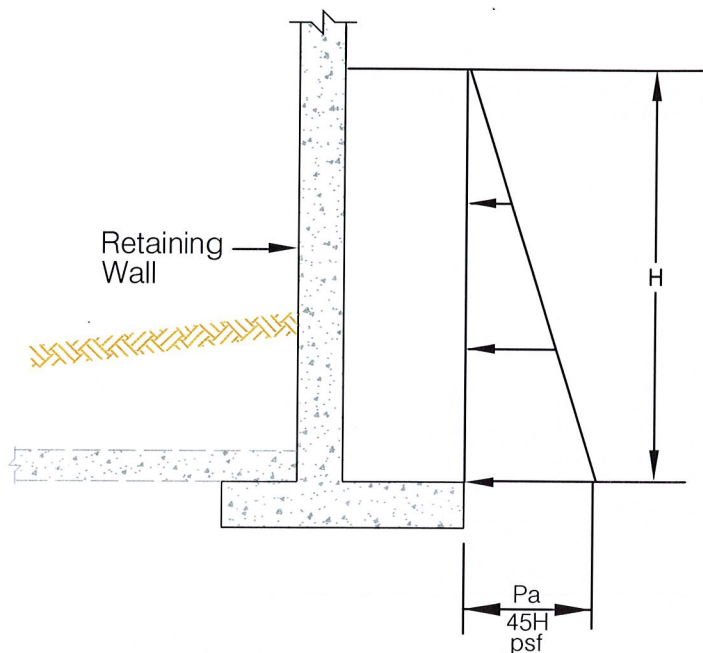
ACTIVE SOIL PRESSURE DIAGRAM

For walls that are free to yield slightly (See Note 2)

- (1) The above are soil pressures only and do not include lateral loads resulting from other sources such as traffic, floor loads, adjacent foundations or other vertical loads.
- (2) If the wall, at surface of the backfill, cannot yield about 0.1% of its' height, at-rest soil pressures should be used.
- (3) The above pressures assume a drained condition. See Plate 22 for drainage and backfill details.
- (4) The above pressures should be used where backfill slope is flatter than 3 horizontal to 1 vertical (3H:1V). Where backfill slope is between 3H:1V and 1.5H:1V, use active pressure of 55H psf and at-rest pressure of 87H psf.
- (5) For design seismic pressures see Retaining Wall section of this report.

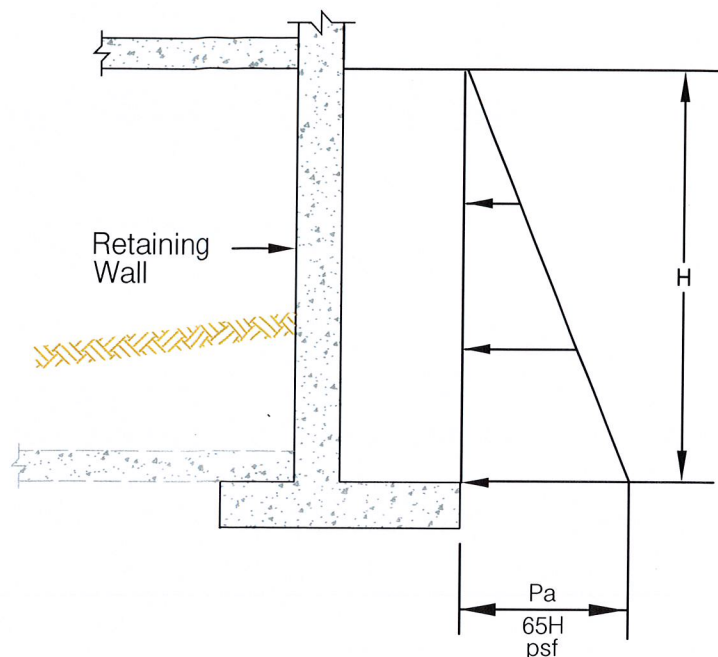
AT-REST SOIL PRESSURE DIAGRAM

For braced walls of substantial rigidity (See Note 2)

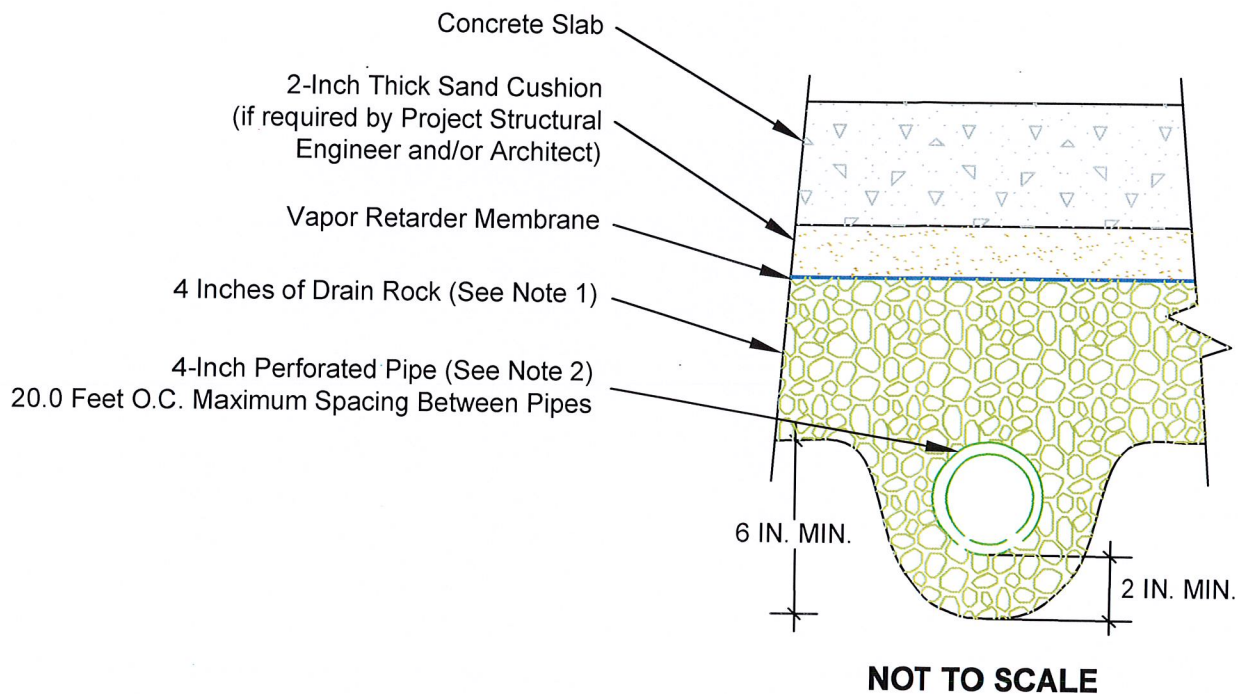
1. Drain rock should be clean, free-draining material graded in size between the No. 4 and 3/4 or 1-1/2 inch sieves.
2. Pipe should be SDR 35 or equivalent, perforations placed down, sloped at least 1% to gravity outlet, or sump with automatic pump.
3. A Clean-Out pipe with cap should be installed at the up-slope end of perforated pipe.

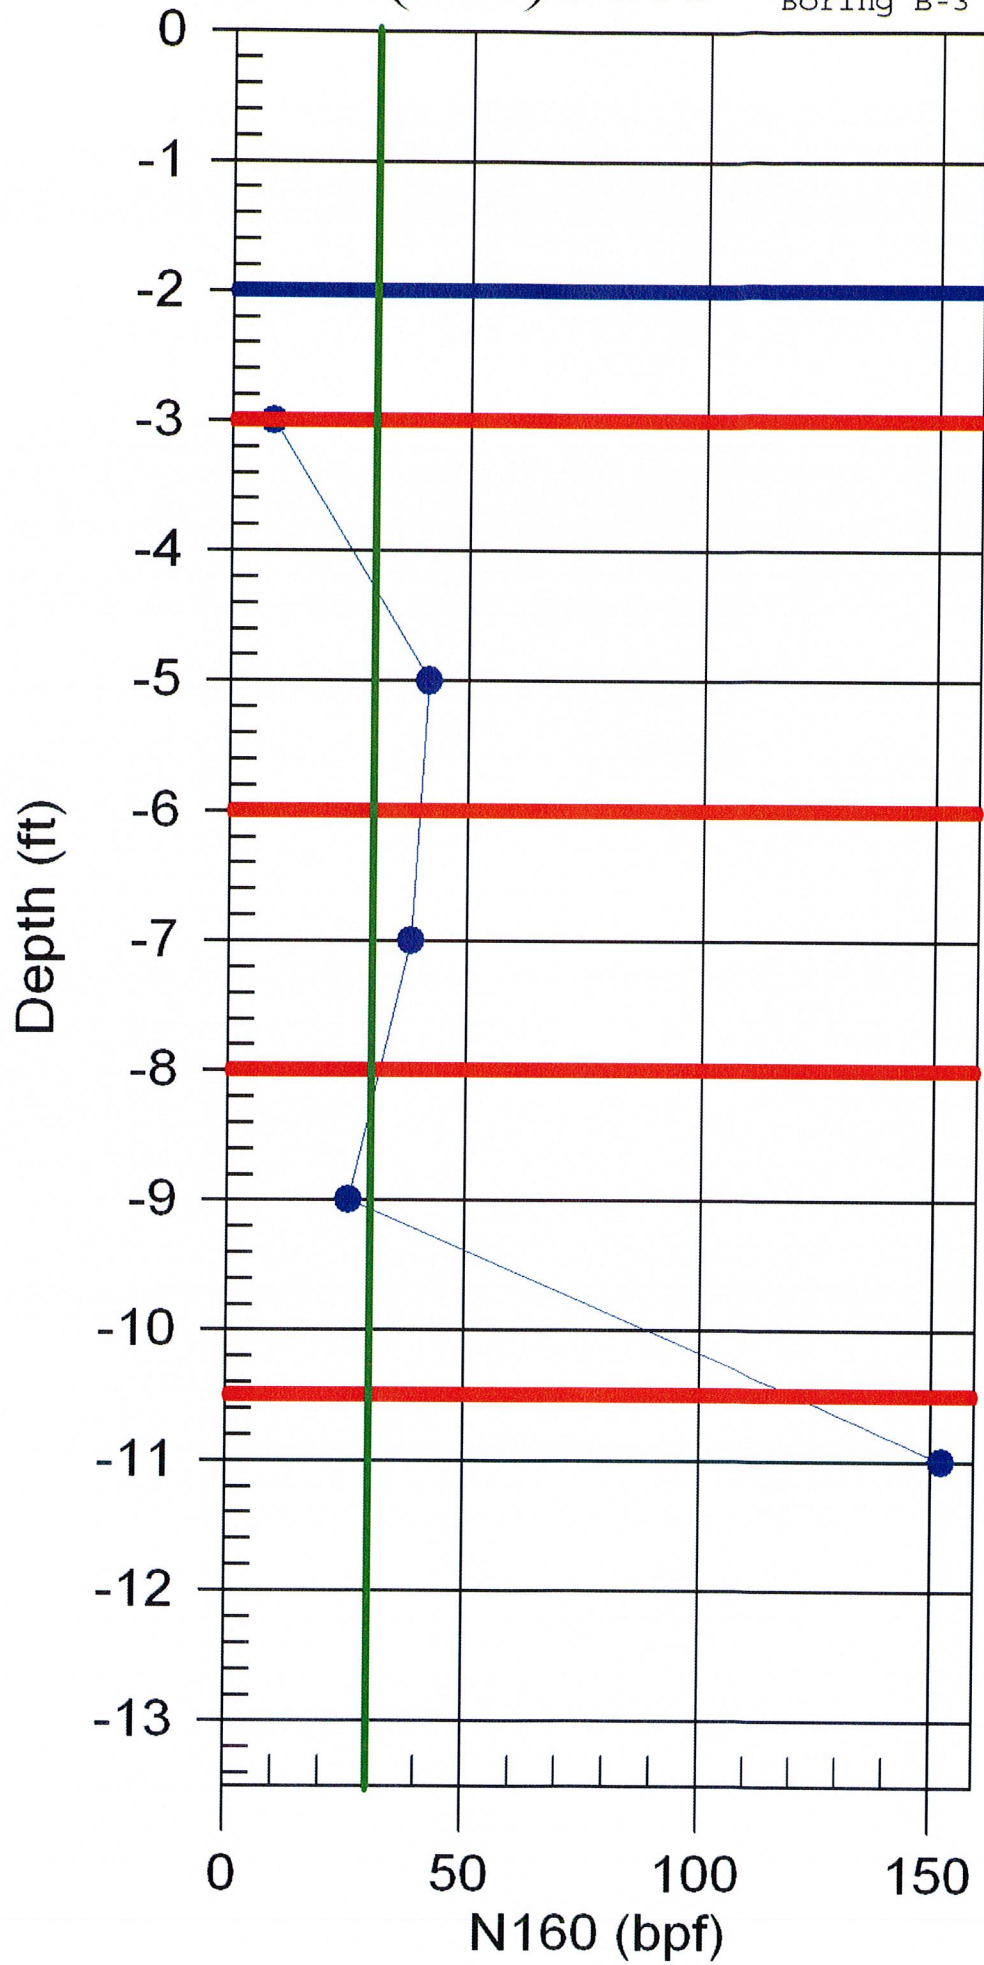
Boring B-3

Factor of Safety

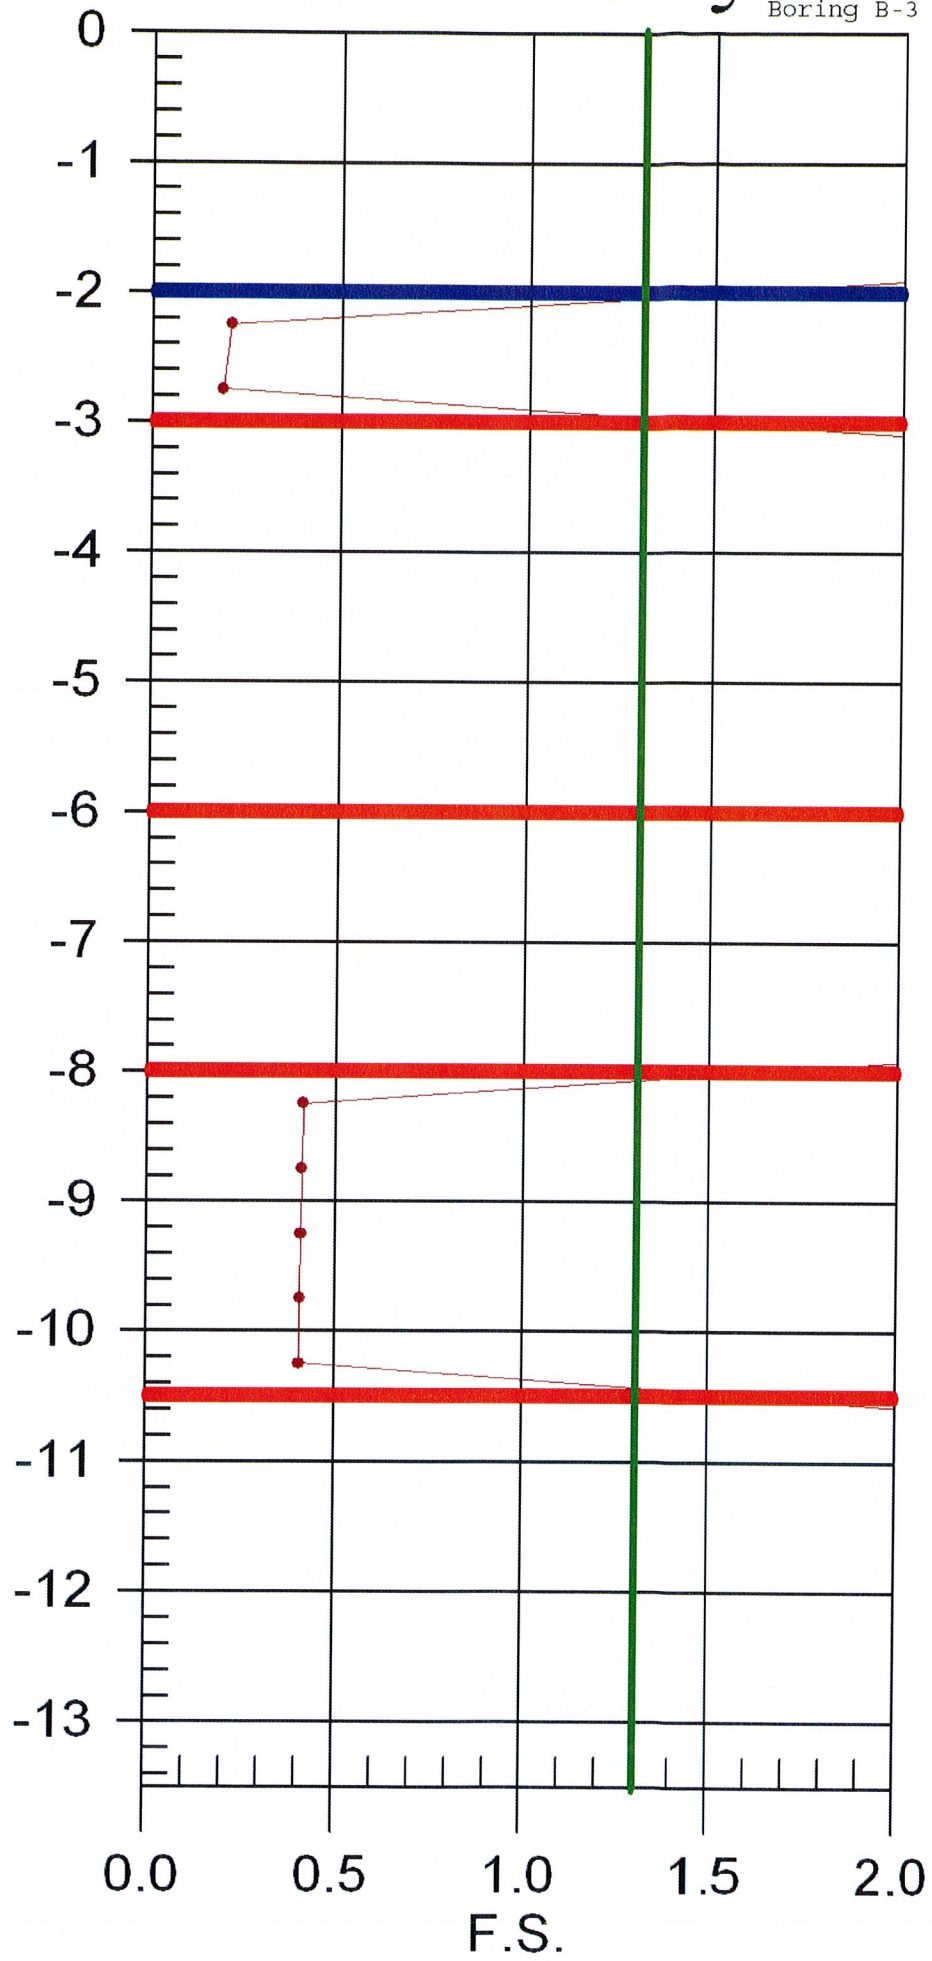
Boring B-3

Induced Vertical Settlement due to Liquefaction

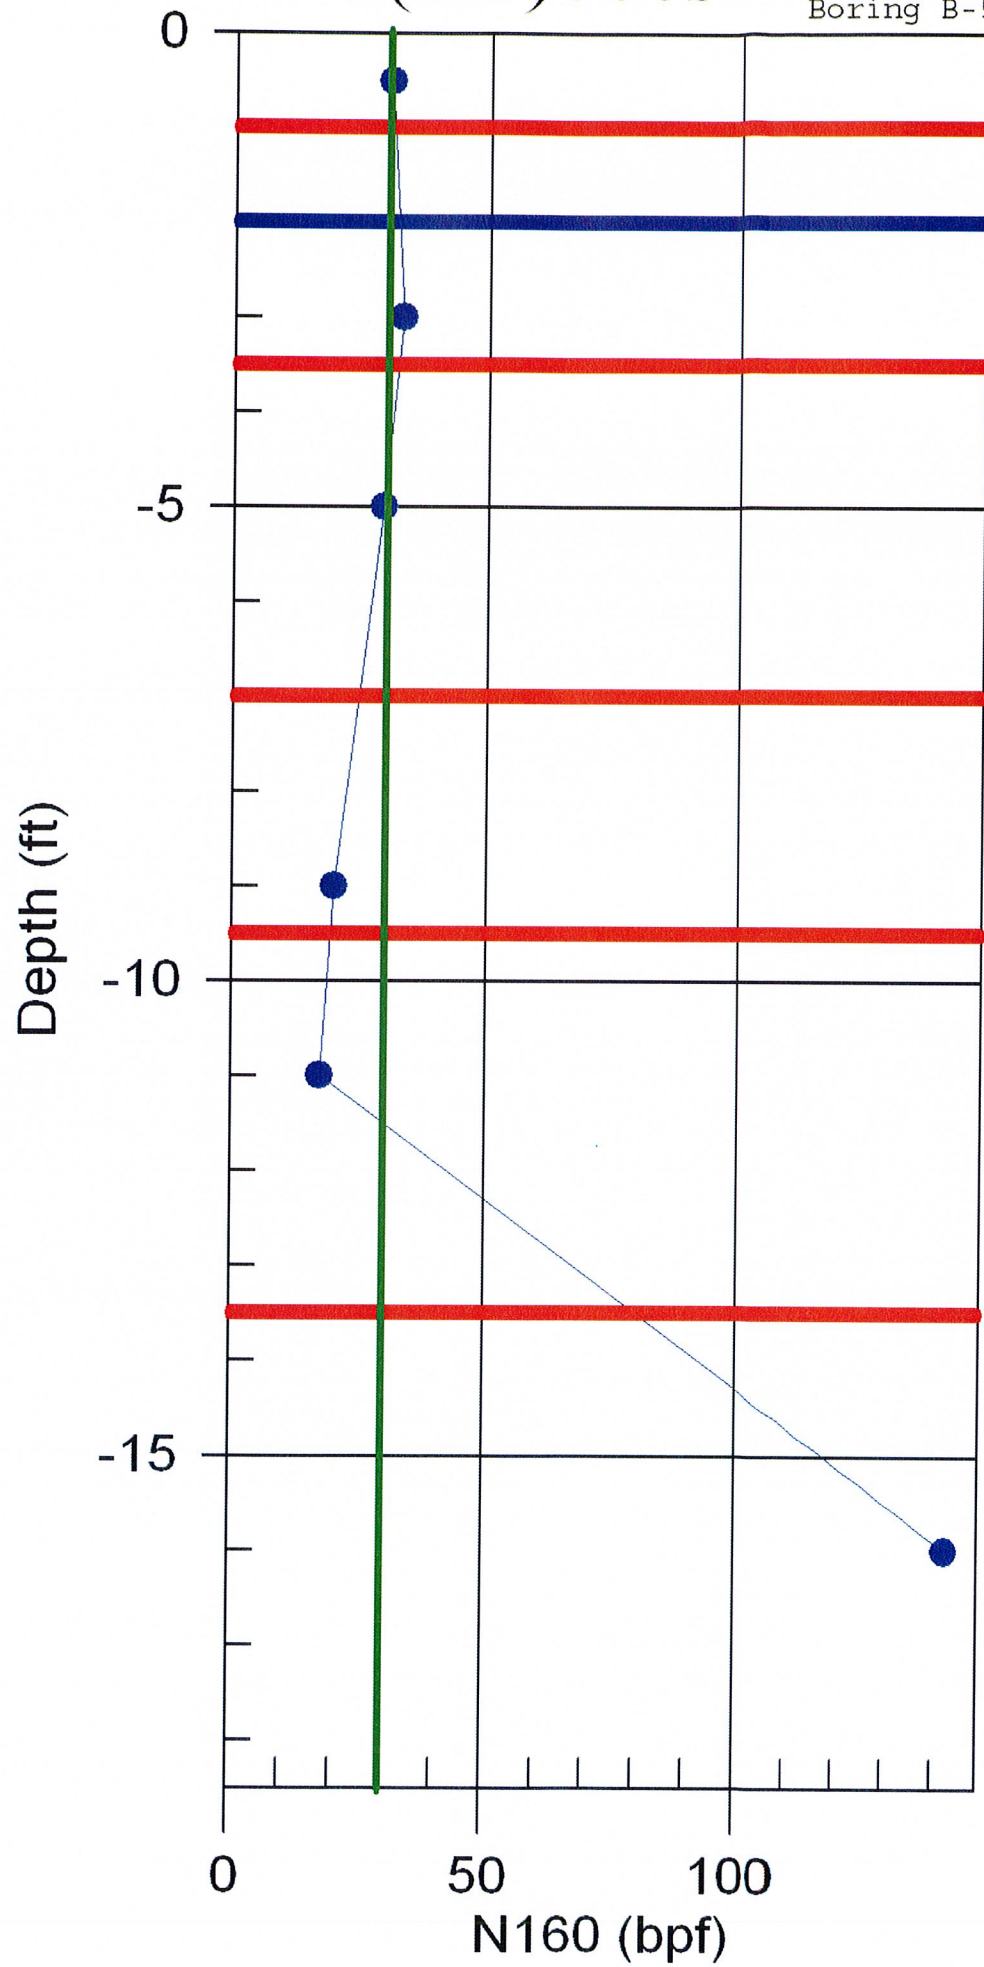
Boring B-5

Factor of Safety

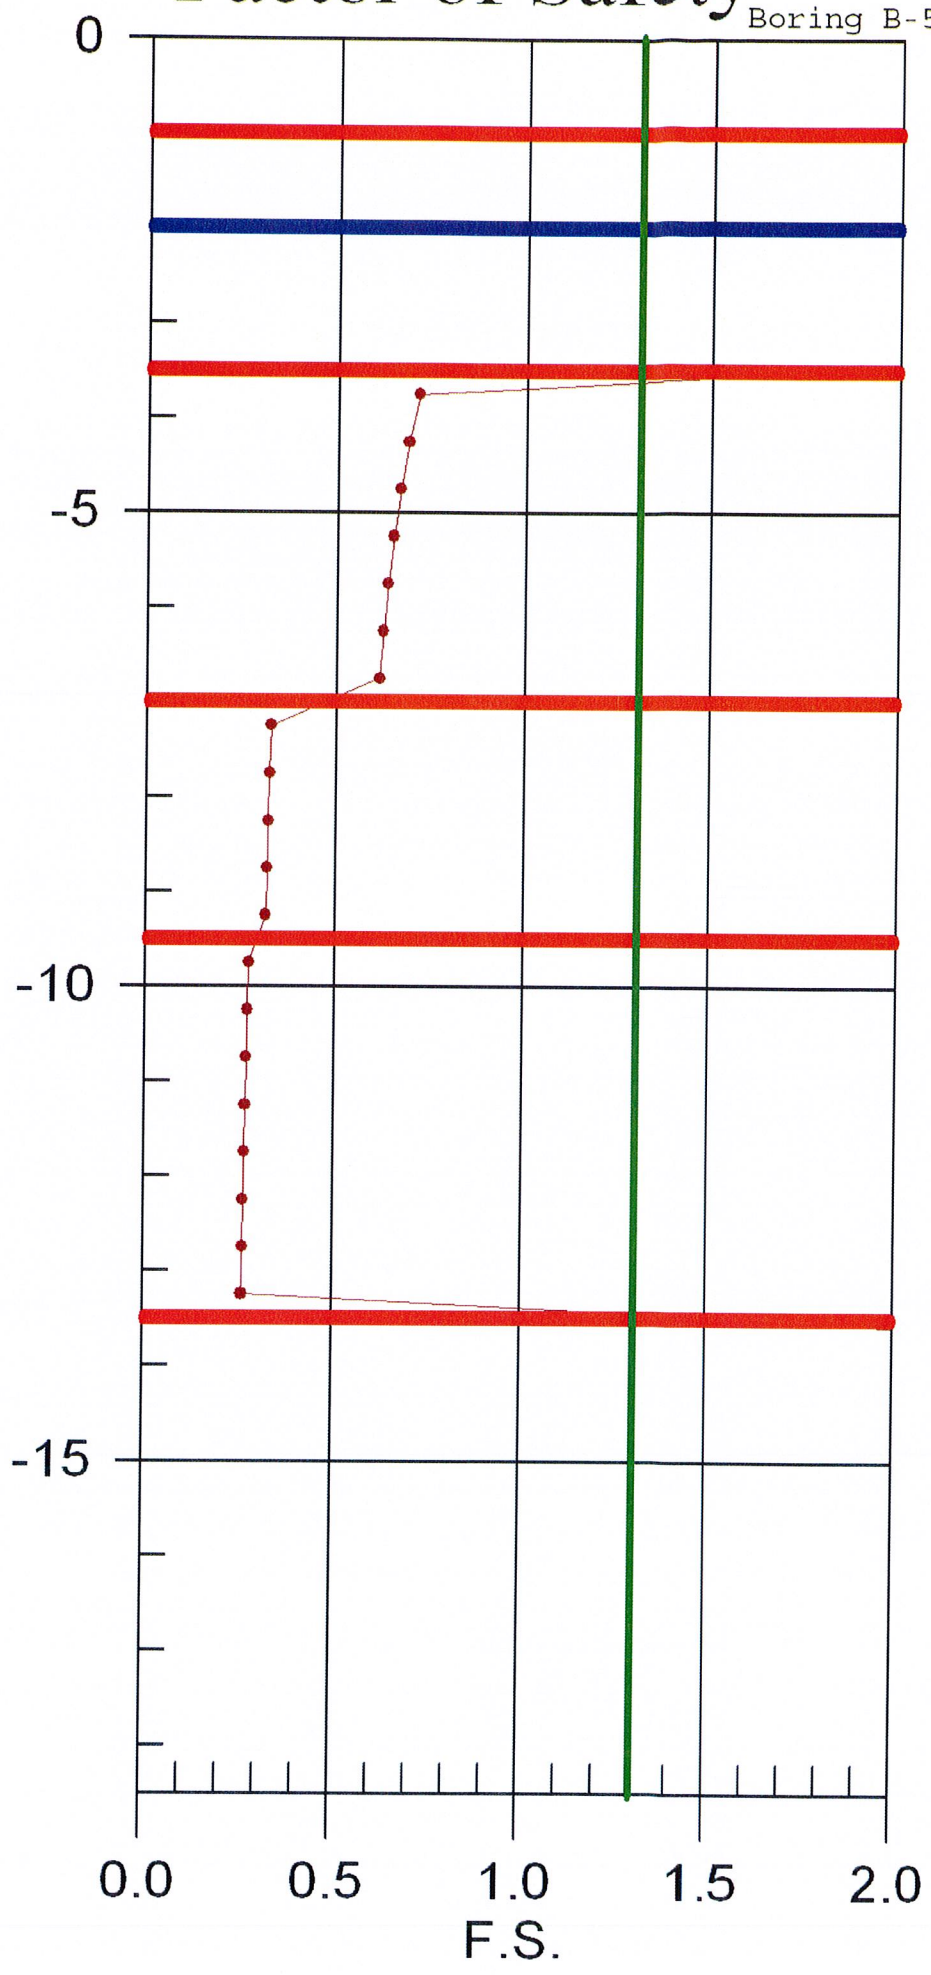
Boring B-5

Induced Vertical Settlement due to Liquefaction
