GEOTECHNICAL INVESTIGATION AND  
GEOLOGIC HAZARDS EVALUATION

FORT BRAGG FIRE DEPARTMENT  
STATION #830  
141 MAIN STREET  
FORT BRAGG, MENDOCINO COUNTY,  
CALIFORNIA

10511.3

July 16, 2009

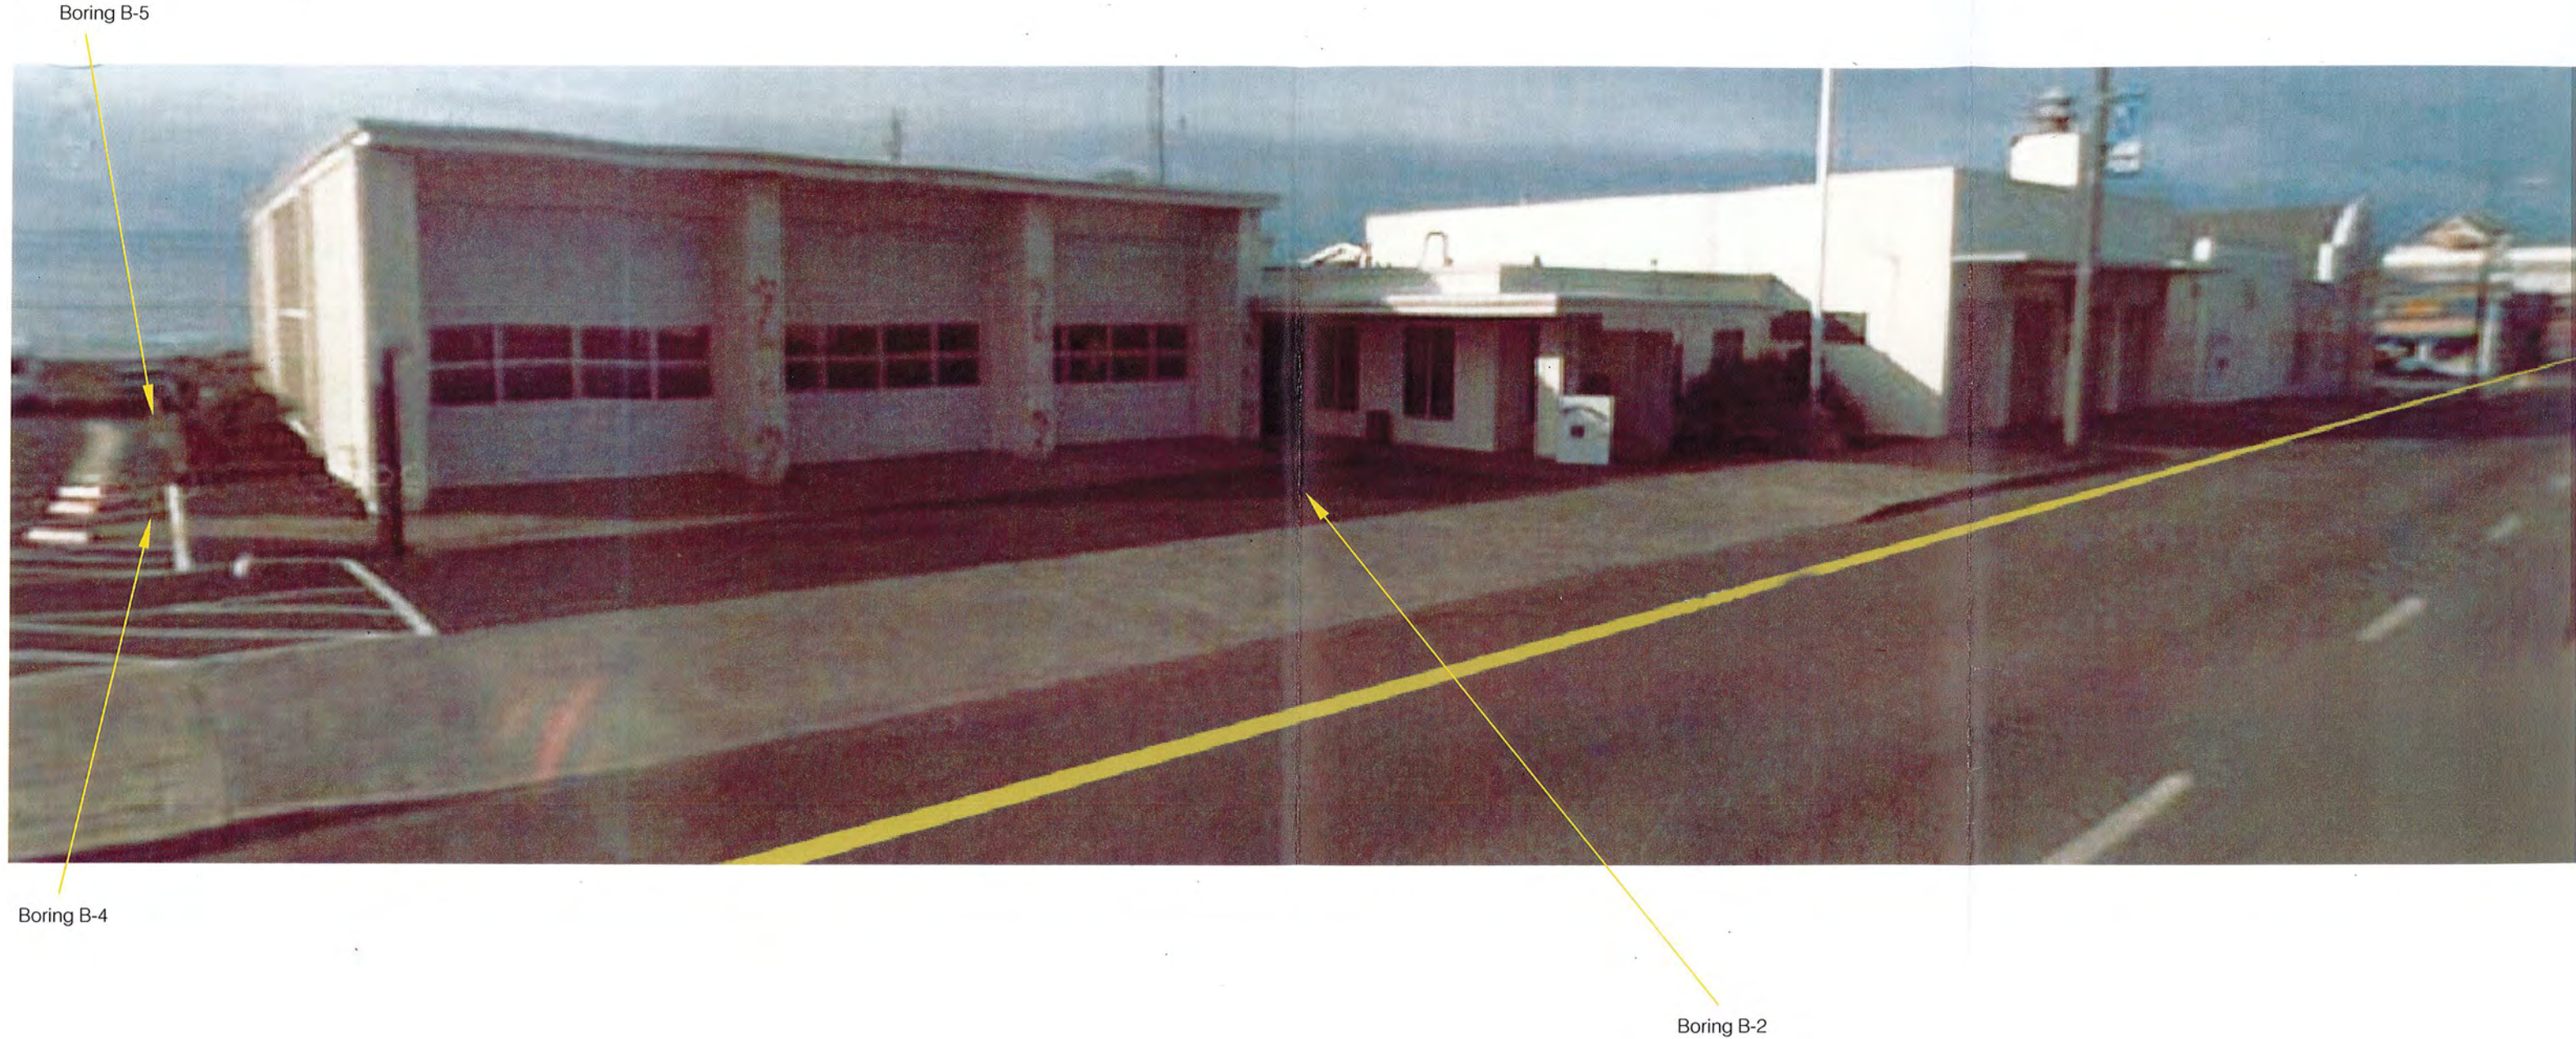
PLATE  
**3**

Fort Bragg Fire Department Station #830  
Looking north-northwest

Boring B-4

Boring B-2

**SITE PHOTOGRAPH A**  
FORT BRAGG FIRE DEPARTMENT  
STATION #830  
141 Main Street  
Fort Bragg, Mendocino County, California

BACE's Principal Engineering Geologist and Senior Civil Engineer performed an initial site reconnaissance on December 12, 2008, to assess site conditions, observe the existing structure, including foundation stem walls, slabs, and pavements, check for evidence of settlement distress, and mark test boring locations. Our Senior Civil Engineer also returned on January 6, 2009, to observe site conditions and subsurface drilling operations. Site Photograph A on Plate 3 shows the site and existing buildings from the southeast.

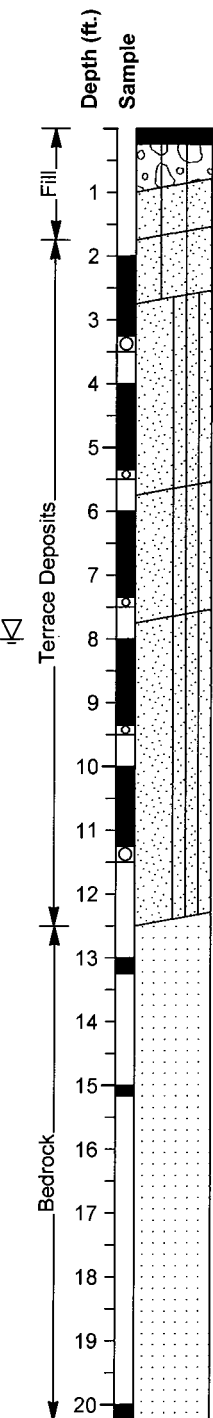
Sampler Type*	Moisture Content (%)	Dry Density (pcf)	Blows/foot
CM	7.7	98	8**
CM	7.0	107	17**
CM	13.2	116	16**
CM	19.1	106	20**
CM	17.9	110	12**
SPT			50/3"
SPT			50/2"
SPT			50/2.5"

ASPHALT  
 LIGHT GRAY SILTY GRAVEL (GM) with sand  
 loose, damp, (Aggregate Base)  
 BROWN-GRAY SILTY SAND (SM)  
 loose, damp, medium to coarse grained sand  
 DARK BROWN SILTY SAND (SM)  
 loose, damp, fine to medium grained sand, organic odor  
 REDDISH-BROWN TO BUFF SAND (SP-SM) with silt  
 loose to medium dense, damp, medium to coarse grained, no odor, oxidized zones  
 BUFF TO LIGHT BROWN SAND (SP-SM) with silt  
 medium dense, wet, coarse grained sand  
 LIGHT BROWN SAND (SP-SM) with silt  
 medium dense, saturated, coarse grained with trace medium grained sand, mostly quartz, well rounded to subrounded  
 GRAY-BROWN TO BLUE-GRAY SANDSTONE  
 intense fracturing, friable to low hardness, deeply weathered, fine to medium grained  
 - becomes hard, little weathered

- Notes:
1. No caving.
  2. Free water encountered at about 8.0 feet.
  3. Practical drilling refusal at 20.0 feet bgs.

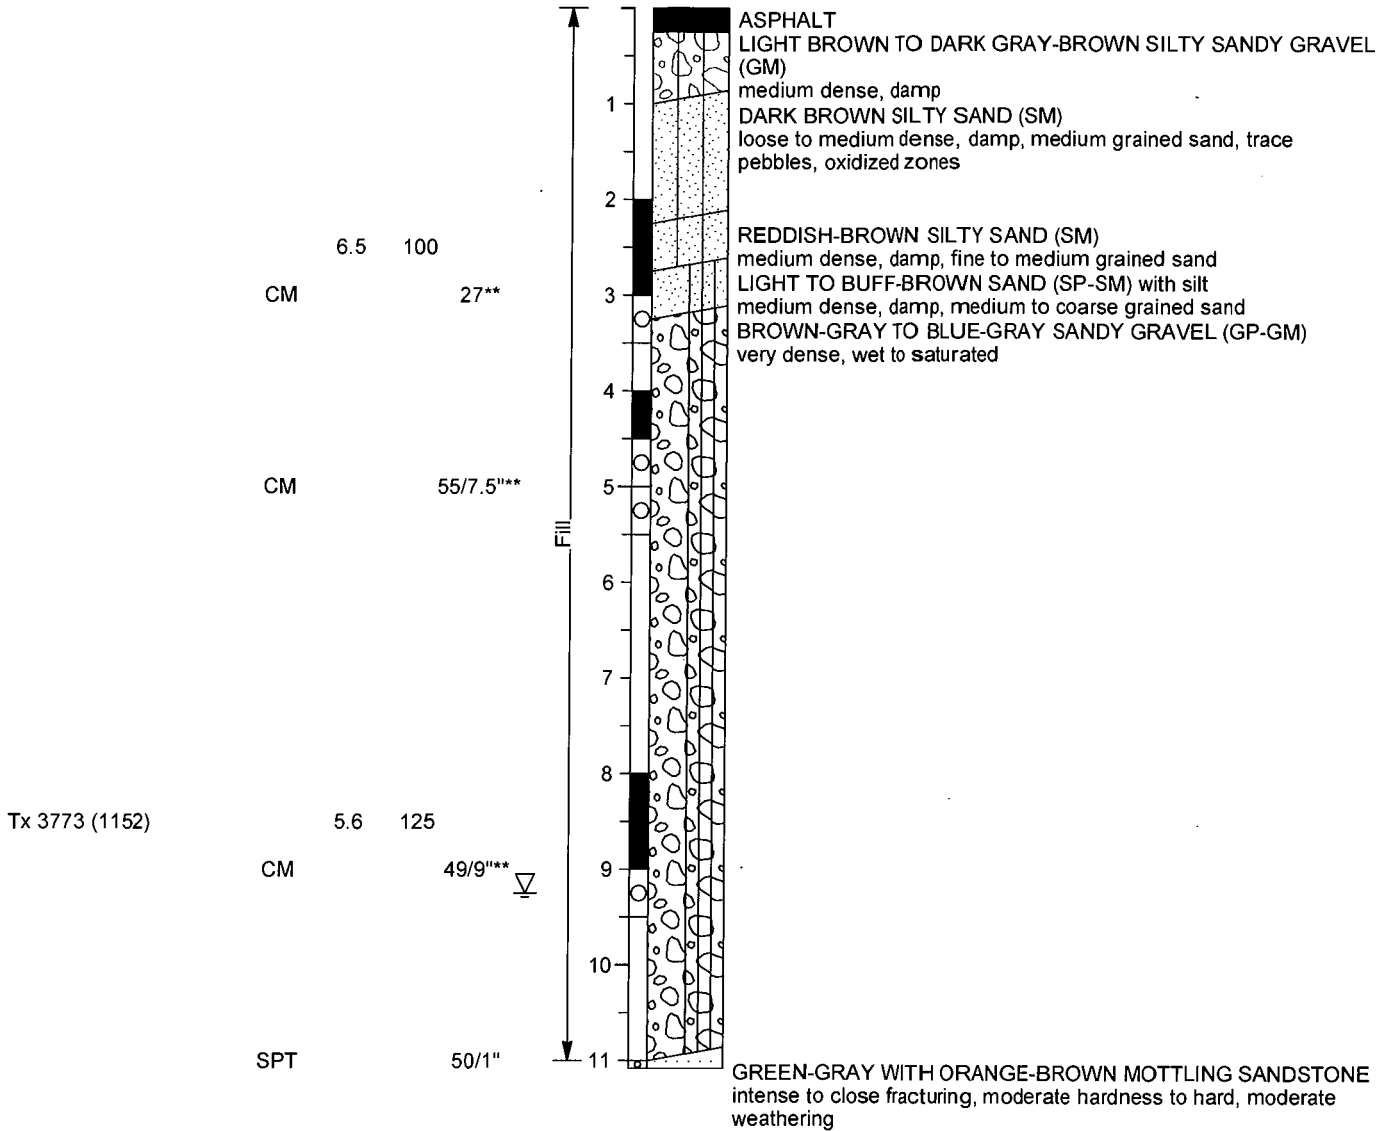
### Notes:

1. No caving
2. Free water encountered at about 9.0 feet bgs.
3. Practical drilling refusal at 11.0 feet bgs.

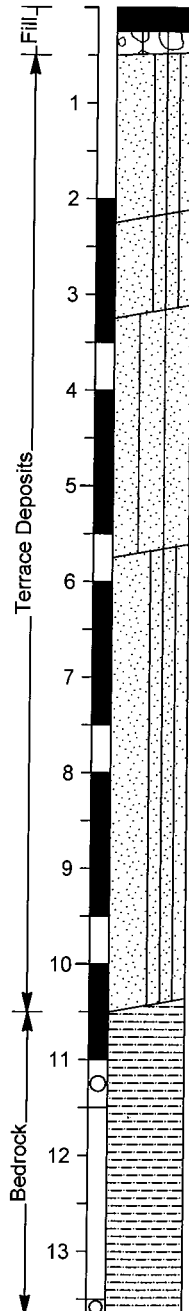
ASPHALT  
 LIGHT GRAY SILTY GRAVEL (GM) with sand  
 medium dense, damp (Aggregate Base)  
 DARK BROWN TO REDDISH-BROWN SILTY SAND (SP-SM)  
 very loose to loose, damp, fine to medium grained sand  
 REDDISH-BROWN TO BUFF-BROWN SAND (SP-SM) with silt  
 very loose, damp, medium to coarse grained sand  
 LIGHT BROWN TO BUFF-BROWN SILTY SAND (SM)  
 very loose to medium dense, damp to wet, medium grained sand,  
 primarily quartz, subrounded (rare), rounded (predominate)  
 BUFF-BROWN MOTTLED WITH ORANGE-BROWN SAND  
 (SP-SM) with silt  
 medium dense, damp to wet, medium grained sand, primarily  
 quartz, subrounded (rare), rounded (predominate)  
 - moisture increase at approximately 8.0 feet bgs.  
 REDDISH-BROWN TO GRAY-BROWN SILTSTONE  
 intensely to little fractured, moderate hardness to hard, deep to  
 moderate weathering with depth, calcite veins in fractures

- Notes:
1. Caving occurred after removing hollow-stem auger.
  2. No free water encountered
  3. Practical drilling refusal at 13.5 feet bgs.

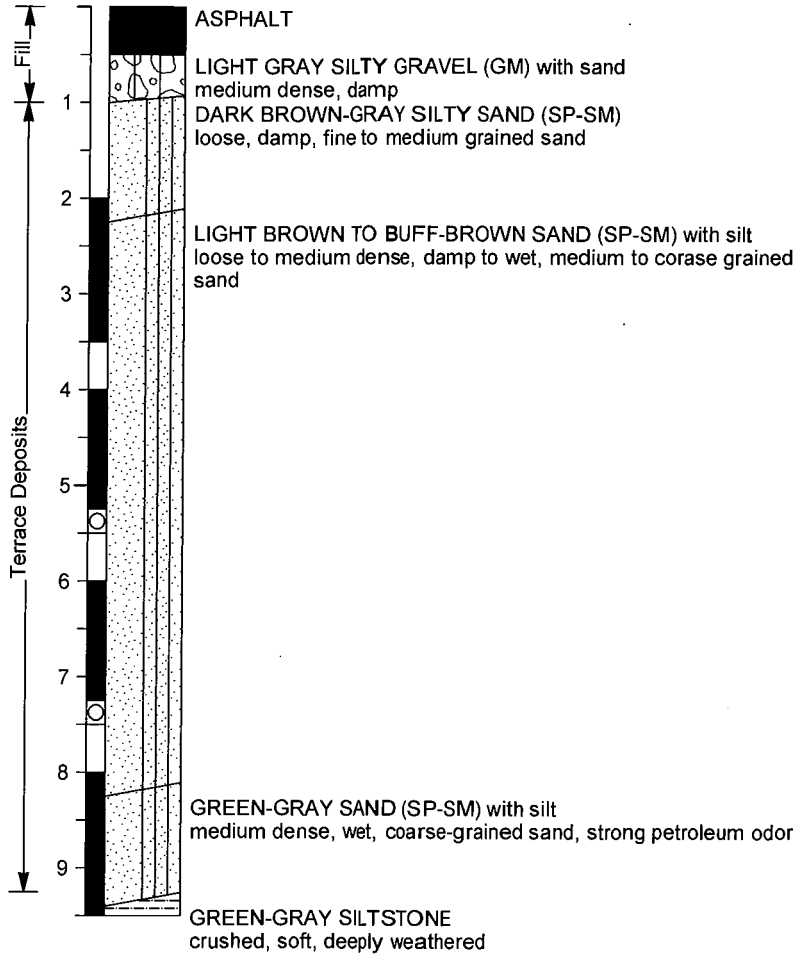
Sampler Type*	Moisture Content (%)	Dry Density (pcf)	Blows/foot
	CM	6.6	89	10**
DS 348 (500)	CM	7.7	111	17**
11% Passing #200 100% Passing #4	SPT	7.7	112	17
	SPT			15

1. No free water encountered
2. No caving
3. Drilling terminated at 9.5 feet due to petroleum odor

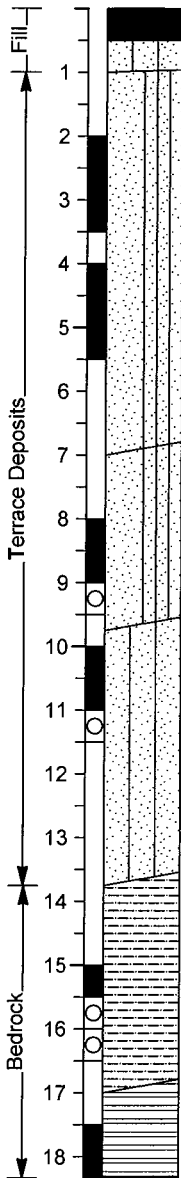
ASPHALT  
DARK BROWN TO LIGHT GRAY-BROWN SILTY SAND (SM)  
loose, damp, grains coarse with depth (fine to medium to medium/coarse  
REDDISH-BROWN TO ORANGE-BROWN SAND (SP-SM) with silt  
loose to medium dense, damp, medium to coarse grained sand, primarily quartz

LIGHT BUFF-BROWN TO WHITE SAND (SP-SM) with silt  
loose to medium dense, saturated, medium grained, mostly quartz

GREEN-GRAY SILTY SAND (SM)  
loose, saturated, coarse sand and pebbles predominate

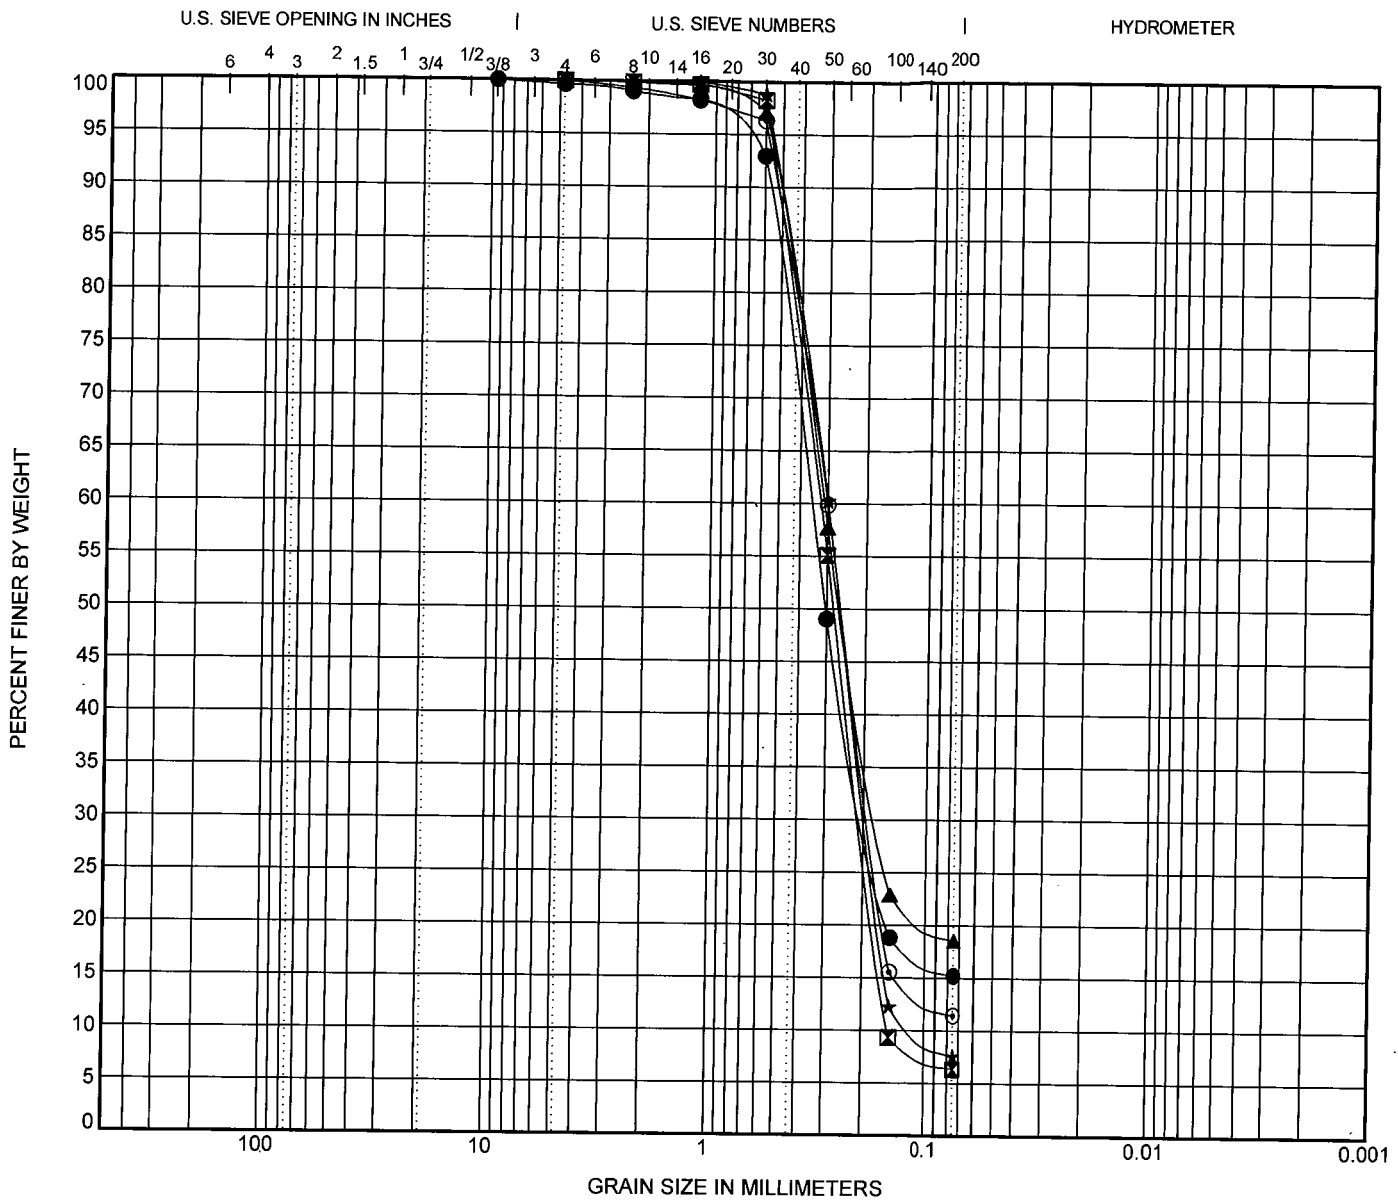
PLATE  
**13**

Specimen Identification	Classification					LL	PL	PI	Cc	Cu
● B-1 2.5 ft	<b>DARK BROWN SILTY SAND (SM)</b>									
☒ B-1 8.5 ft	<b>LIGHT BROWN SAND (SP-SM) with silt</b>								0.86	2.14
▲ B-3 4.0 ft	<b>LIGHT BROWN TO BUFF-BROWN SILTY SAND (SM)</b>									
★ B-3 8.5 ft	<b>BUFF-BROWN MOTTLED WITH ORANGE-BROWN SAND (SP-SM) with silt</b>								1.17	2.79
⊙ B-4 6.5 ft	<b>LIGHT BROWN TO BUFF-BROWN SAND (SP-SM) with silt</b>								2.00	5.11
Specimen Identification	D100	D60	D30	D10	%Gravel	%Sand	%Silt	%Clay		
● B-1 2.5 ft	9.5	0.357	0.194		0.3	84.4	15.2			
☒ B-1 8.5 ft	4.75	0.325	0.205	0.152		93.7	6.3			
▲ B-3 4.0 ft	4.75	0.313	0.173			81.5	18.5			
★ B-3 8.5 ft	2.36	0.299	0.194	0.107		92.4	7.6			
⊙ B-4 6.5 ft	4.75	0.301	0.188			88.6	11.4

The test results are presented opposite the samples tested on the test boring logs. A Key to Test Data is provided on Plate 10. In addition, grain size distribution test results are presented on Plates 13 and 14, triaxial compression test data on Plate 15, and direct shear test results on Plate 16. Near-surface soil samples were sent to JDH Corrosion Consultants, Inc. for corrosivity potential testing consisting of resistivity, pH, chloride, sulfate and redox. Corrosivity test results are presented in Appendix B.

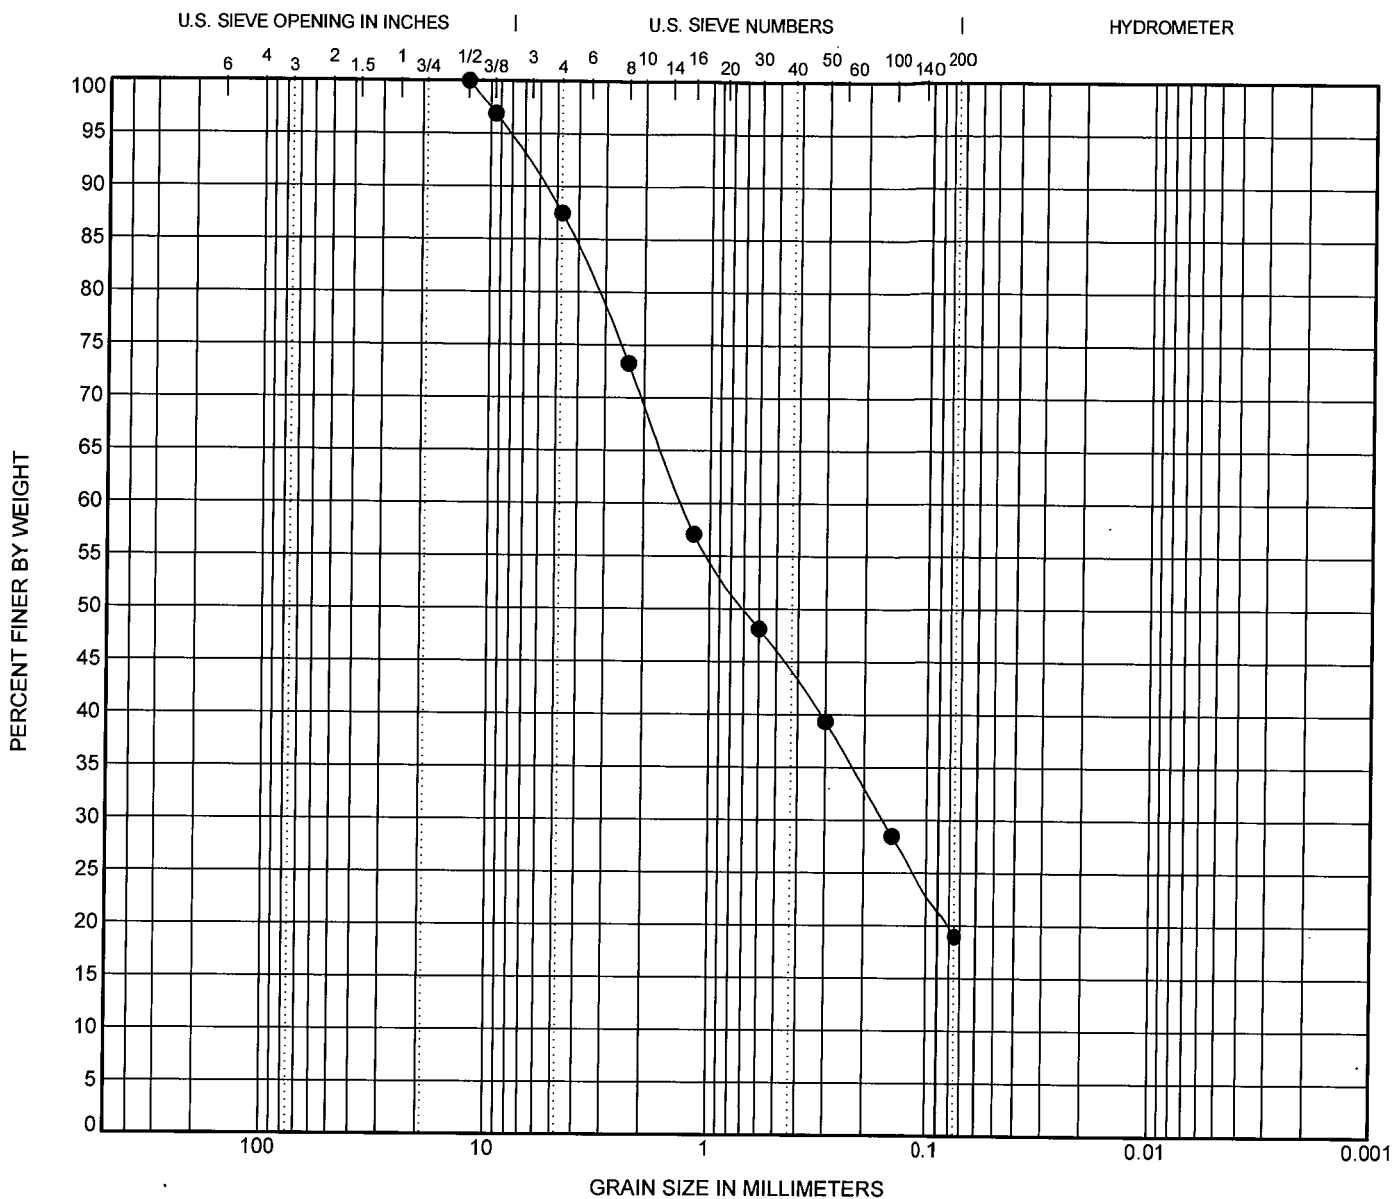
**14**

Specimen Identification	Classification					LL	PL	PI	Cc	Cu
● B-5 10.0 ft	<b>GREEN-GRAY SILTY SAND (SM)</b>									
Specimen Identification	D100	D60	D30	D10	%Gravel	%Sand	%Silt	%Clay		
● B-5 10.0 ft	12.5	1.338	0.165		12.5	68.5	19.0

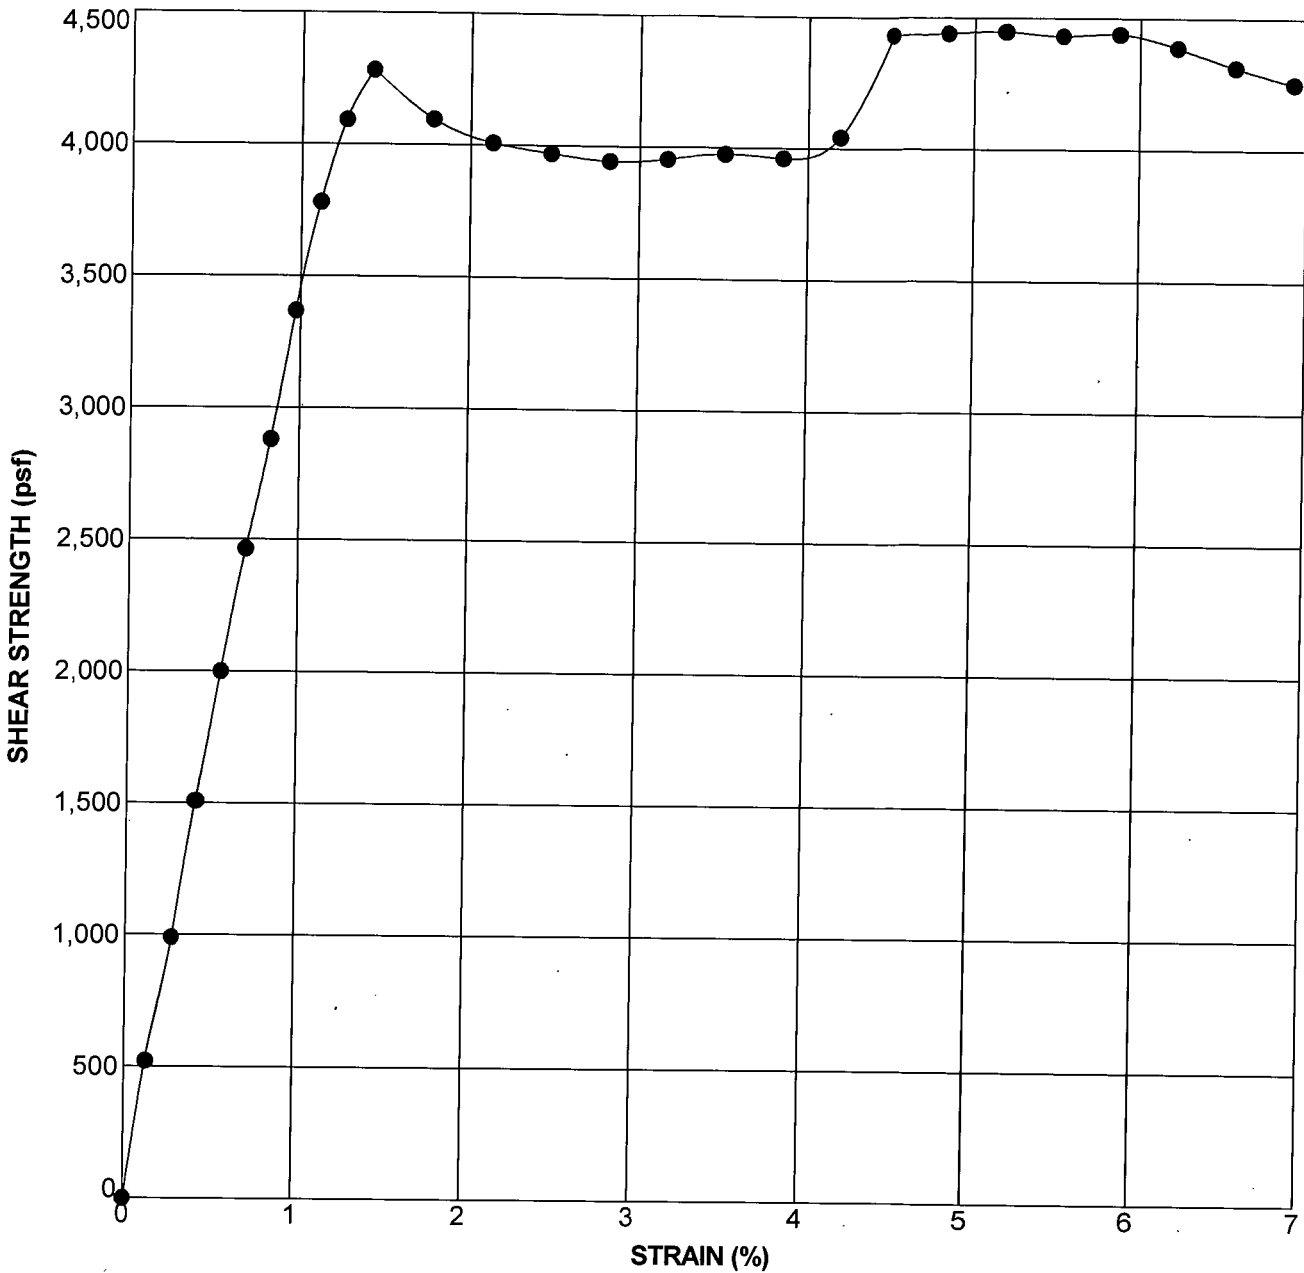
Sample Source	Classification	Confining Pressure (psf)	Yield Strength (psf)	Strain (%)	Dry Density (pcf)	Moisture Content (%)
● B-2 @ 8.5 ft	BROWN-GRAY TO BLUE-GRAY SANDY GRAVEL (GP-GM)	1152	3773	1.1	125	5.6

<b>BACE GEOTECHNICAL</b> a division of <b>Brunsing Associates, Inc.</b> (707) 528-6108	Job No.: 10511.3  Appr.: <i>KAC</i>  Date: 07/16/09	<b>UNCONSOLIDATED UNDRAINED TRIAXIAL COMPRESSION TEST</b>  FORT BRAGG FIRE DEPARTMENT STATION #830 141 Main Street Fort Bragg, Mendocino County, California	PLATE  <b>15</b>
--	---	---	--	------------------------

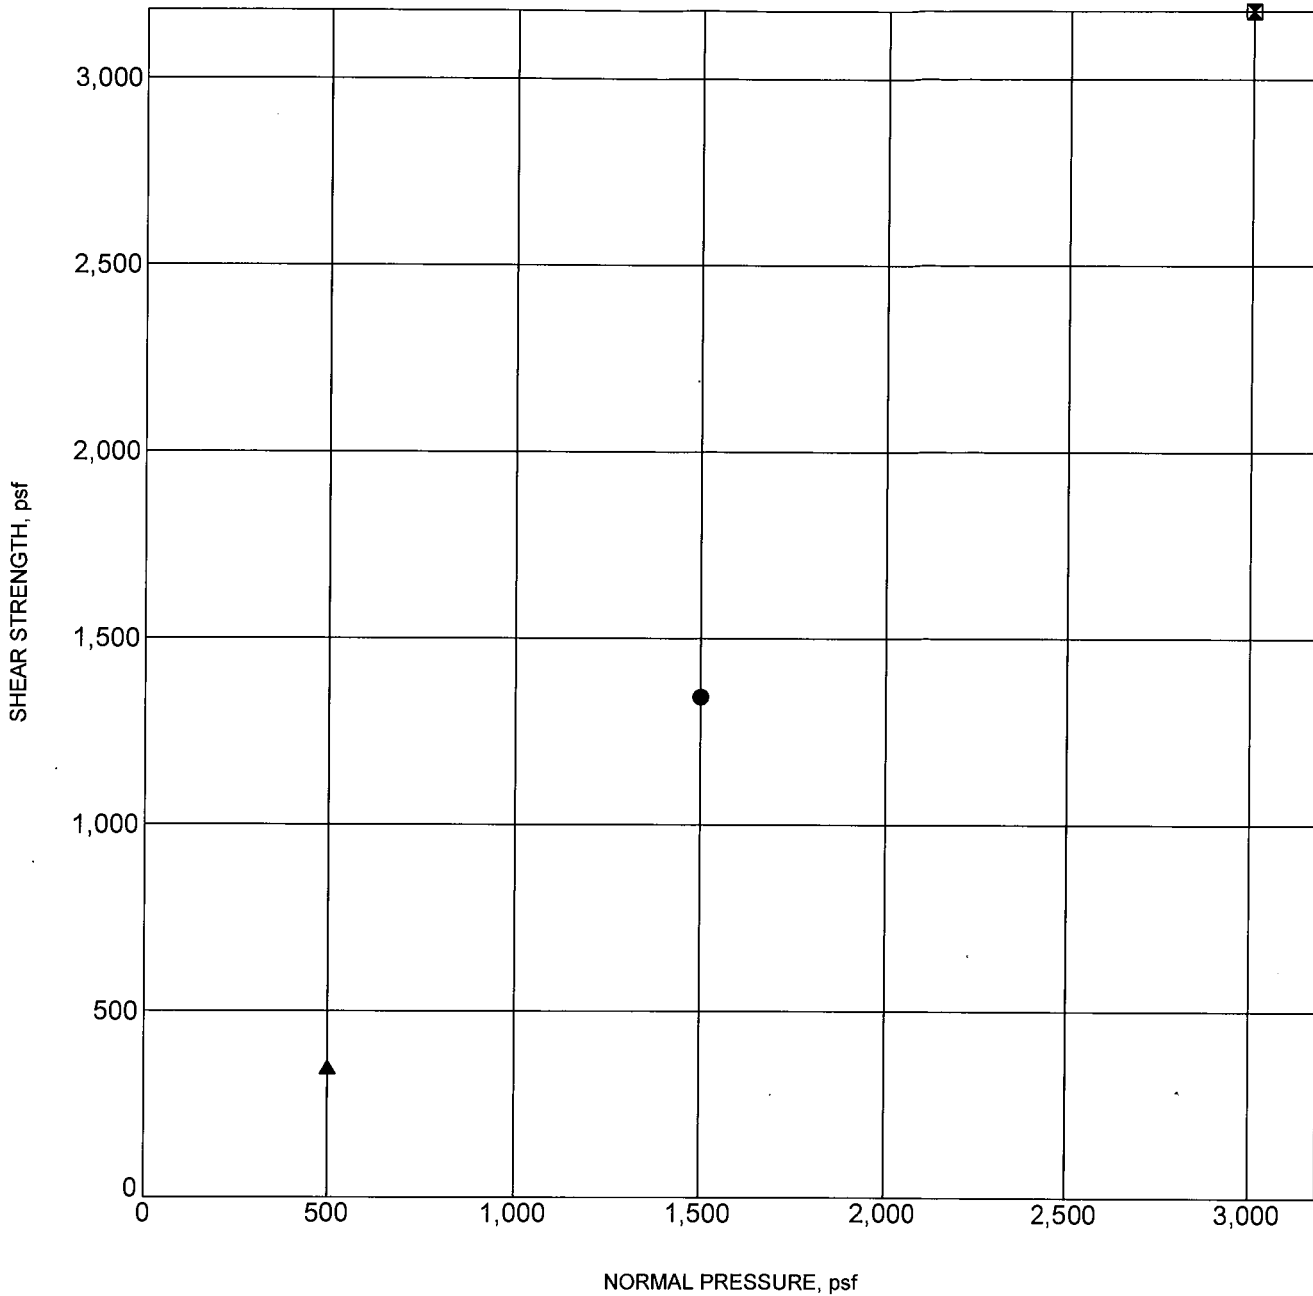
- EXPLANATION**
- DEBRIS SLIDE: includes scarp and slide deposits; solid where active, dashed where dormant.
  - DEBRIS FLOW/TORRENT TRACK: solid where active, dashed where dormant.

Specimen Identification	Classification	$\gamma_d$	MC%	c	$\phi$ (degree)
● B-1 at 6.5 ft	BUFF TO LIGHT BROWN SAND (SP) with silt	116	13.2	0	42
☒ B-1 at 10.5 ft	LIGHT BROWN SAND (SP-SM) with silt	110	17.9	0	47
▲ B-4 at 4.5 ft	LIGHT BROWN TO BUFF-BROWN SAND (SP-SM) with silt	111	7.7	0	34
<b>Average</b>				<b>0</b>	<b>41</b>

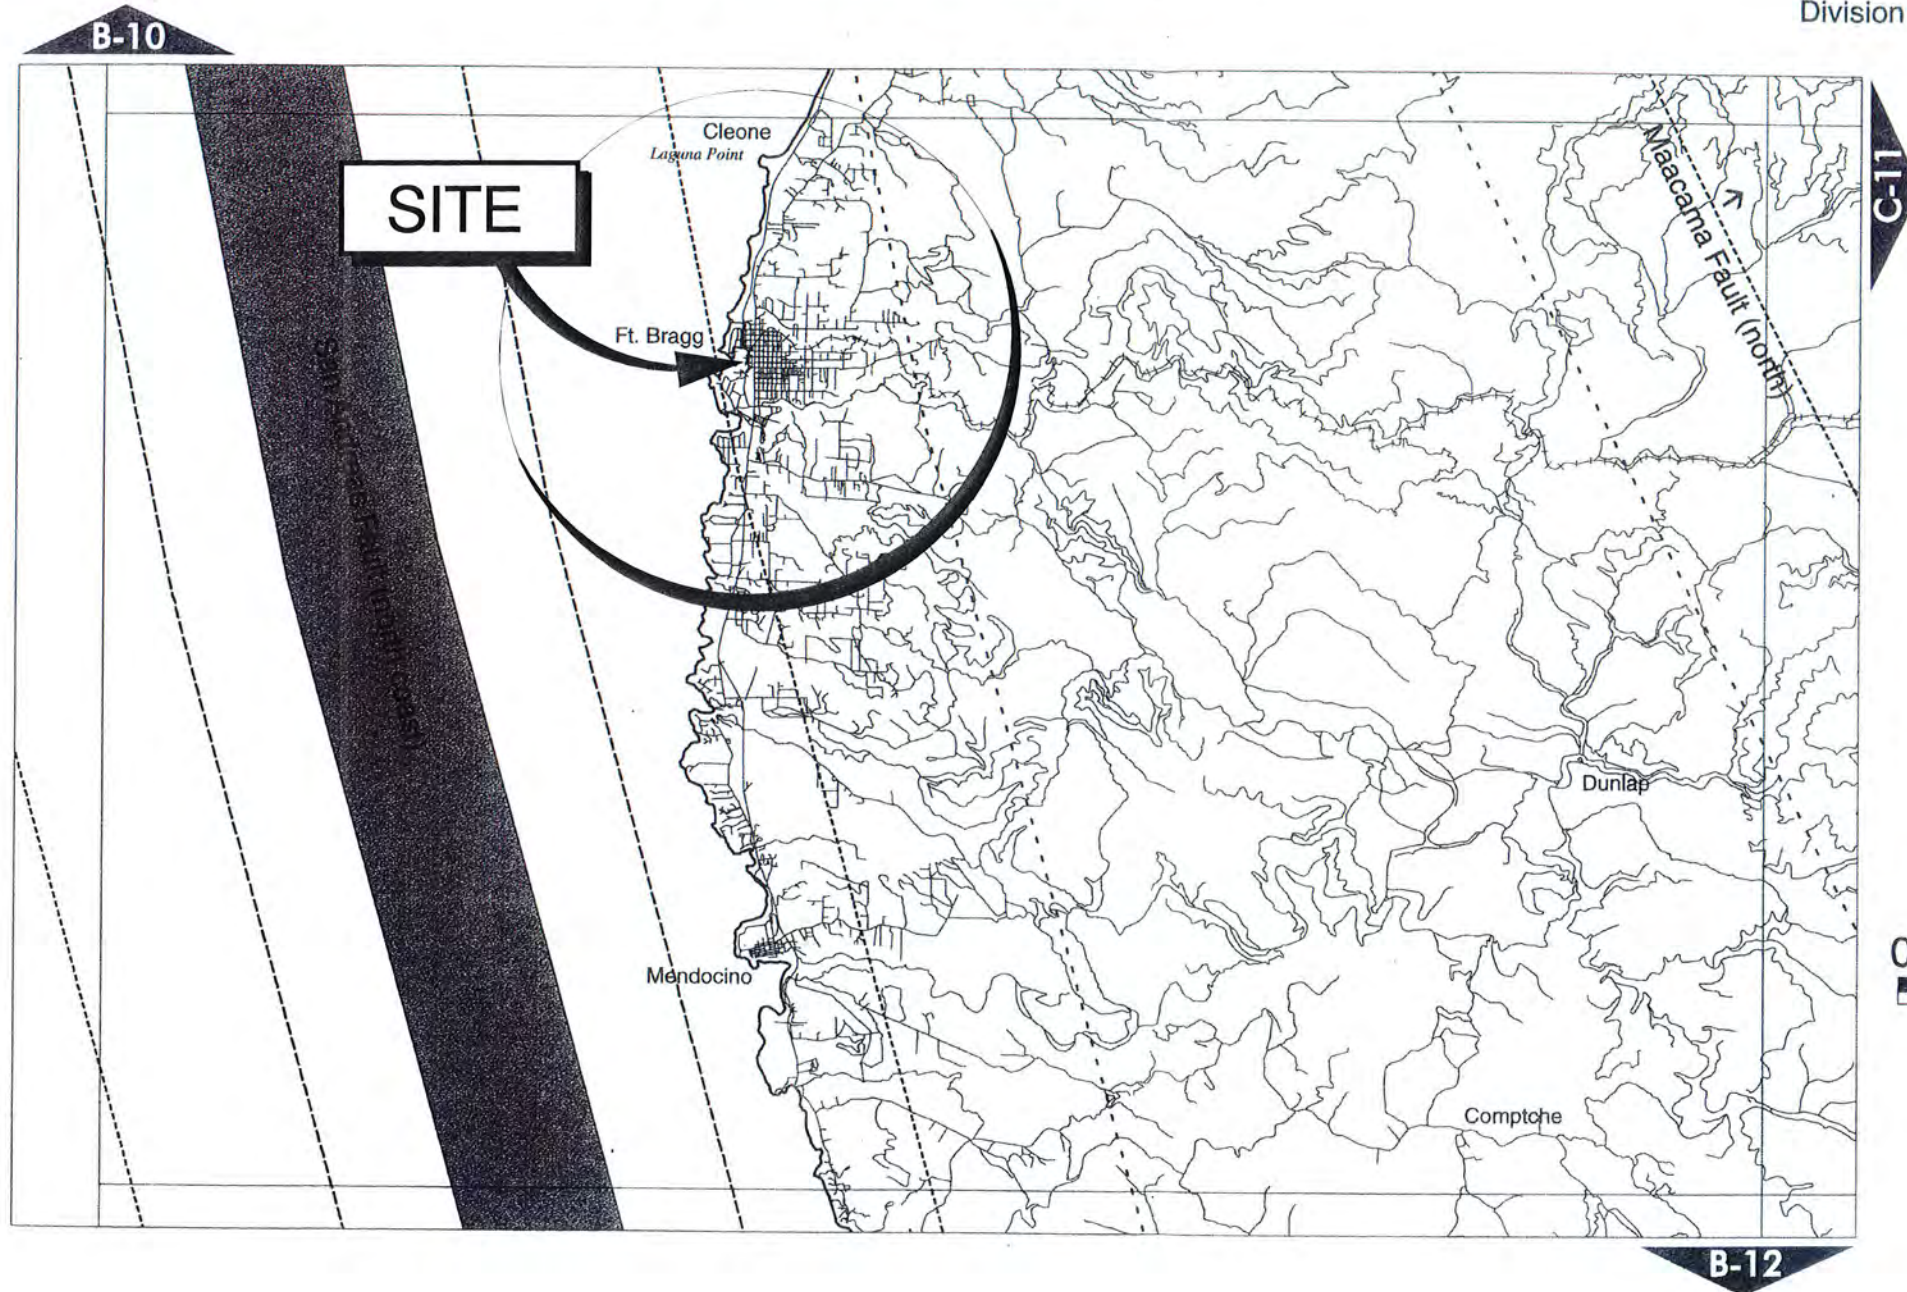
<b>BACE Geotechnical</b> a division of Brunsing Associates, Inc. (707) 528-6108	Job No.: 10511.3 Appr.: <i>EEO</i> Date: 07/16/09	<b>REGIONAL ACTIVE FAULT MAP</b> FORT BRAGG FIRE DEPARTMENT STATION #830 141 Main Street Fort Bragg, Mendocino County, California	PLATE <b>18</b>
---	--	---	---	--------------------

The August 1998 CDMG Active Fault Near-Source Zones map (page B-11 of Reference 12), Plate 18, covering the site vicinity indicates that the site is approximately 10.8 kilometers from the nearest known seismic source. Since the nearest active fault (San Andreas Fault) is located about 10.8 kilometers (6.7 miles) away, and no evidence of faulting was observed at the site, nor shown on the geologic maps and literature we reviewed, we do not consider surface fault rupture to pose a hazard to the site.

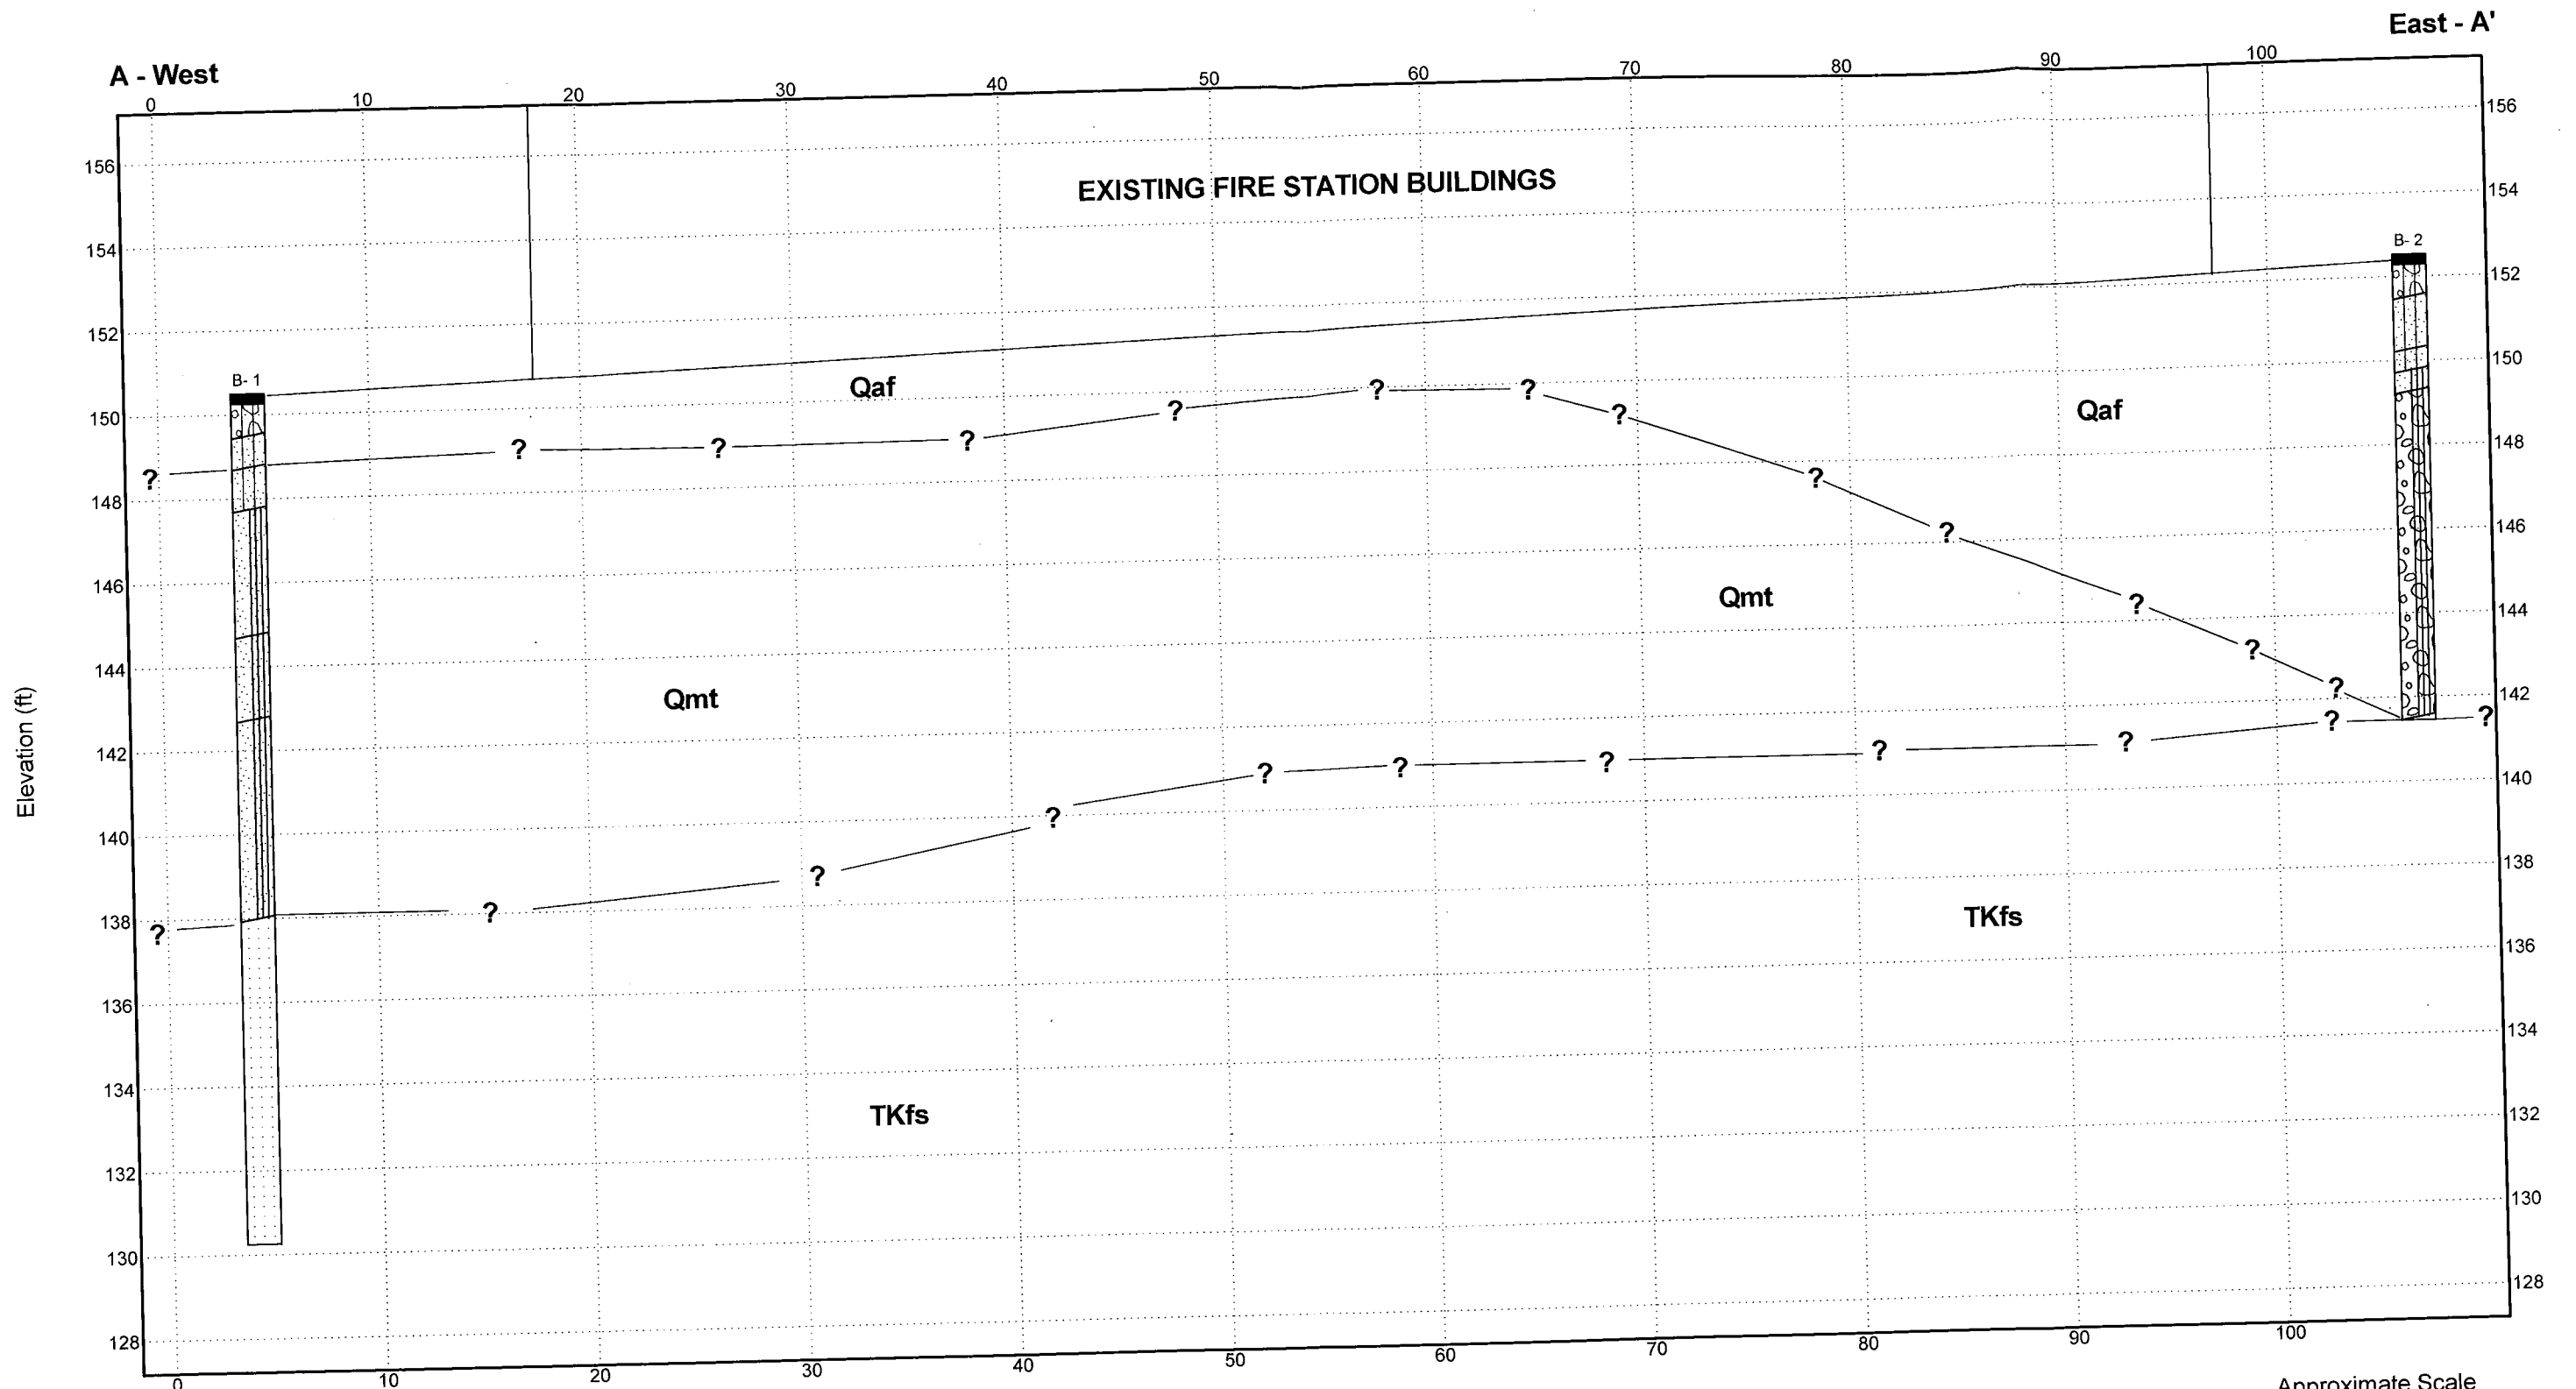
- - - ? Geologic contact, dashed and queried where certain
- Qaf - Historic Artificial Fill Deposits
- Qmt - Quaternary Marine Terrace Deposits
- TKfs - Tertiary-Cretaceous Coastal Belt Franciscan Complex

BACE GEOTECHNICAL a division of Brunsing Associates, Inc. (707) 528-6108	Job No.: 10511.3 Appr.: <i>KAC</i> Date: 07/16/09	<b>SECTION A - A'</b> FORT BRAGG FIRE DEPARTMENT STATION #830 141 Main Street Fort Bragg, Mendocino County, California	PLATE <b>19</b>
---	---	---	--	--------------------

Franciscan Complex bedrock was encountered in our test borings at approximately 9.5 to 13.5 feet bgs. The bedrock generally consists of sandstone, siltstone and shale. The sandstone is gray brown, blue gray and green gray with orange brown mottling. The sandstone is generally intensely to little fractured, friable to hard and deeply to little weathered. The siltstone is reddish brown to gray brown and green brown. The siltstone is crushed to little fractured, soft to hard and deeply to little weathered. The dark gray shale is intensely to little fractured, moderately hard to hard and moderately to little weathered. The upper few feet of bedrock is generally deeply weathered and reddish-brown to gray-brown. Weathering generally decreases with depth, and hardness increases. Since the ground surface at the site is entirely overlain with terrace deposits, and no bedrock surface outcrops were observed, a site-specific geologic map was not prepared. Geologic Cross sections A-A' and B-B' on Plates 19 and 20, respectively, depict our interpretation of the subsurface conditions and show the approximate existing building locations.
