GEOTECHNICAL INVESTIGATION AND  
GEOLOGIC HAZARDS EVALUATION

FORT BRAGG FIRE DEPARTMENT  
STATION #830  
141 MAIN STREET  
FORT BRAGG, MENDOCINO COUNTY,  
CALIFORNIA

10511.3

July 16, 2009

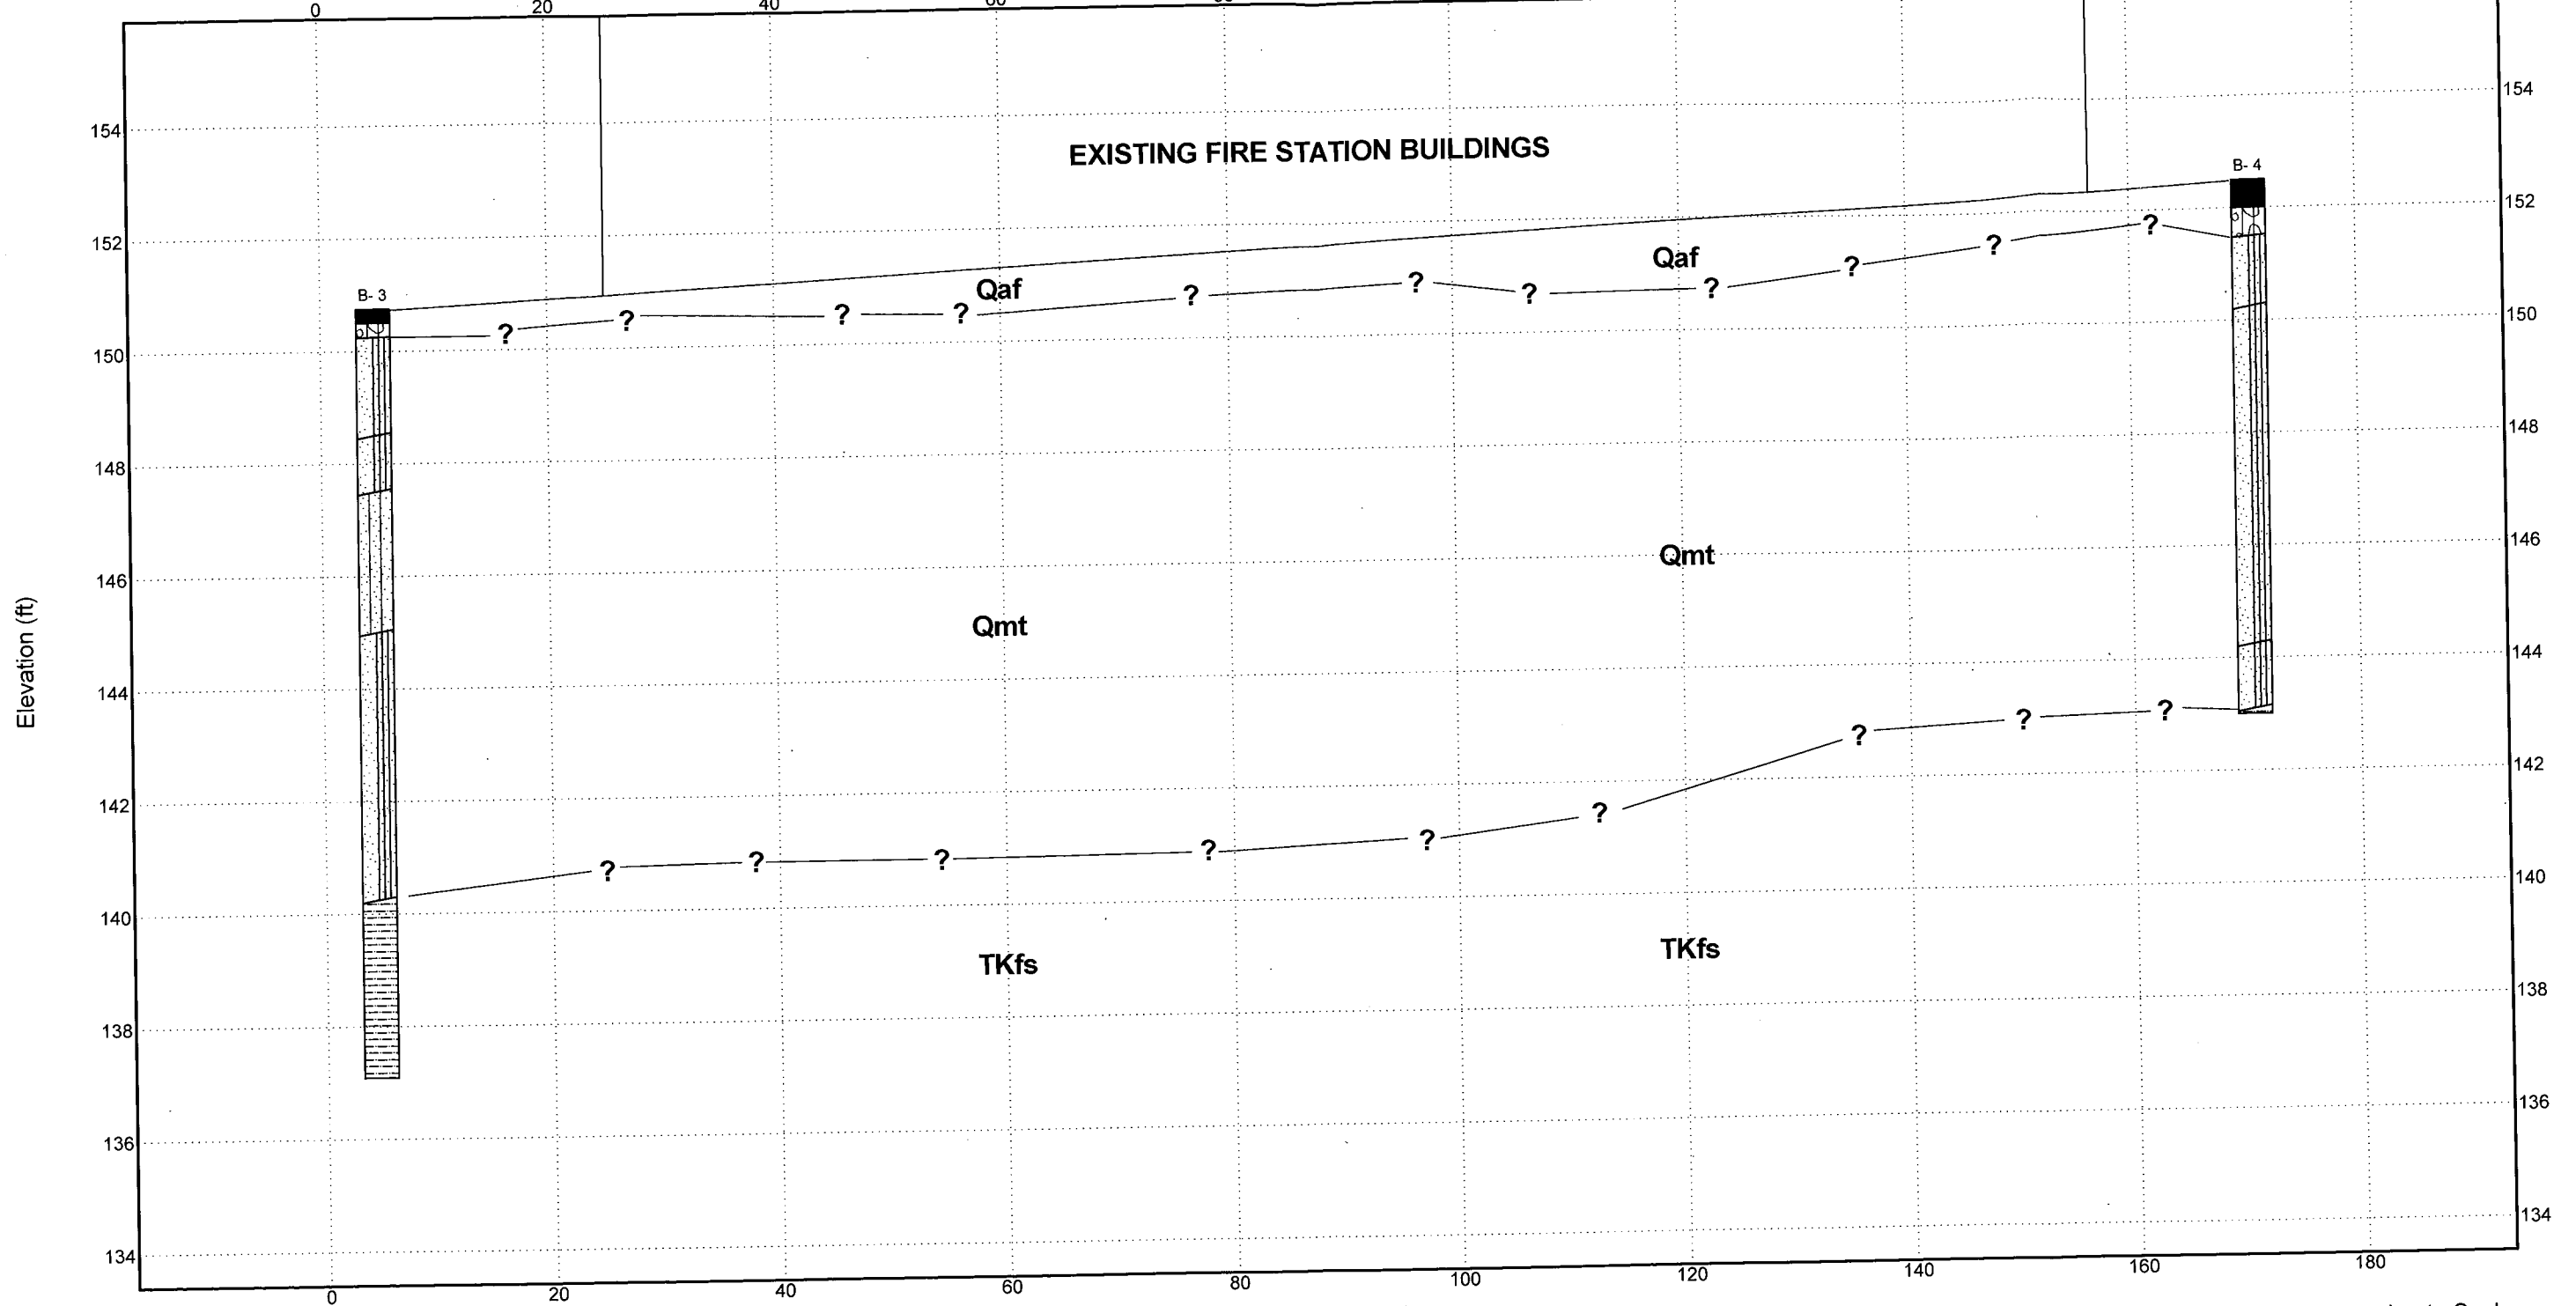
**B - North-Northwest** **South-Southeast - B'**

—? Geologic Contact, dashed and queried where uncertain

Franciscan Complex bedrock was encountered in our test borings at approximately 9.5 to 13.5 feet bgs. The bedrock generally consists of sandstone, siltstone and shale. The sandstone is gray brown, blue gray and green gray with orange brown mottling. The sandstone is generally intensely to little fractured, friable to hard and deeply to little weathered. The siltstone is reddish brown to gray brown and green brown. The siltstone is crushed to little fractured, soft to hard and deeply to little weathered. The dark gray shale is intensely to little fractured, moderately hard to hard and moderately to little weathered. The upper few feet of bedrock is generally deeply weathered and reddish-brown to gray-brown. Weathering generally decreases with depth, and hardness increases. Since the ground surface at the site is entirely overlain with terrace deposits, and no bedrock surface outcrops were observed, a site-specific geologic map was not prepared. Geologic Cross sections A-A' and B-B' on Plates 19 and 20, respectively, depict our interpretation of the subsurface conditions and show the approximate existing building locations.

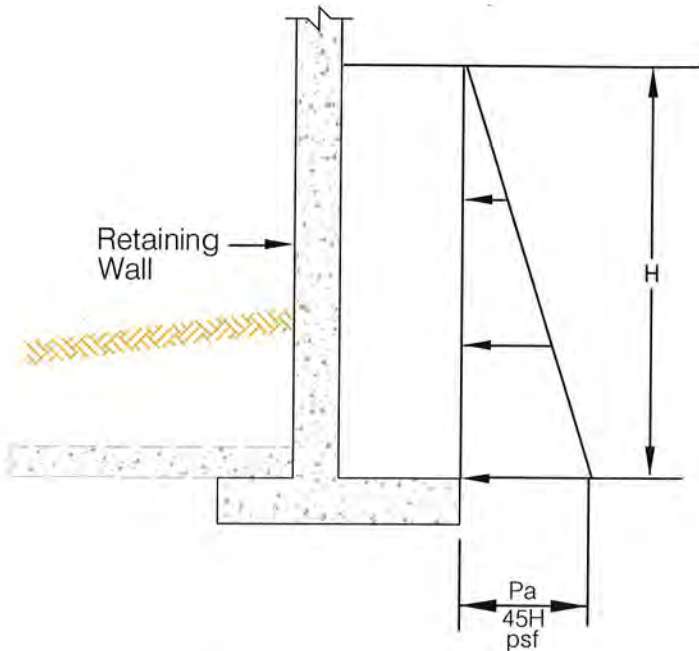
### ACTIVE SOIL PRESSURE DIAGRAM

For walls that are free to yield slightly (See Note 2)

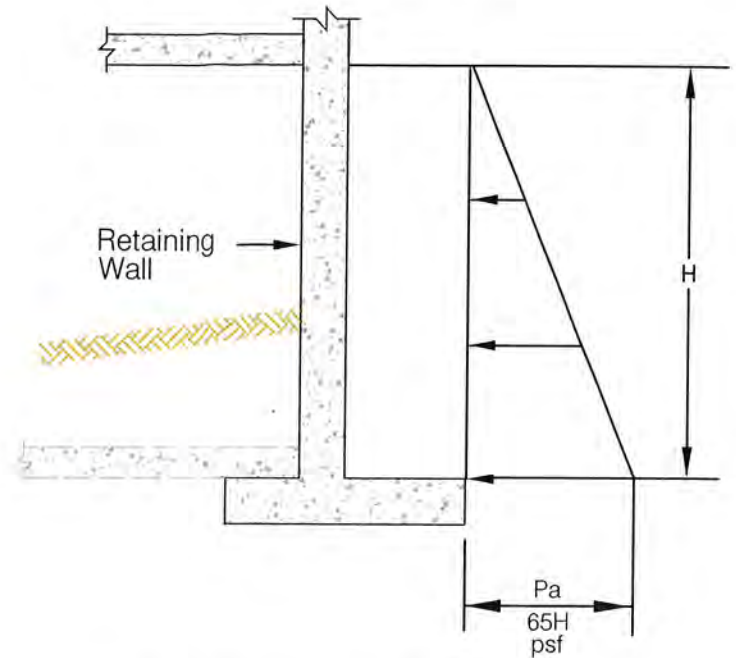
### AT-REST SOIL PRESSURE DIAGRAM

For braced walls of substantial rigidity (See Note 2)

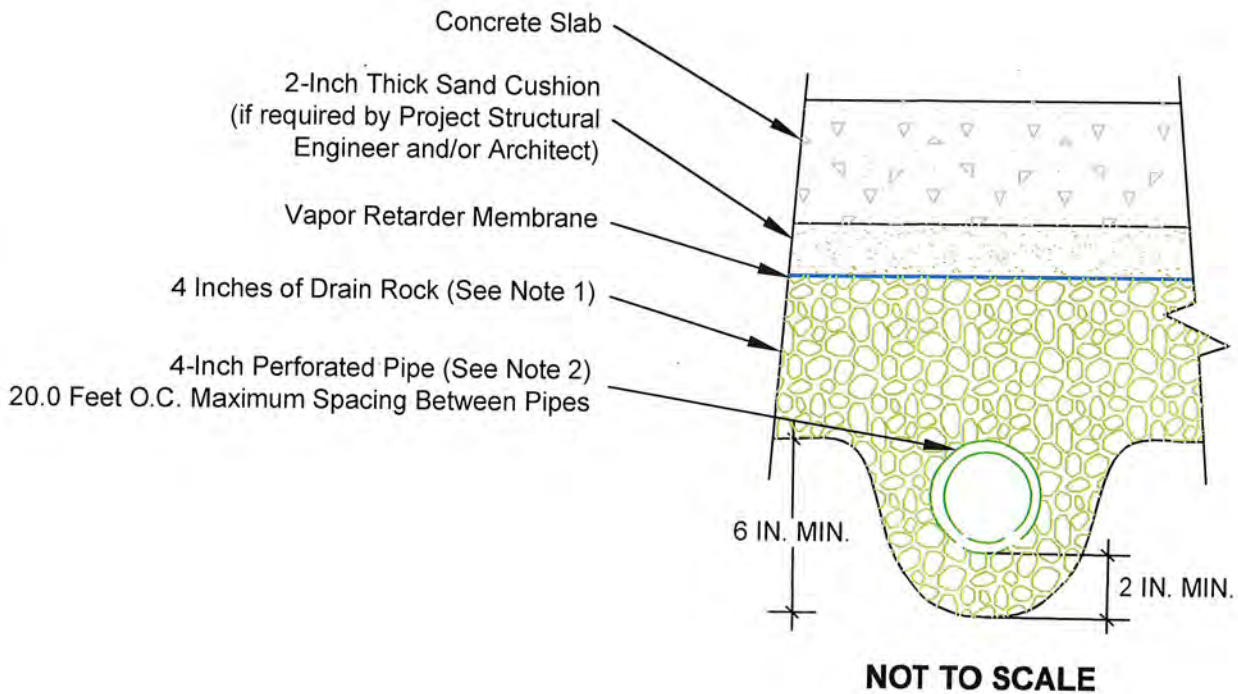
1. Drain rock should be clean, free-draining material graded in size between the No. 4 and 3/4 or 1-1/2 inch sieves.
2. Pipe should be SDR 35 or equivalent, perforations placed down, sloped at least 1% to gravity outlet, or sump with automatic pump.
3. A Clean-Out pipe with cap should be installed at the up-slope end of perforated pipe.

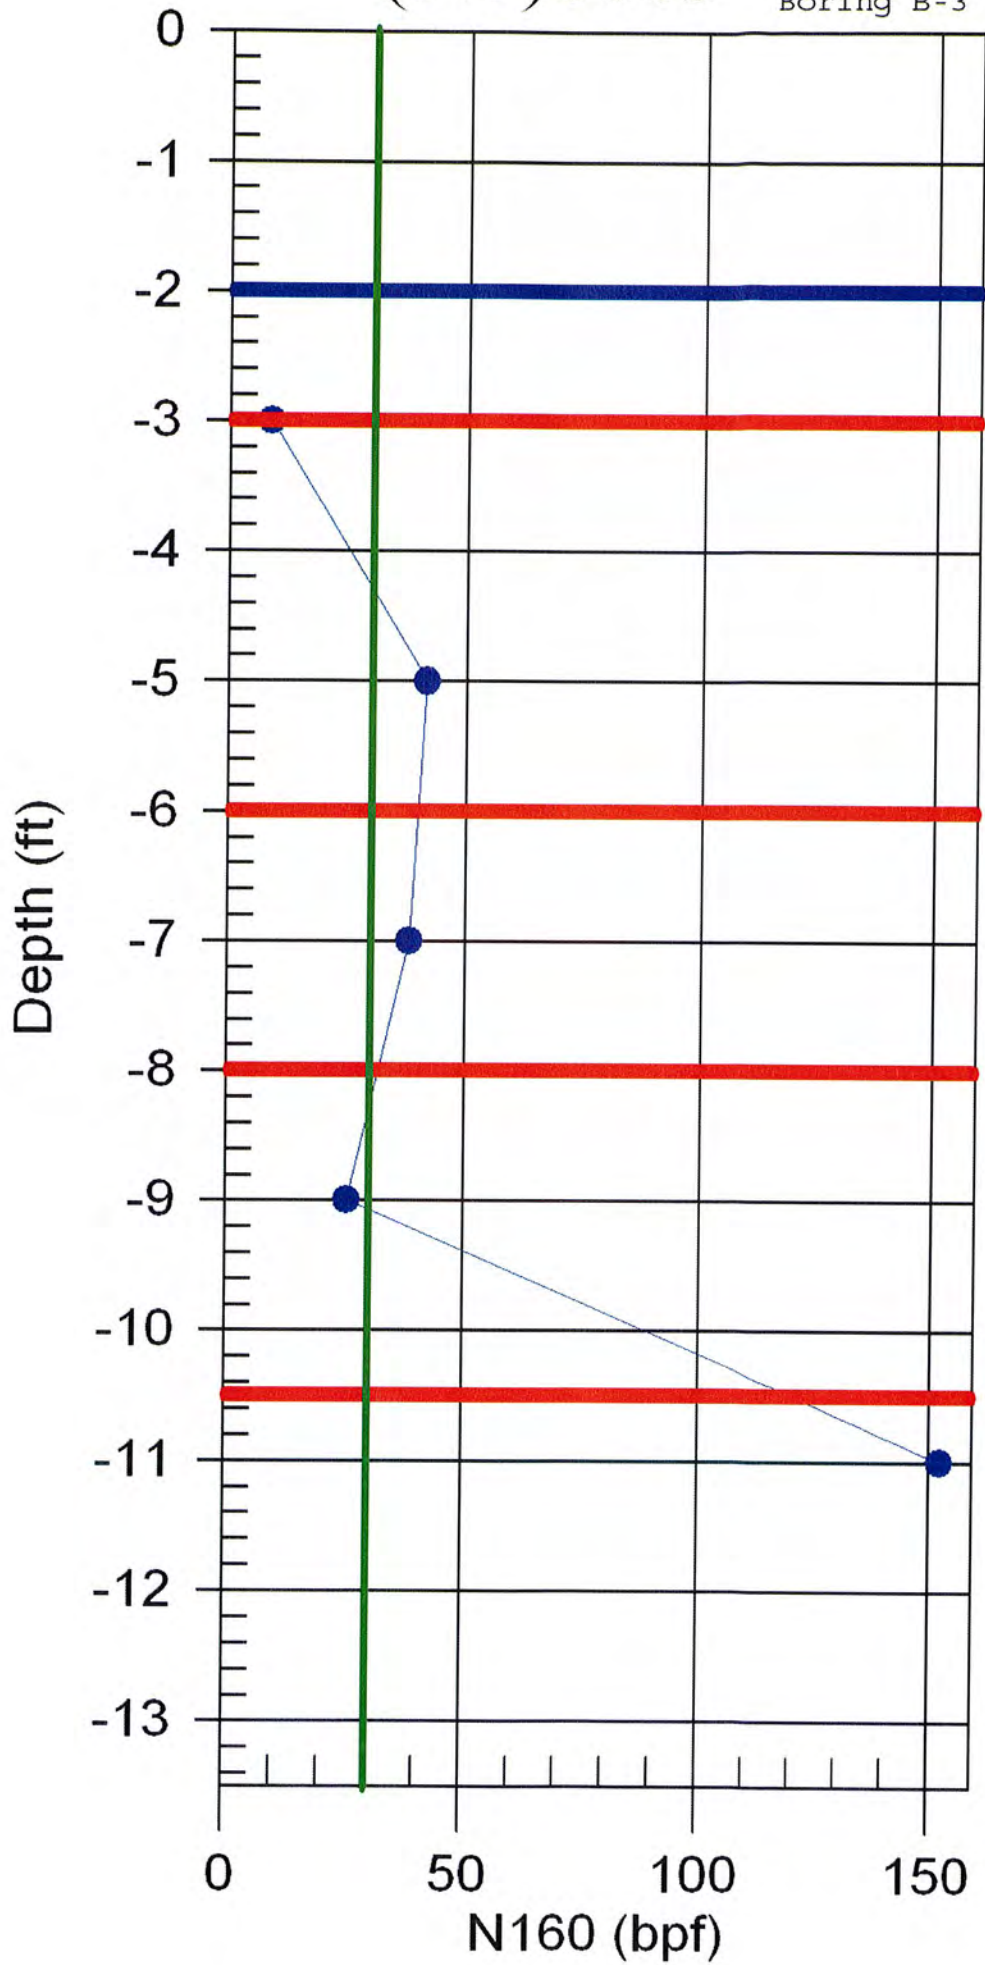
Boring B-3

Base	Field N	0/1	Unit wt.	Fines	D50	SPT Depth
▲	4	1	103	12	0.3	3
	6	1	123	19	0.26	5
	8	1	122	8	0.26	7
	10.5	1	129	7	0.26	9
*	13.5	1	132	10	0.7	11

# (N1)60cs

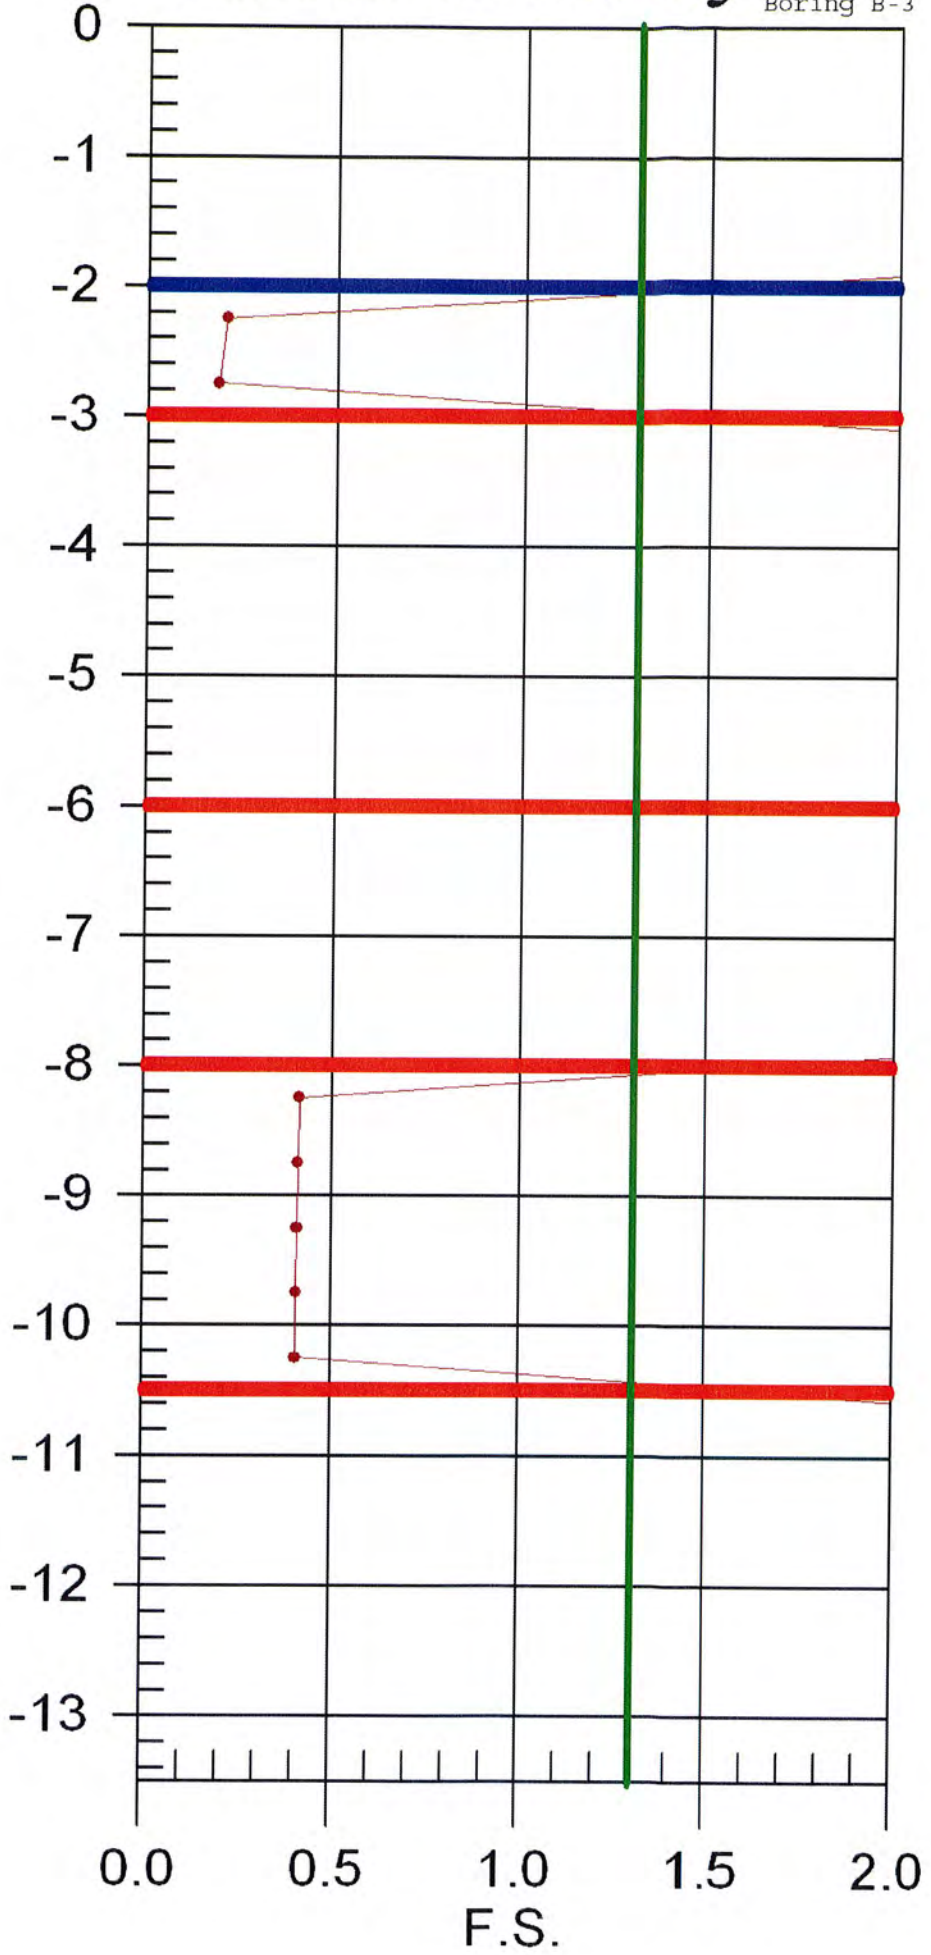
Boring B-3

# Factor of Safety

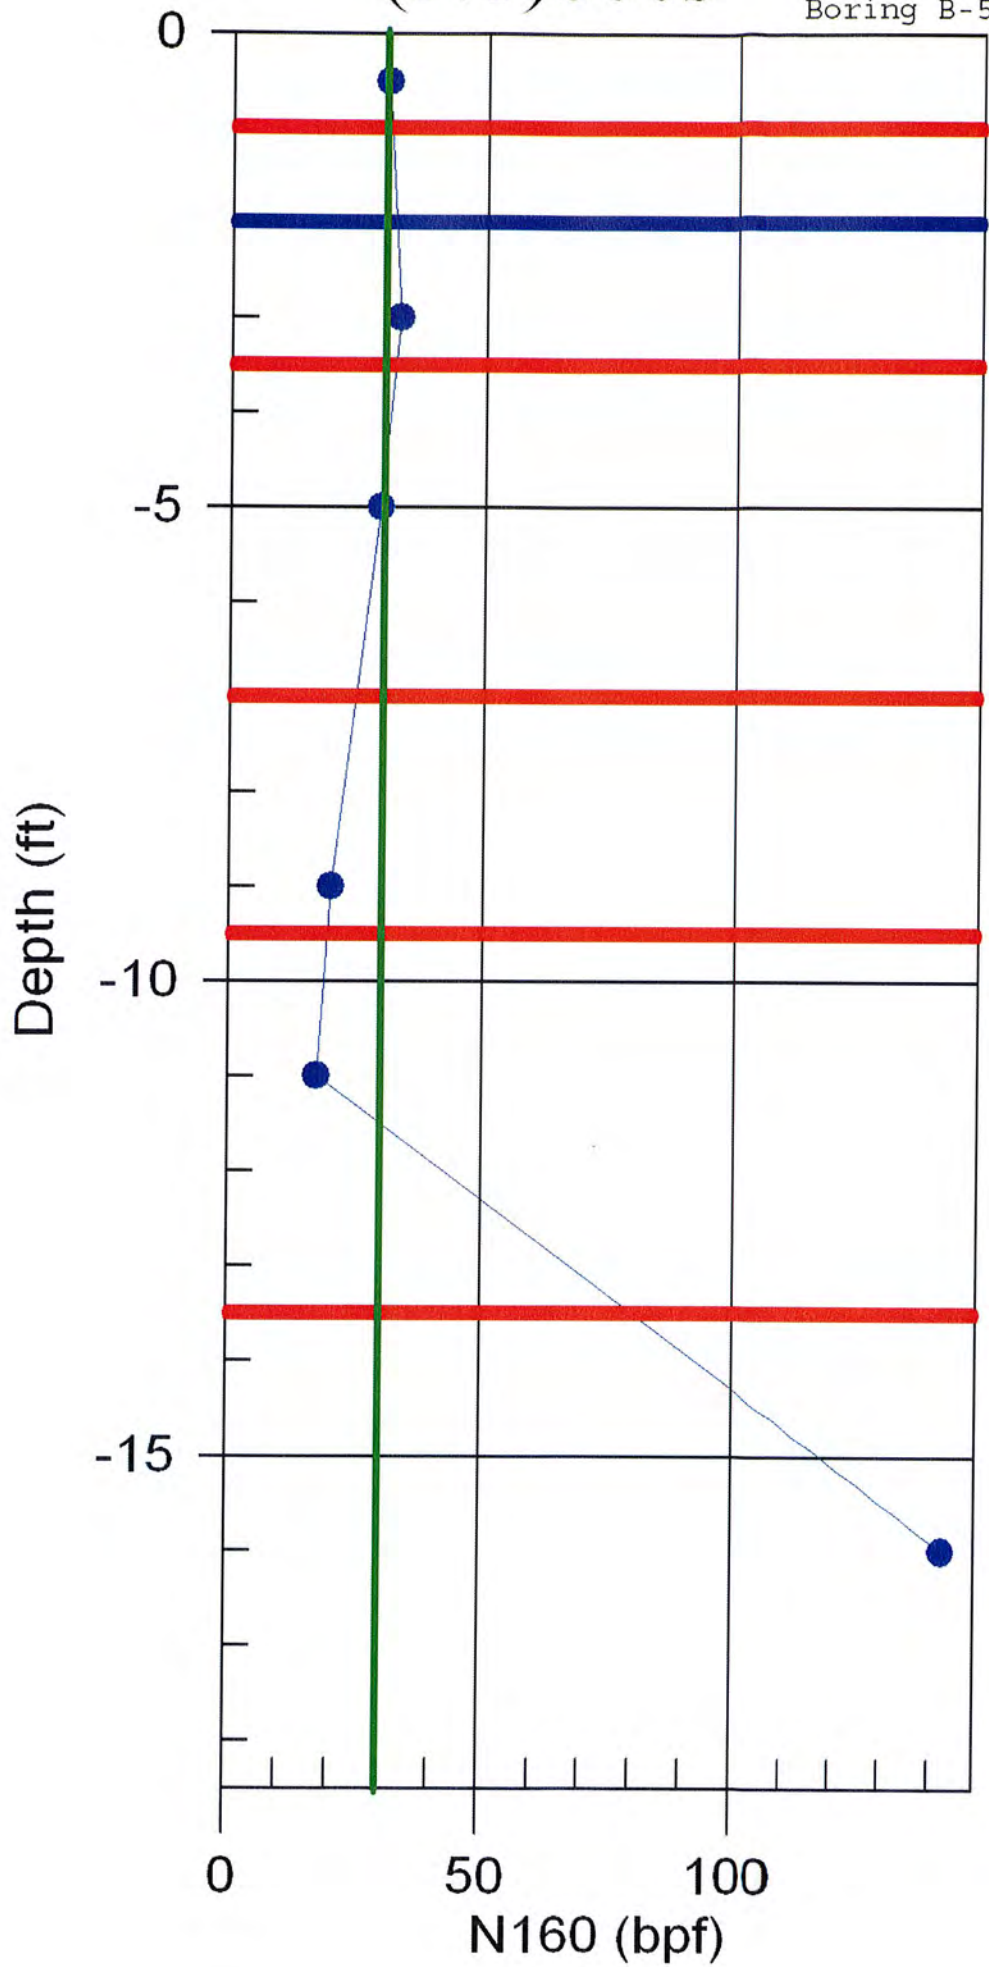
Boring B-5

Base	Field N	0/1	Unit wt.	Fines	D50	SPT Depth
▲	15	1	105	18	0.7	0.5
	3.5	1	126	8	0.3	3
	7	1	126	7	0.27	5
	9.5	1	128	12	0.3	9
	13.5	1	115	19	0.7	11
	18.5	1	125	10	0.4	16
*

# (N1)60cs

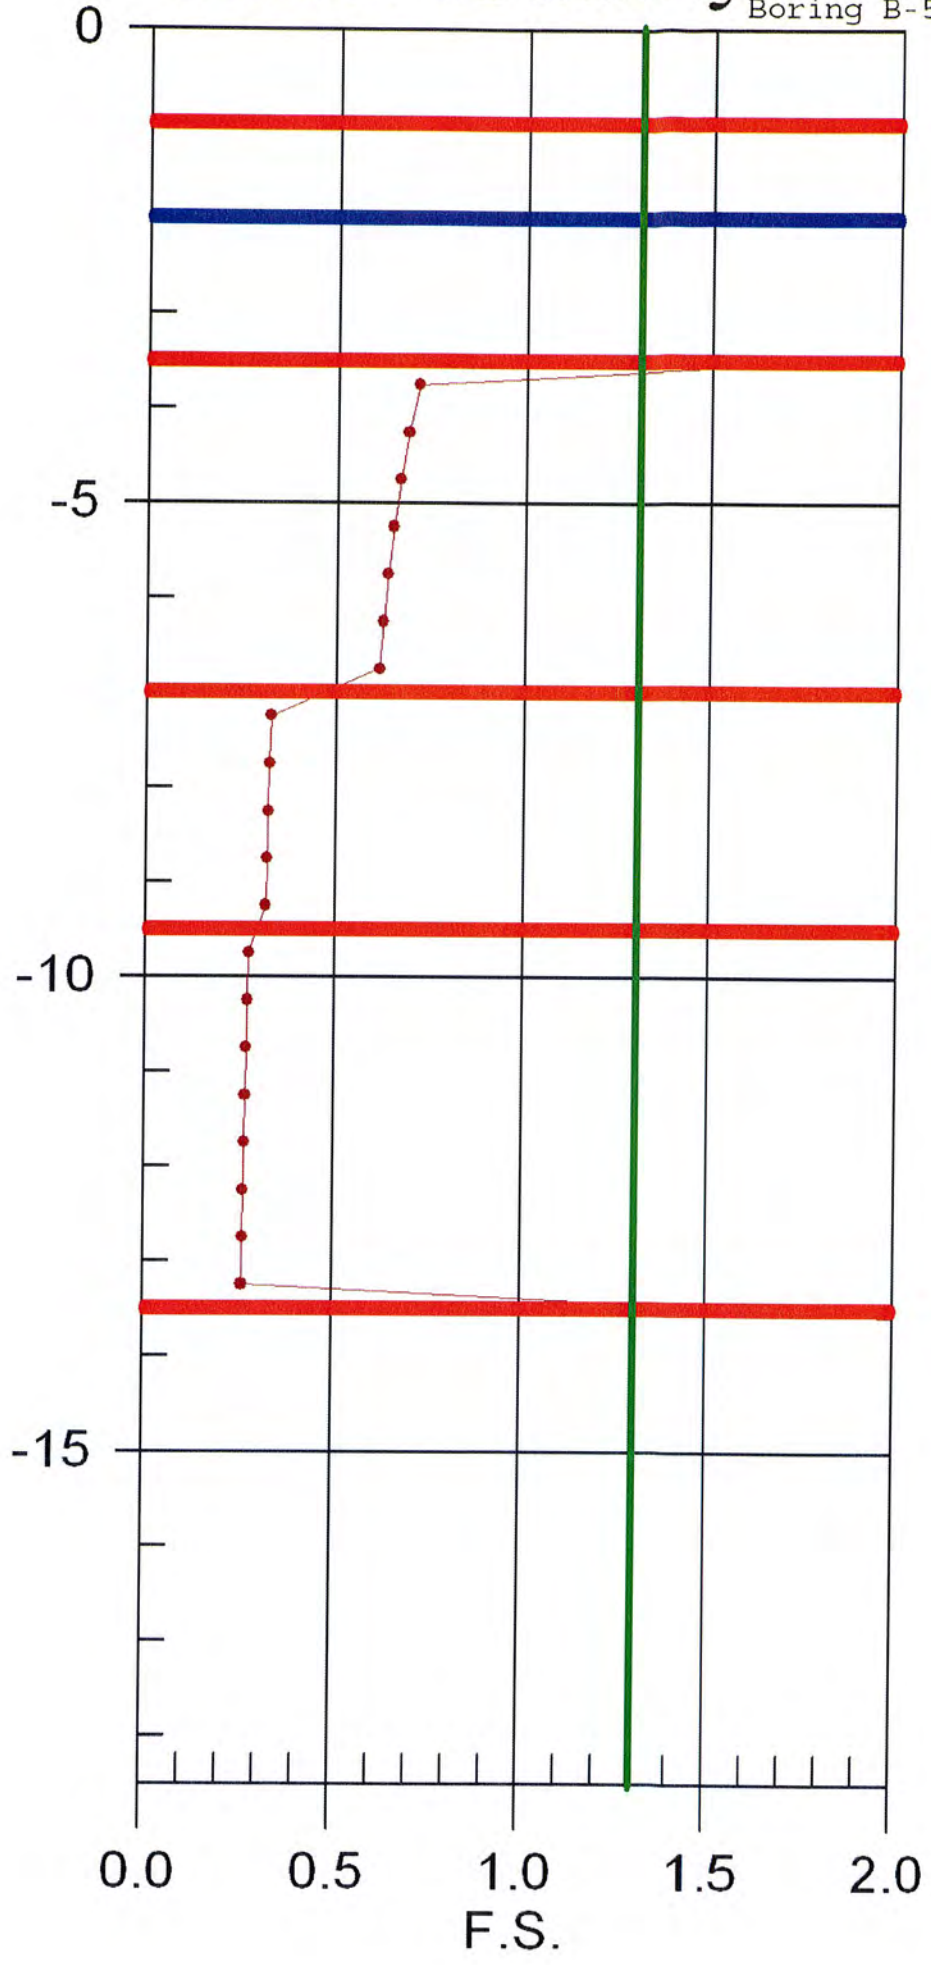
Boring B-5

# Factor of Safety
